SIA PROJECT : A 125 ton Beauty Salon session:

SIA TASK : Class 15F No.3052 ☞Avril☞ Fire Lighting and Preparation :

SIA REPAIR : Class 15F No.3052 n Avril n Vacuum Brake Line :

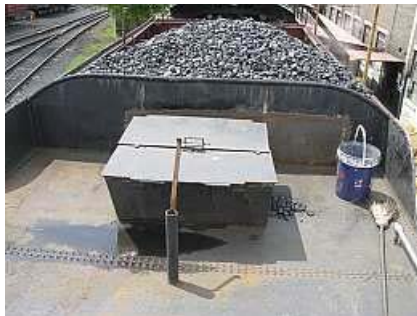
Another Lee Gates job was the painting of the tender deck, the original condition which is shown in Pic L11. (Below.) Only the water chute and the scuttle plate are visible from the ground. But the paint on the entire deck was badly worn and the tin worms were just starting to get a hold. The new patch in the scuttle plate was starting to rust too. It looked like being a dreadful job to do in the summer afternoon.

L11 ☞ An empty palette aka one rusty tender top with a patched scuttle plate.

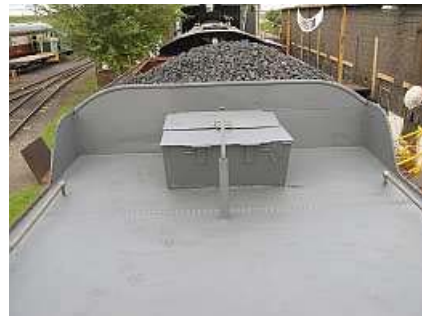
L12 ☞ Freshly painted tender deck doesn't actually gleam in the sun, but looks a lot neater and should help prevent future corrosion.

Actually, it wasn't so bad, once Stewart Currie pointed my way to a functioning wide paint brush. That paint deserves special mention as it was an industrial Polyurethane with an industrial stench. I had in mind dog putty that had been left to soak in a bucket of warm dish-washer dregs for a week. It really stank and I was grateful to be painting out in the open fresh breezy air and not in the confines of the shed. But those fumes got around. I was amused to see several people walk by the tender, unaware I was high up on the deck ☞ and suddenly stop dead with wrinkled noses and comically looking around everywhere but up. Shaun Ackerman popped up to check on progress and commented on the smell. He hadn't yet ☞clicked☞ that it was the paint and took a typically boisterously Ackerman-sniff right up to his ears in the almost empty paint bucket ☞ and froze, with an explosive plastic-echoed blanch. It reminded me of a draft horse coughing into his nosebag. I was thinking ☞Yeah! Breathe deeply, Big Boy!☞ He pinned the smell's description down even more accurately. Blocked Drain. Yeah. A back-alley restaurant drain juicily backed up, with the manhole cover steadily weeping luke-warm, pale grey water and oozing grease clots in the sun.

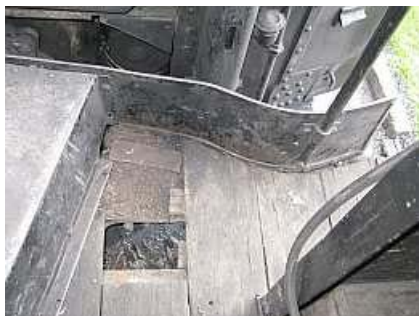
F08 The wobbly floor in the ball room. "Avril's" floor boards are nearly all soft splintery and coming loose from their mountings. This loose plank on the fireman's side was repaired last week.

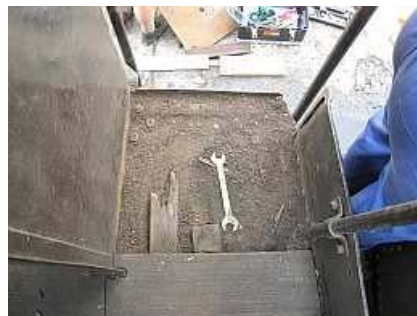
F09 Two planks came up on the driver's side, revealing rotten cross braces, termite dust, splinters, coal dust and fluff. You're looking down at the steel under tray after cleaning, but before the angled step cap was removed.

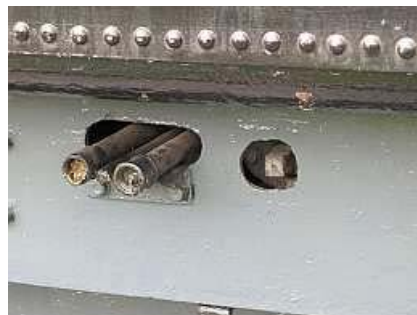
F12 The oil lines for the Stoker Motor's gearboxes. These protrude through the left tender frame and accept graphite grease.

From on the cab deck to under the tender. Shaun Ackerman and Andrew King got busy with some more greasing and lubrication. I didn't get any pics of this job though. They were held up badly by a failed grease pump and had to waste time fixing the pump rather than the engine. The main lubrication work was that of the bolster pin pivots as well as the brake linkages. The stoker's gearbox was also filled up with graphite grease pumped in fresh through the convenient externally mounted grease points. (Pic F12 above)

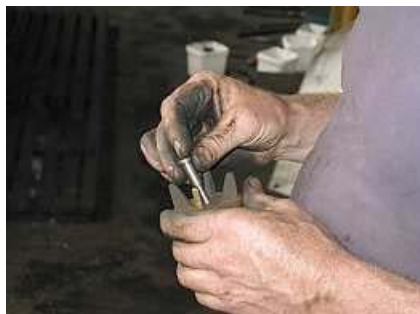
A problem discovered with the original set up was that the main air clack valve wasn't operating properly. It was found to be a combination of an incorrect limit pin and a very worn can follower. The new valve limit pin was measured up and turned down in the lathe from a 15mm stainless steel rod. (Pic E02 below) The barrel is in two diameters. This was done using the tailstock of the lathe, and a thread die-nut held in the chuck. (Pic E03 below) The lathe wasn't powered to cut the thread but being turned over by hand, the chuck providing a bit of leverage.

E04 Test fitting a new valve limiting pin. The wider head prevents the valve from lifting so far as to disengaged the guides from the seat when operating.

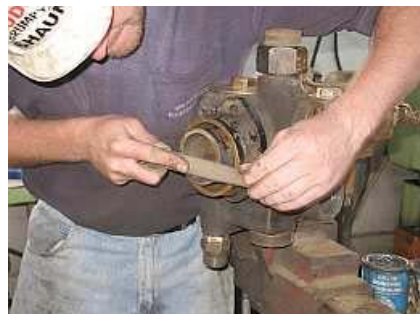
E06 Dressing the sealing surfaces of the vacuum pipe union. This is the face on which the gasket would bear.

But, back to the job. The sealing face of the vacuum line was carefully dressed with a file. (Pic E06 below) This would be later be fitted with a custom made gasket but for now, the slightly corroded brass was skimmed up to a shiny finish on the lathe and the worn, rounded spanner flats also dressed up with a file.

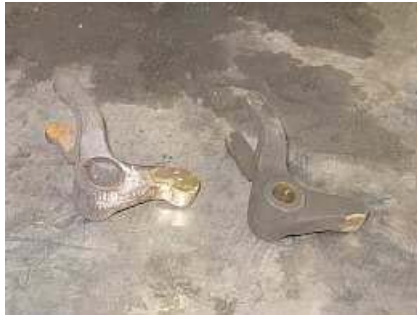
Andrew 'Noddy' King had been mysteriously gone for most of the morning. He's normally like steel shavings around a lathe always there. He'd taken a worn valve lifter from another ejector to his workshop where he's employed, to weld it up and then roughly grind it back down to the original profile. (Pic E11 below) It would be impossible for Andrew to match the profile exactly without dimensioned drawings or an original spec casting to guide him. And these ejectors all wear slightly differently anyway. Still, he did a remarkable job of building up the cam follower part of the valve lifter to a workable profile.

E11 A rebuilt valve lifter \ cam follower is shown to the left while the worn unit from Avri's ejector is shown to the right. No wonder the air valves weren't opening.

So the built-up valve lifter was fitted, through a remarkably small hole which caused some cussing! Hardly room for the knuckles much less the hand. The valve assembly is spring loaded and there was some difficulty in engaging the two stirrup-like claws. And then the center hole on the lifter had to be lined up for the insertion of the spindle. (Pic E12 below) No, not an easy job at all. One would need the hand of a gynecologist or an obstetrician to do this job with a small profile and strong fingers.

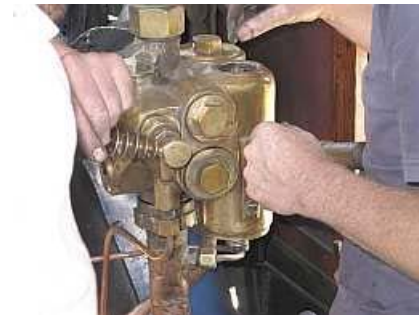
E23 Hunt the Hitch. A hopeful search for a classic dumb mistake or perhaps some dirt that got into the injector.

Reluctantly, the boys partially dismantled their, by now, rather warm injector, looking for the possibility that a mistake had been made, or some dirt or fillings got into the works. Although it would have bruised the egos a bit if they had found something in the ejector, it would have been the easier solution. However, nothing amiss was found. The only recourse remaining without opening and blanking the vacuum brake system was a very close inspection of the brake lines.

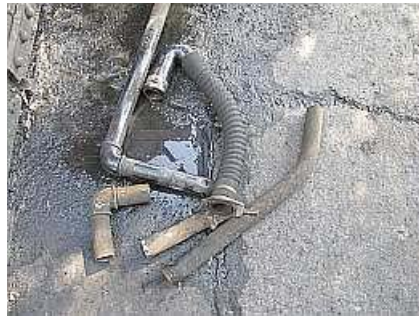
B02 A collection of cut up and dismantled brake lines. The black painted pipes are the exposed pipes for the brake stand. The angled pipe at the bottom right is the cross pipe between the running board and the center line. The rusty pipes are the dropper from the running board height to that of the front buffer.

The holed pipe had to be cut out from behind that angled plate and the entire brake stand dismantled, as there would be no room to turn a pipe back onto its threads. You can see the disemboweled pipes in Pic 02 (Below) and the split visible in the sawn-through dropper pipe in Pic 03. (Below) It could probably have been patched but that's a degradation of standards. And false economy too as the rest of that pipe isn't in great shape.

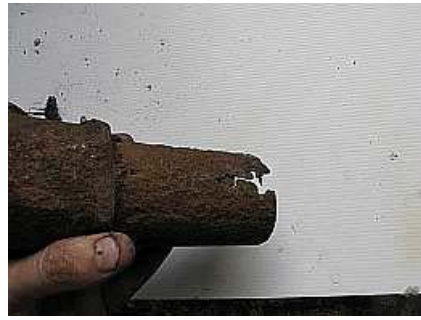
Eventually, a visible fault was found as a 1 1/2 inch long split was found in the vacuum brake line, right up front behind the angled wind deflector plate under the smokebox. It had obviously been a problem for a while but must have been patched, as the locomotive had passed brake tests previously. A problem with vacuum brake systems is that a patch can get sucked INWARDS rather than be blown off as would be expected on a pressurized pipe. It brought much joy to the boys as they'd found a problem, and some grief for it's quite an awkward location in which to work with big pipe. It's the subject of the next section

B03 Here's half the split in the very rusty dropper pipe.

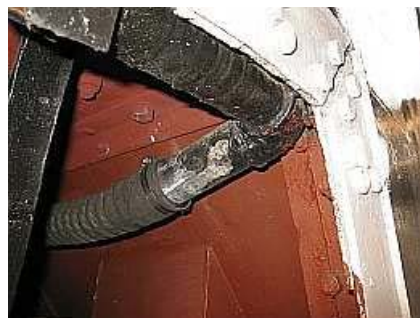
B12 The flexible pipe used to make the final connection to the angled train vacuum pipe. The front of the locomotive is to the right.

To make the final connection, a brake hose was used. The original transverse pipe was bent at an angle of about 10 degrees and we don't have the tools to do pipe bending of that diameter. We could have done a rough job with an acetylene torch and bending the pipe at red hot heat but that would weaken the steel and also burn off the galvanizing. The outside could have been painted to cover the vulnerable exposed DE-galvanized mild steel, but the interior cannot.
