### **PROJECT - Hunslet Taylor Engine Reassembly :**

**PROJECTS : Sandstone Coach Fitting :**

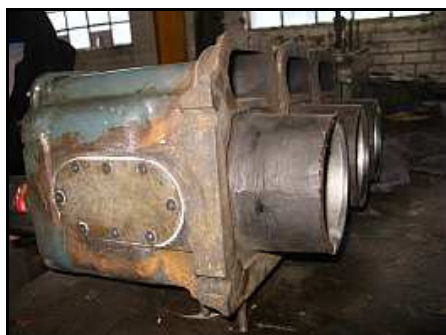
The lil' green critter's Gardner 6L series engine is coming back together and will soon be back on the frames, instead of a disemboweled monster lying pathetically upon its side. (Pic E01 below) The undignified position has proved to be useful though as both the top and the bottom of the engine are available for close-up inspection. The original problem that prompted the engine dismantling, being a leaking end plate tucked away impossibly out-of-reach between the two separate cylinder blocks, has been resolved. (Pic E02 below)

E02 – The oval end plate where the original coolant leak was, has been resealed with a gasket and with sealant. Notice that the eight bolts are actually allen heads – totally impossible to undo with the two engine blocks standing end-to-end on the crank case with about a 4mm gap..

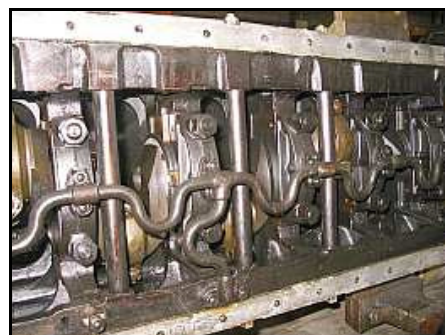
E03 – The oil distribution pipe for the main bearings. As the big ends are too big to pass through the cylinder bores, the pistons would need to come out though the crank case – so that obstructive pipe just had to go.

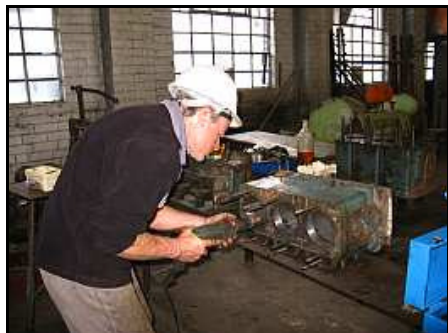
The cylinder bores were found to be in reasonable shape and didn't require honing, although the top area of the bores needed to be buffed off a little bit. (Pic E04 below) Being a diesel engine, with typically tall pistons, but UNtypically only having two compression rings, there's quite a large land between the top ring and the piston crown. (Pic E05 below) Furthermore this is a 'heron head' engine with the entire combustion chamber in a semi-hemispheric bowl inset into the pistons and the entire bore area is used as the 'squish zone.' Unlike more conventional diesel engines, and most petrol engines, there is a large part of the bore area that is 'unswept', that is, the piston rings don't contact it in service. (Pic E05 below) Andrew King rigged up a home made flapper wheel with a longitudinal cut down a shaft (with a hacksaw too!) and winding a reel of fine emery paper through the slot.

E04 – The carbon smeared unswept area of upper bores receive a good but gentle polishing with a home made flapper. This is the first cycle and you can already see the shine developing.

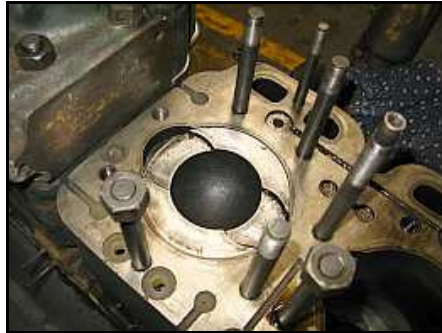
E17 – Top dead center. In practise, the induction air would swirl inwards in a toroidal pattern. (it is, colourfully, 'called 'squish') When the injector fires, right into the center of the cupped piston crown, the atomized fuel is well mixed into the rapidly heating and very turbulent air.

Notice how the inlet valve cut out (the larger one at 10 o'clock) doesn't quite line up with the pocket in the bore ... I wonder if these pistons are original to this engine?

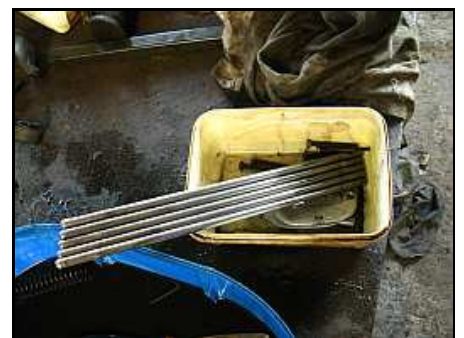
He wire brushed the mucky or crusty parts, such as the rockers and the exhaust stack clapper. But he was enjoying the job so much that he ended up power brushing almost every part except for the pushrods. These rods are worth mentioning, being strange, featureless dome headed rods of light alloy. They engage with deep hemispheric indents in the tappets and cups on the rockers. They are designed to be weaker than the rockers or the valves, so should the timing gear fail, the timing chain breaks say, when the pistons hit the valves, it is the relatively cheap and easy to replace pushrod that bends first.

E21 – The newly cleaned and rather strange looking and feeling lightweight push rods. The missing rod number 6 is the faulty rod.

The engine may have to stand for a few weeks as the Chief Engineer has visiting family to attend to. But the engine cannot progress until the two broken studs, the damaged rocker and the scrapped valve spring's replacements are obtained anyway. However, if the parts can be sourced and we have enough hands on the deck, engine reassembly will continue, and there's work to be done within the engine bay, on the radiator and the engine hood itself.

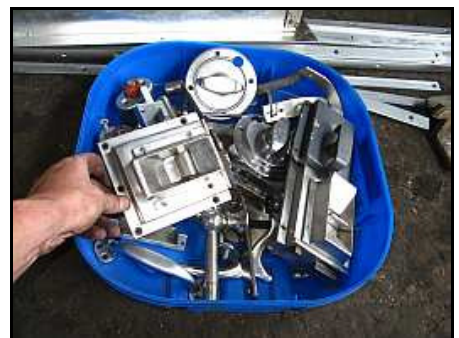
C03 – A recently cleaned and overhauled slam latch gleams in my hands as the stripped down doors themselves strike the eye in clean white primer paint.

All of the door latches were dismantled, repaired, lubricated and reassembled, with bent latches straightened and missing or broken springs replaced. (Pic C03 above) We are currently on a drive to make sure all the latches work on all the exterior doors of all our in-service coaches. Lex and Wilhelm Wehmeyer have been replacing and repairing latches on the running coach fleet.

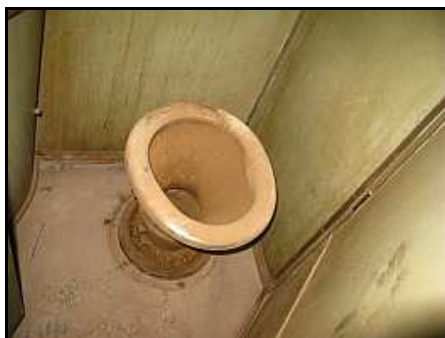
C07 – What these sarcophagic toilet compartments looked like when the long sealed up doors were first opened. After cleaning, the dust lifted easily enough. However, the streaks and stains on the compartment walls just would not shift.

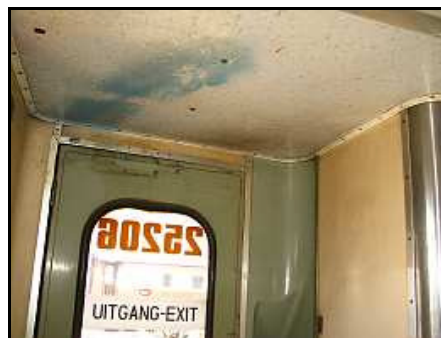
C09 – Grubby paint, yellowed laminates and a chemically stained ceiling. It looks as if the door closer had been 'repaired' and the hinges rubbed against the ceiling and someone used strong solvents to try to clean up, damaging the laminates.

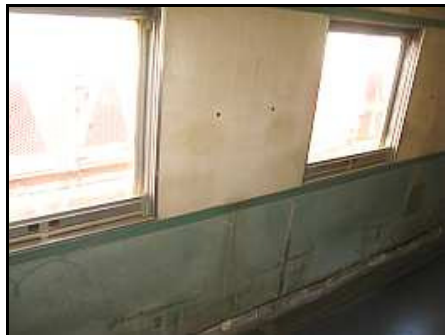
New replacements are not available and 2<sup>nd</sup> hand spares recovered from other equally well-used coaches are likely to be an equally grotty condition. Years of grime and the nicotine of cigarette smoke have taken their toll. Also, the hard laminates on these panels do oxidize over time and turn yellow – and no amount of elbow grease will remove that.

C13 – Courtesy of high-mileage Sandstone Coach No.25206, the tired original Union Carriage and Wagon SAR laminates after 30 years plus of service. The rough looking 'skirting' is actually the under plating of the original steam heating pipes, which have been removed.

So, it's been decided to smarten up our coaches with decent interior paint jobs. This way, it is also possible to fill in and patch up holes left behind when fittings have been removed or roughly modified – whereas it is quite hard to make an invisible patch in a laminated board. With spare paint, a hole can be plated or puttied in, sanded down and simply repainted. The 2 Sandstone Day-sitters are to be the test coaches for the new colour scheme. If the paint scheme is well liked, and proves to be practical in terms of cleaning and patching, all of our coaches are to gradually be cleaned and painted like these. The brown was selected as a neutral colour. The darker brown under the window sills will obviously not show dirt as much. (Pic C14 below)

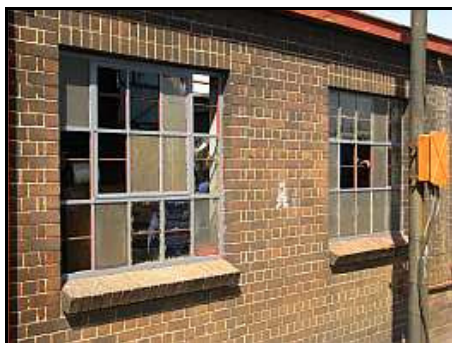
The broken panes are being removed first and being replaced with fresh, clear new panes of glass. When this is done, the existing intact but very dirty window panes will be removed, cleaned and then re-installed with fresh putty. (Pic G01 below) So at the end of this project, every single window pane will have been serviced.

G01 – Three stages of work. The broken glass has been removed first and the empty frames are having new glass fitted. Then the existing, dirty glass will be removed, the glass cleaned and remounted in the frames with fresh putty.
