FP01 Fixing the parts to enjoy the whole. (A very big whole) The leading engine unit of the [Sandstone Heritage Trust](#)'s GMAM Garratt No.4079 [Lyndie Lou](#) oversees and approves of the Saturday Bissel Truck assembly project.

PROJECT Assembling the Trailing Bissel Truck :

PROJECT Stripping Axle Bearings :

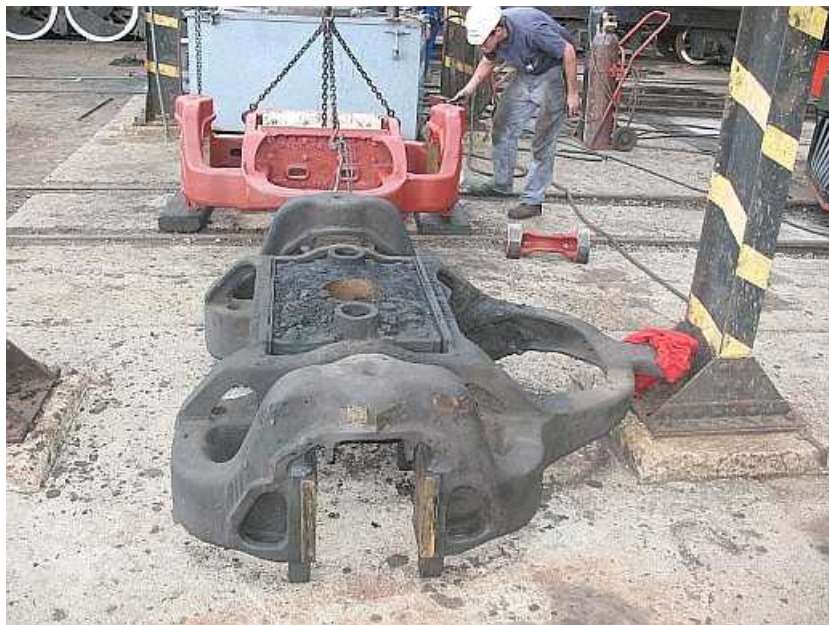
FP02 Comparison. The original rear engine unit's Bissel frame in front of the original front Bissel's frame undergoing assembly. Once the GMAM Garratt is running again, we'll clean this frame and free up the seized Bolster Plate before putting it into storage.

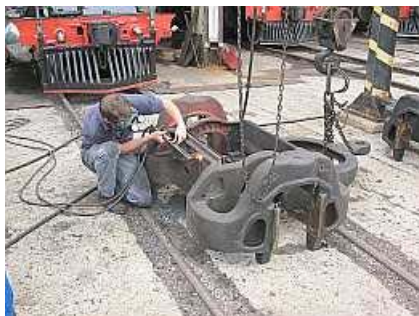
B01 ☞ Shaun Ackerman (☞Smudge☞) tackles the first row of rusty rivets holding the original plate type bolster slide bearings in place. That acetylene torch was in use for Bissel and Axle work throughout the entire day!

The Bissel Truck assembly started with the removal of the original steel-plate slide bearing rivets. These are round headed rivets which offer little mechanical purchase. They could have been chiseled off after much laboursome whacking, but our experienced Bissel Boys went straight for the acetylene option. (Pic B01 below) The original bolster slide plates are plate steel and are held on by eight rivets each, in two rows of four, with the outer rivet head a classic half-sphere, and the internal heads ground off flush against the bearing surfaces. The original Bolster Plate installation has its own strip bearing on either side, and it contacts the two slide plates above the top row of rivets. The end pins and the connecting bars of the swing links likewise contact the slide plates in between the two rows of rivets.

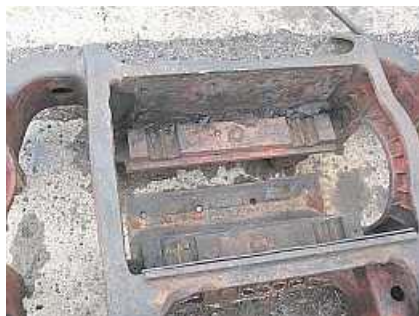
B02 ☞ The rather crusty interior of the Bissel Frame with one slide plate (top) removed and the lower slide plate still in place. Notice all that corrosion evident where the top plate was. You can see how the lower plate is distorted and pushed inwards at the top edge.

The removal of the rivets and the original rusted slide bearings went without trouble and it wasn't long between the pneumatic descaling tool was in use. (Pic B03 below) This work was very necessary as there was much corrosion revealed when the slide bearings had their rivets removed and were punched out. The expansion effect of the corrosion behind the slide plates is the crux of the problem with these Bissel Trucks, as it pushed the two plates inwards, reducing the clearances and literally pinching the Bolster Plate within the effectively narrower frames. (Pic B02 below) The frame was given a good (and rather noisy) cleaning inside and out, with special attention to the crevices, the old rivet holes and the swing link bearing pads. Dawie Viljoen would have done a dentist proud, meticulously going for all the crevices and the gaps.

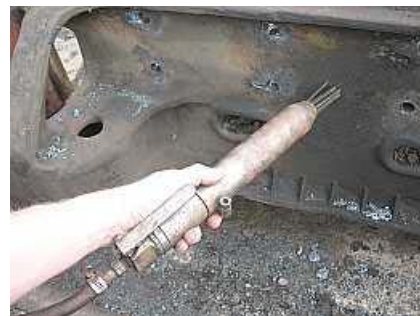
B03 ☞ A close up of the pneumatic descaling tool which Dawie and Shaun used in turn. (The vibration gets to be too much after a while.) Notice the metal shavings on the lower flange lip and the ground, the remnants of torched rivets.

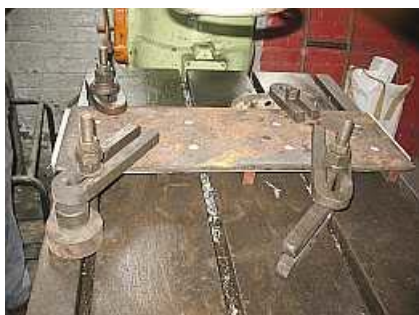
B04 ☞ The two new blank Vesconite plates clamped with one of the original slide plates as a template for drilling.

The next step was the removal of the original slide plates and setting them up as a drill guide with the two new blank [Vesconite](#) plates ☞ obviously cleaning them up a bit first. (Pic B04 below) Care was taken to make sure that the holes actually matched in both plates (by stacking them and checking that the holes overlapped) and then making sure that they were centralized on the Vesconite Plates as the Vesconite is actually longer than the original steel. The heavy duty self-feeding radial arm drill was used with both coarse and fine feed settings used carefully.

Once the 8 holes were bored through the plates, the Vesconite sandwich was dismantled and one sheet of 16mm thick Hi-Lube [Vesconite](#) inserted between the clamps. An even larger drill bit was used ☞ the fluted end to act as a crude but effective countersinking tool. (Pic B05 below) It was easy to match the diameter ☞ but each hole had to be carefully tested with the inverted head of a countersunk bolt to make sure that the final bolt head fitting would truly be below the bearing surface. Otherwise the bolts would scrape against the sliding bolster plate or the swing link bars ☞ defeating the entire purpose of the Bissel Truck overhaul. Drilling and test fitting each hole was a tedious and finicky affair, traversing and rotating the cumbersome drill. The guys switched over to manual feed for this operation.

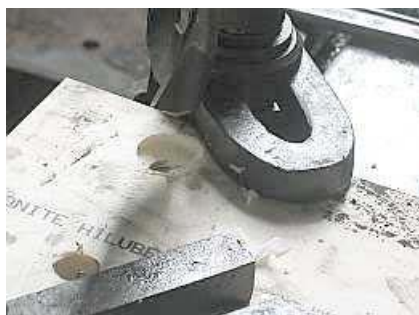
B05 ☞ A close up of a newly drilled countersunk hole next to a standard bore. This is actually much cleaner than it should be, as the characteristic very long curly Vesconite shavings have been removed.

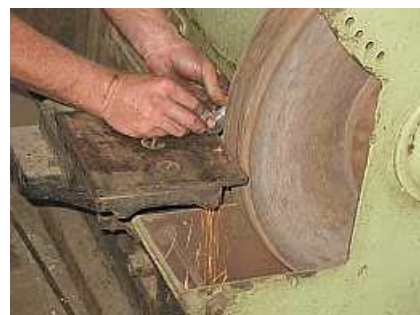
B06 ☞ The Countersinking Keys are being ground off the bearing bolts on the large grinder. You get an idea of the size of this machine by looking at the scale of the hands and the grinding wheel.

Two batches of countersunk bolts were used to get this Bissel Truck back together. The first set of eight bolts was supplied with integral locking keys under the angled face of the head. The second set of eight bolts were fabricated on site by our James Thomson, across the shed in the ☞Lathe Cave☞.

The original idea was for the locking key to embedded into the [Vesconite](#) material, cutting its own slot and locking the bolt while the nuts are

being tightened up. In practice, this has proven to be useless, as the bolts still need to be jacked in right up to molecular squeak level to stop them from turning and there's the risk of scraping away the countersunk hole. Shaun had the delightful task of grinding away those keys on the monster sized grinder. (Pic B06 above)

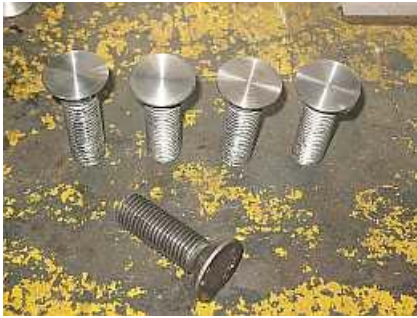
B07 A row of newly fabricated countersunk slide bearing bolts stand to attention behind the fallen original bolt used as a sample.

Notice the radial moiré patterns on the turned down heads instead of the flat reflections of a typical stamped bolt head.

James was turning and threading a set of eight brand new bolts in the Lathe Cave at the back of the upper shed. (Pic B07 below) Meanwhile, back at the Bissel Building site, Fred Sewell was exercising his wrists by polishing up the moving components of the Bissel, comprising of the swing links, the connecting bars and the four radius ramps under the Bolster Plates. (Pic B08 below) All these surfaces were roughly cleaned up several weeks ago, but as the parts have been standing around, they've become dull and a little oxidized.

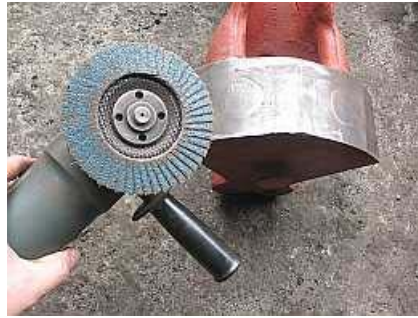
B08 The useful emery flap grinding wheel used to polish up the working faces of the swing links, the radius ramps and bearing surfaces of the sliding Bolster Plate.

Fred Sparky Sewell had some fun trying to get the two strip bearings off from the long sides of the Bolster Plate. He didn't have a proper grinder disk on him although the emery flap wheel was useful for grinding off residual corrosion. The plates had to be levered off, with a combination of two crow bars and some wedges and Fred almost tested his safety shoes when the plate fell over under the leverage. The strip bearing was originally meant to protect the casting of the Bolster Plate and to slide on the slide bearing plates of the same material. This is not necessary with the Vesconite. These overhauled Bissel Trucks thus have fewer crevices.

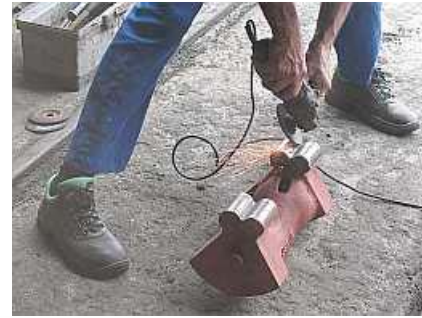
B09 The unusual geometry of the swing links (Upside down) ensures that the Bolster Plate is supported at the same height whether the locomotive is on a curve or a straight track. They are ingeniously designed so that when they are tilted at an angle, the circular lobes on the underside engage and jack up the quadrant to make up the height that would be lost in the diagonal movement.

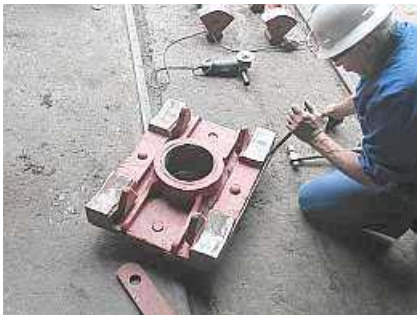
B10 Fred Sewell is levering off the two strip bearing plates from the Bolster plate. (Upside down) This pic also shows the ramps in the corners that engage the large quadrants of the swing links

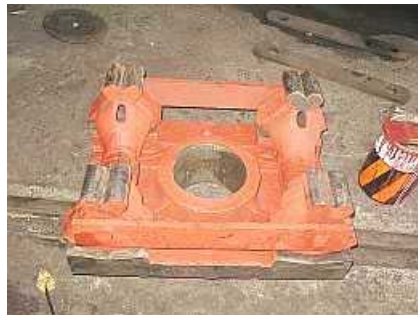
B11 The Bissel works. (Albeit upside down) Here you see the swing links, connecting bars and the Bolster plate assembled as they would have been within the Bissel Frame.

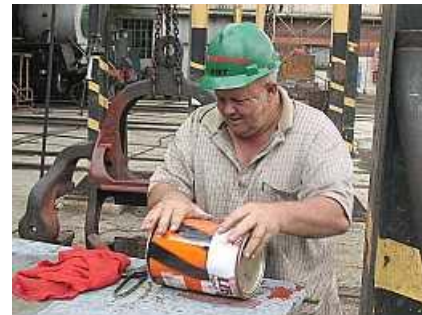
B12 The Bissel Frame is painted. Piet Buffels Steenkamp stirs up the primer by rocking the tin on the Komati box.

Simultaneously, Piet Buffels Steenkamp was painting the Bissel Frame so this big piece of locomotive had two people working on the axle, one painter, two drillers, one machinist and one whacker. The primer had settled within the paint tin. Fred Sewell started the painting process but the paint didn't spread too well. Piet, in his green Site Manager hard hat, mixed up a fresh tin of primer. He was being a bit of a skelm (Sneak for the Brits), as his official job was to help Oom Attie de Necker sanding off the paint from the locomotive's pipe, brass and copper work. Ultimately, the Bissel Frame received two coatings of primer.

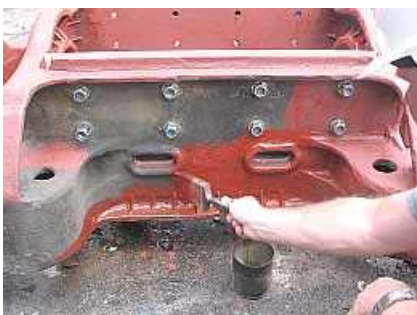
B13 Work threads converge. Piet Steenkamp sneaks in some extra primer paint around the newly fitted but still loose slide bearing nuts while the Bissel boys were looking for jacking components.

We first needed to rig up a jack and a spacer block to span the frame cavity using the jack to push the bolts all the way home and hold them tight so we could attach the nuts. Remember that those countersunk heads inconveniently have no features whatsoever and cannot be gripped. We've been tidying up the place recently and had a few wasted minutes looking for suitable wood blocks which normally lie around like acorns under an autumn oak tree. We couldn't find any suitable convenient blocks as the nice sized ones just happen to be in use to hold up the rear engine unit of the GMAM. We discovered that a span bolt sleeve makes a great spacer. (Pic B14 below) Considering its normal, role under the axles, it's not too inappropriate a job either. Fred Sparky Swell and Shaun Smudge Ackerman aligned the countersunk heads and a nut in-between the bolts and the jack ram. Dawie Viljoen got to do the tightening of the brand new Nylock Nuts and washers, while Lee Gates operated the jack. 5 men on the job. Restoration Safety Tip It is really not a good idea to put a deaf man in charge of the hydraulics!

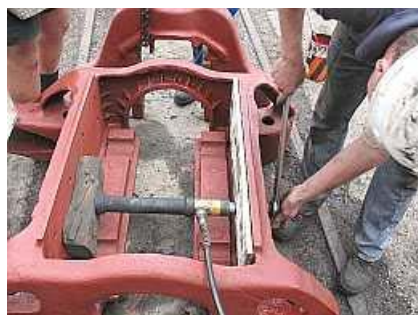
B14 An overhead view of the hydraulic jack and the spacer arrangement with a span bolt sleeve in the center. This shot was taken before we used a nut between the hydraulic ram and the bolt to drift the

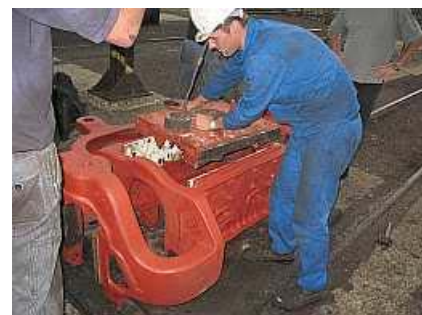
B15 Test Fit. The Bolster Plate is hoisted into place between the slide bearings. It fits between the sides of the Bissel Truck frame.

All 16 bolts and brand new Nylock nuts were installed without any fingers getting nipped. The plates cooperated and settled in well under the application pressure with no buckling. We had Piet Steenkamp sneaking in with his paint brush in between the jacking operations. The entire Bissel Truck frame received a cat's lick coat of primer after assembly anyway. We managed to chain up the Bolster plate with the octo chain and get it suspended between the Bissel Frame cavity, now narrower because of the two Vesconite bearings. It was a good fit and we left it suspended in the frame (without swing links) as the evening's rain started up and drove us to start packing our tools and especially the electrical equipment.

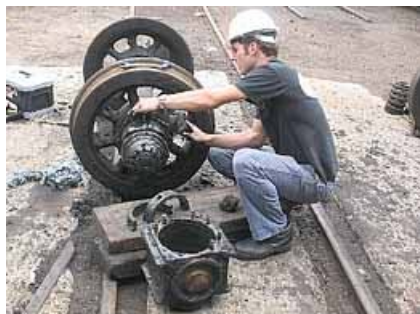
A01 Patrick Ackerman is scraping off an axle box back end. The axle box lays seal end upwards in front. Notice that two of the studs got left behind in the back plate. The blocks of wood were used to stop the box from turning. On top of the wood are the semi-circular intercostal spacers for the two outer bearing races.

The axle bearing work started with the removal of the axle boxes. (Pic A01 below) These are unbolted from their back plates with eight nuts and simply pull off longitudinally along the axle shaft end. It's not as easy as it sounds as the bolts are literally buried under literally years of dirt, as they aren't even all that accessible even with the locomotive on an inspection pit. So, the bearing work started with much scraping of dirt in-between the axle boxes and the wheels. On a removed axle, the axle boxes can just spin freely on the axle end. Thus, the box needs to be wedged and held down so it doesn't just spin on the axle when the bearings are exposed.

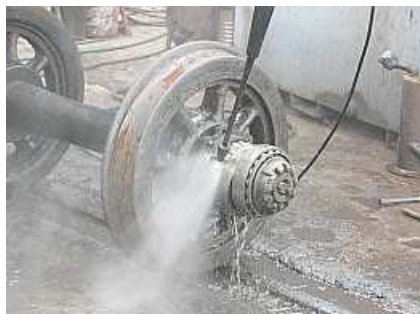
A02 A high pressure water wash in action. Care was taken not to over spin the bearings although the drag of the displaced outer races acted as a brake anyway. The bearings would later be washed with a mixture of degreaser and diesel fuel.

The bearings were then cleaned with rags and the grease within the boxes was scooped out. Then it was time for a high pressure cold water wash. (Pic A02 above) It may seem counter intuitive to wash a bearing out with water but this is simply an economical way to physically blast grease from the bearing cavities and races. We were using the brute hydraulic force of the water rather than chemical action of solvents and degreasers. This was a rinse-and-repeat operation the bearings getting blasted and then turned to expose new surface. Even though a light film of the grease remained, (Pic A03 above), the bearings could be inspected under the scattered water droplets.

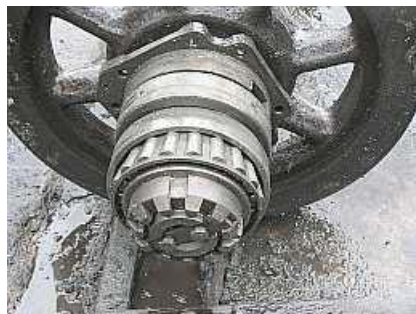
However, those axle bearings were found to have become spalled, the case hardening beginning to crack showing characteristic black inclusions and slightly pitted areas. This leads to flaking. With the case hardening disintegrating, while the softer materials deform when the rollers get pounded under the point loads, the hard chips and fragments mix in with the grease and pound the rollers accelerating bearing wear. Rolling bearing wear is exponential the rate of destruction increasing over time.

A03 A freshly water-cleaned bearing glistens under the oily droplets. Notice the almost horizontal split pin holding the castellated retaining ring in place.

The two silvery rings on the outside are the outer bearing races, and the darker notched ring at the back is integral with the backing plate, and acts as a combination spacer, thrust plate and axle grease seal retainer.

We really weren't happy having to condemn this set of bearings, especially as we have no spares. Safety dictates that the bearings be in top shape for a Bissel Truck especially on a symmetrical double-ended locomotive such as a Garratt, where a trailing Bissel Truck could just as easily become a leading unit at mainline speeds. Nevertheless, the Reefsteamers' focus on engineering excellence, as per our motto, means that we weren't going to bodge this job. We could have gotten away with just stuffing the axle boxes full of grease and running the engine on suspect bearings.

With the degreasing done, not forgetting the axle boxes (Pic A05 above), the intercostal spacers and the classic old Timken bearing covers (Pic A06 above), closer inspection of the bearings could now take place. The bearings at both ends of the axle displayed evidence of spalling ☞ the case hardened layer beginning to break up ☞ and one of the bearings was found to have some mild chipping starting in the rollers. As inconvenient as it is for our tight schedule, the axle bearings were condemned and made ready for removal.

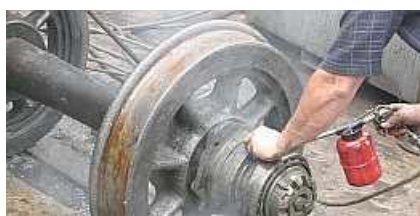
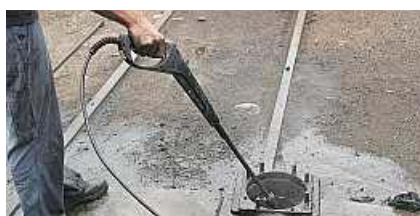
A04 ☞ Degreaser and diesel mixture being applied to the bearings. The air gun had a small capacity and needed frequent topping up ☞ but the compact wand could be aimed directly into the cavities.
Notice the catch container to catch the dribbles.

It didn't look too bad, so Andre and Patrick continued setting up the spray gun to apply the degreaser \ diesel mix as pre-prepared by Piet Steenkamp. It looked like weak antifreeze. The degreaser would strip the remainder of the grease, while the diesel would serve to do the same, but also to help clean up the water as diesel fuel is hygroscopic.

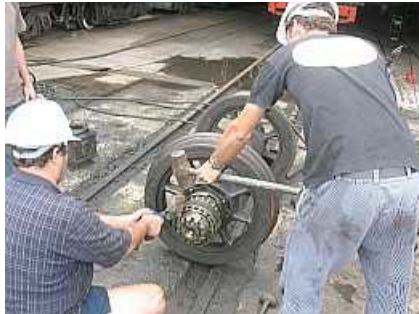
A07 ☞ The first attempt to get the castellated retainer ring off. We were very wary of the possibility of hurting someone in this operation.

This meant some entertaining grunt work in getting the split pin off the castellated retaining ring and then trying to remove the ring itself. No doubt the Railways had some sort of tool that enclosed the retaining ring and engaged with the slots, and allowed for the application of leverage. We had to make do with a drift. We tried initially with a hand drift, and eventually with a wedge held in the handle of an old spade. (Which is better not photographed.) We wanted to have the guys standing well clear of the mallet stroke. Eventually the retaining ring had to be heated, and evenly too, for these would have to be reused. It was a right royal battle to get them off and some of the castellated slots got damaged. It has been seriously suggested that we design and fabricate a tool to perform this job, especially when our coach bearings start requiring attention.

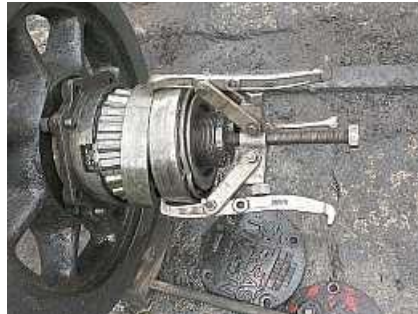
A08 ☞ A tripod bearing puller takes the strain. Notice the nuts wedged behind the arms to keep the claws straight. The bearings still had to be tapped and the inner races heated to get them off.

The bearings themselves weren't much easier to get off and it was amazing how much they were able to resist the enormous traction that we had applied. A tripod bearing puller was applied but was unable to grip properly due to the diameter of the bearing. Hex nuts were used to wedge the arms away from the center frame and thus line up the claws for a better grip. (Pic A08 above) The puller alone was unable to do the job. We cycled between heating the inner bearing race with the acetylene torch in an attempt to expand it, and trying to jar the bearing free with a copper hammer applied to the center bolt of the puller.

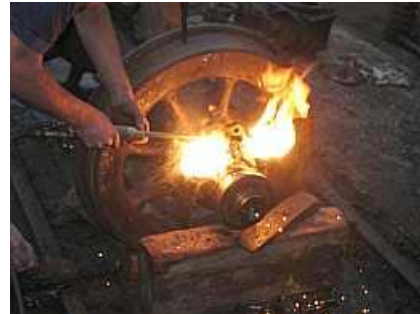
A09 ☞ Inelegant defeat ☞ using a torch to cut up a bearing after it cannot be withdrawn from the shaft. The flames are from the residual degreaser and diesel fuel that has ignited.

A bit of chisel and hammer work in the heated sections cut the bearings up amongst a scatter of rollers.

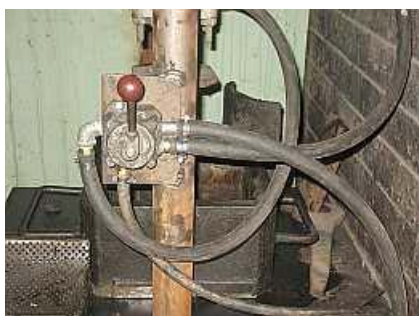
P01 The newly installed grease press pneumatic cylinder control valve. The rectangular container in the background is the grease pad mould.

The cylinder has been connected up and the bi-directional control valve installed. (Pic P01 above) Andrew Noddy King conducted a cycle test with all the trimmings, a block of grease, a dolly, a profile plate and some compressed air. The test was a failure. The grease was sufficiently indented to accept the profile plate but there was insufficient pressure to force the grease through the holes. (Pic P03 above.)

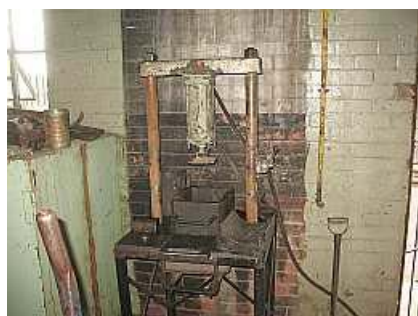
P02 Looking like a medieval instrument of torture, the Axle Pad Grease Press is almost complete. The mould is in place and the grease gate, fabricated last week, is in the closed position. Below the grease gate is the waiting, empty catch frame.

The Axle Pad Grease Press was completed and tested for the first time today. The machine accepts the extruded block of grease, and presses them into a rectangular mould. This grease is very stiff ☞ it has to be, to hydrodynamically bear the weight of a locomotive within the axle bearings. On top of the grease block is mounted a perforated semi-circular profile plate that matches standard axle journal diameters. Then a matching semi-circular shaped dolly is inserted within the concave surface. The pressure of the ram presses the semi-circular plate into the block of grease ☞ the plate's shape being backed up by the dolly block. The grease is meant to ooze through and protrude through the perforations.

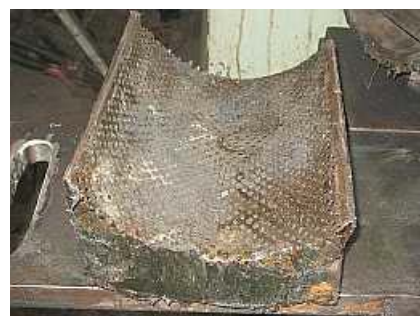
P03 Failed test sample. The former plate is sufficiently indented into the grease but the grease has failed to penetrate through the holes. This test sample is resting sideways on the withdrawn grease gate.

I happened to walk into the grease shop on one of my photo patrols just in time to see the conclusion of the test. It is been a while since I've seen Andrew looking so disgusted. Andrew now faces the exciting choice of either using a wider cylinder, or rigging up a hydraulic system, which can inherently supply more force in the actuator cylinder than the equivalent pneumatic system. Apparently Fred Sewell has found a hydraulic kit this week, so both options are open.

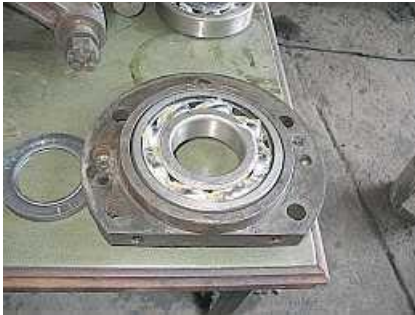
S01 New Crankshaft Main Bearing installed into one of the crankcase end housings. It's merely an interference fit no press was required to insert the bearing.

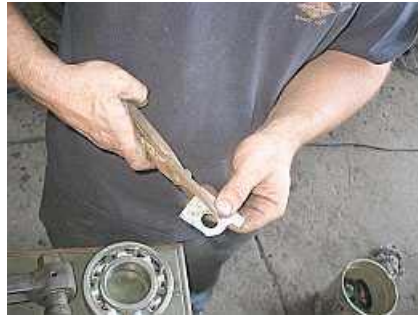
S02 Cutting out new shims, using an original brass shim as a template.

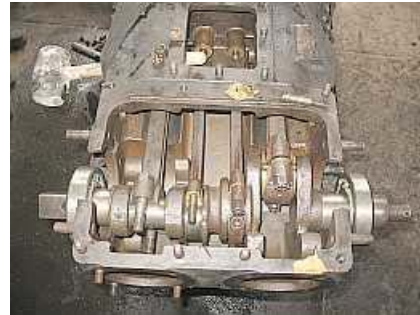
S03 Top view of the open Crankcase with all internal components installed (except the left hand big end bearing cap)

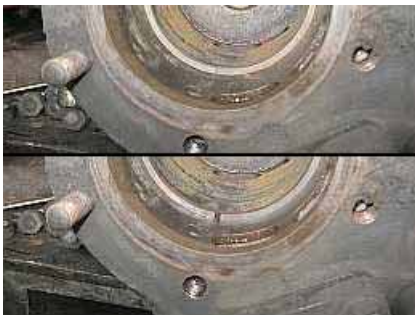
S04 Comparison with new and old piston rings, the end gap of the worn rings quite evident in the lower photo, and the gap properly almost closed in the top photo.

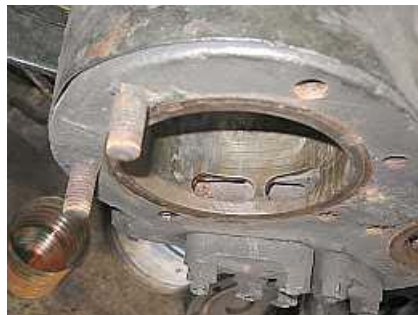
S05 A view of the steam ports in the cylinders. The valve chamber covers still need to be removed. Notice the two cylinder head studs still seized in place. Michael cleaned and serviced each one of the studs.

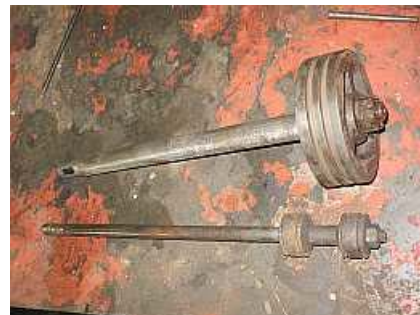
S06 A removed piston and valve spindle. The piston has been roughly cleaned but the valve spindle is as-removed. Notice that the valve ring slots, of which seven had NO rings, have filled in with corrosion.

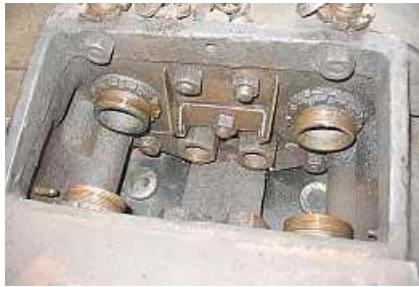
S07 View of the empty rod chamber after the pistons and valve spindles have been removed. The valve rod apertures are the two smaller ones in the center.

With the pistons and the valves removed, the gland packing could be taken out. (Pic S07 above) This is done from above the engine, with tapping on the characteristic castellated gland nuts. These were in poor condition and will need to be replaced. The engine design cleverly uses an empty rod chamber between the oil filled crankcase and the live steam components. It is vented and acts as a buffer for leaks. Michael also fabricated new gaskets (Pic S09 above) from the crankcase end covers using the classic ball-peen tap-against the work piece methodology to outline the gaskets. However, the holes had to be marked and drilled, and the curved inner and outer surfaces had to be neatened and dressed.

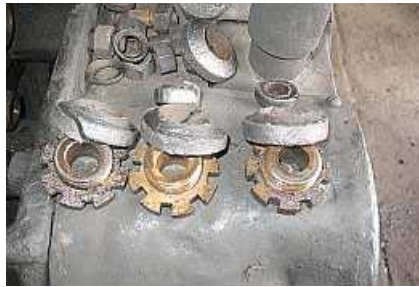
S08 An array of piston rod glands and the castellated gland nuts lay spread out on the cylinder cladding. Notice the correct helical gap in the gland seal on the left.

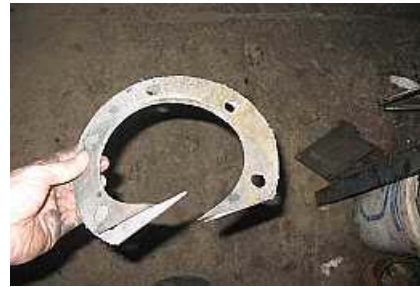
S09 A newly fabricated gasket for one of the two crankcase end covers.

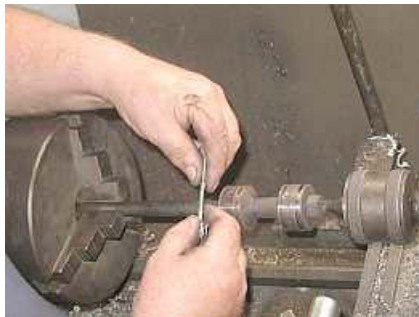
S10 James measures the thicknesses of Valve Ring grooves while spinning the spindle on the lathe for cleaning.

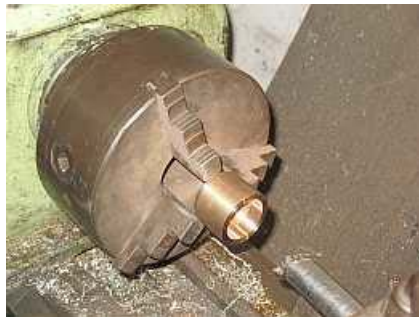
S11 The brass stock centered in the lathe for turning.

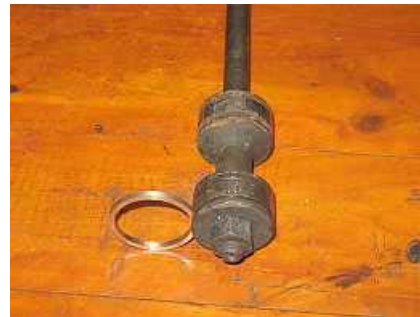
S12 A newly machined valve ring blank engaged in a groove on the valve spool. The ring's slot hasn't been cut yet.

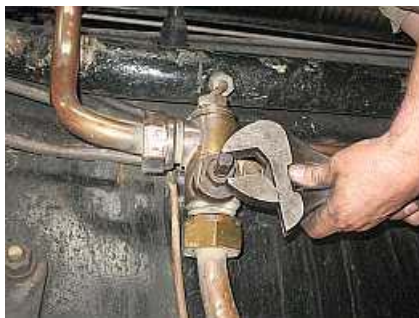
G01 A close up of the Class 15CA No.2056 Drifter Valve with Johann adjusting his wrench to fit the gland packing nut. The cab is to the left of the picture.

There was much work to be done. The Drifter Valve, as well as the Injector Seller's Valves on both sides had to have their gland packings replaced. Johann found the drifter to be easy but the Seller's packing needed quite a bit of patient winking out with a stout hooked wire. The glands of the reverser valve chambers just needed to be tightened up a bit. (Pic G02 above) Johann did have the luxury of a stout, stable scaffolding frame upon which to work, as well as a boiler only luke warm and cooling down from the previous day.

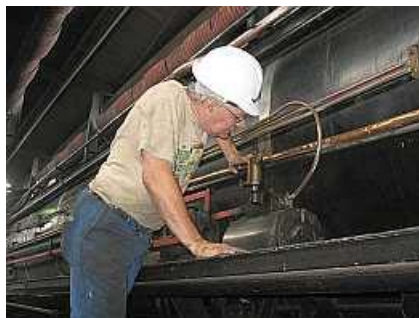
G02 Johann Breydenbach visually checks the glands for the Power Reverser's Actuator Cylinder's Valve Chamber. He's resting his left hand on the Displacement Lubricator and is actually looking at the gland for the 1/4 inch steam supply line for the cylinder.

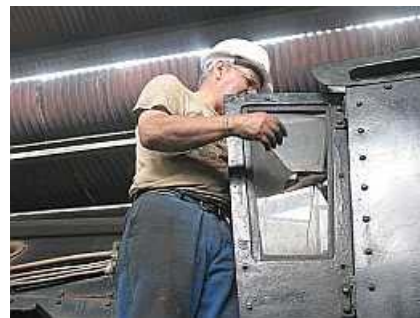
G03 The train was stoned on a recent trip and one of the rocks smashed the fireman's window. Here the frame containing the broken glass is being removed.

As you can see from the photo, the glass was just standard glass, neither toughened or laminated. Johann removed the pane with the broken glass, still intact within its frame. (Pic G03 above) Although the shape of the broken window is irregular, the glass is flat and should be reasonably easy for a competent glazier to duplicate.

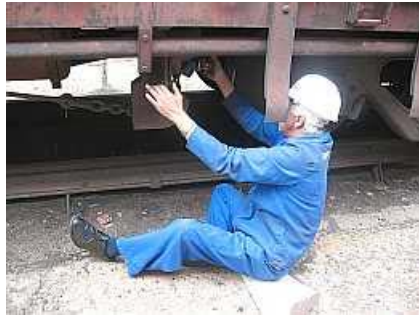
W02 ☹️ Safety Officer Cliffie Mathee spent the day inspecting handbrakes on the rolling stock. Here, he is lubricating the very stiff handbrake gearing and chain pulleys on the Friends of the Rail NZ Gondola. His left hand is on the quadrant block and you can see the actuating chain angling up to the left.

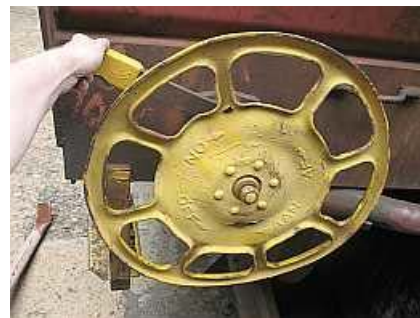
W06 ☹️ Lee and Cliffie test a handbrake quick release lever. This one was totally disengaged and the one on the other end won't move ☹️ this beat old wagon needs some serious maintenance!
