Project GMAM Garratt Bissel Truck overhaul :

Project Stoker Motor Overhaul :

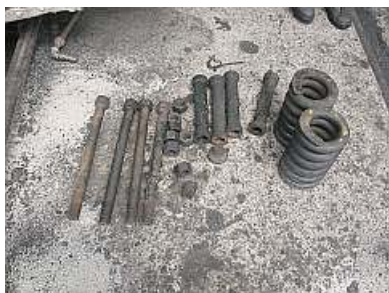
P01 A choice assortment of dirty axle bolts, sleeves, springs and nuts wait to be cleaned, lubricated, primered and then painted..

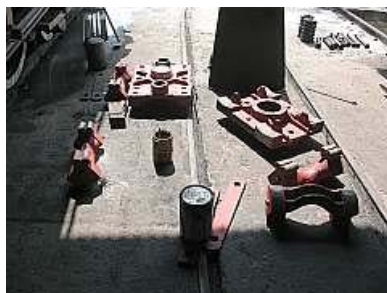
P02 Some cleaned and painted Garratt Bissel hardware from last week with rusty threads from being left in the rain. Those strange looking twisted brackets in front are for the Bissel oil cups.

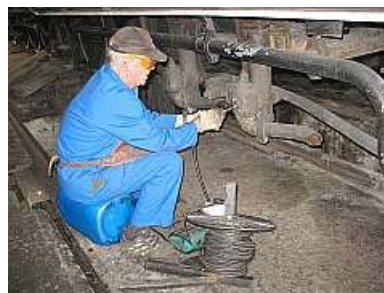
P03 Tony King gets to play with some flexible shafted power-toys. He's busy cleaning the dirt from the GMAM Garratt's injectors.

Without the team leaders guys present, and the tool store still locked, the waiting Reefsteamers kept themselves busy in other ways. Tony 'Soapy' King set up a neat little flexible drive on a power drill and started wire brushing the dull patina'd injectors on the Sandstone Estates GMAM Garratt (Pic P03), while Lee fired up the workshop wire-wheel and got busy cleaning removed pieces of Bissel Truck hardware. (Pic P01 and P02) Andre and Piet kept themselves busy cutting a desk organizer in half to suit the length of our trestle tables.

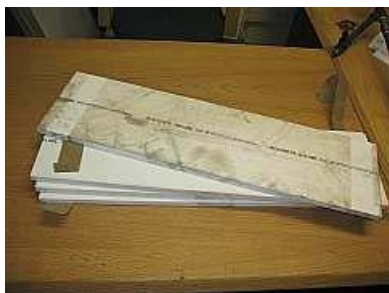
P04 Hi-Tech breadboards. Four sheets of HiLube Vesconite as obtained by Shaun during the week. These are to be used for the sliding surfaces on either sides of the bolster plates.

Shaun Ackerman managed to get his greasy mitts on some vesconite sheets during the week. It's the HiLube Vesconite variety of 200mm wide and 16mm thick. (The original stock length is 2000mm) It has taken me a while to get used to the appearance of Vesconite tube stock looking like thick walled conduit. And now here's Vesconite sheeting, looking like rough cut, very hard, bread boards ... or perhaps a stack of cheese platters. (Pic P04) It's seriously good stuff though and is currently in use by Transnet Rail Freight on their locomotives. you can spot a refit bogie yards away by looking for the gleaming white in amongst the axle slides and the traction gear. This Vesconite is to be used for the Bissel Bolster Plate slides, both fore and aft. It's hard wearing, tolerant of dirt ingress and self lubricating, all of which are very desirable qualities in the mucky, and frequently infrequently (pun intended) lubricated under pinning of any locomotive. (Diesels and toasters too, for that matter.)

It was hoped to mount the Vesconite today but it needs countersunk bolt to fasten it to the Bissel frame which is a Sunday Project. A further modification will be the drilling and tapping of the Bissel frame for an array of grease nipples. Although the bearings and slides will survive without greasing a bit of regular tribology makes things work even smoother.

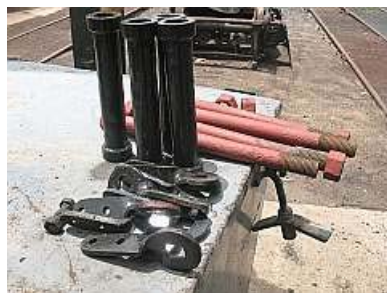
P05 A spread of cleaned and primered removable Bissel Truck parts.

Some progress had been made during the week. The liberal, repeated application on diesel fuel on the seized bolster slides of the original Bissel Truck eventually freed those slides. I wonder how that would do as a constipation cure? During the week, the removed Bissel Truck was dismantled and the removable hardware cleaned and primered. (Pic P05) The fixed hardware, such as the guide plates, axle slides and the swing link bearings still need to be removed and the rivet holes sorted. For now, the Bissel frame is hanging forlornly from the gantry hoist.

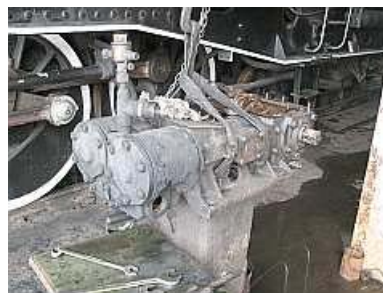
P06 The removed Sandstone GMAM Garret Stoker Motor awaits some attention on a work pedestal. Notice that the crankcase has already been opened in this pic.

Although not Bissel related, additional progress was made in the removal of the Sandstone Estates GMAM Garratt's stoker motor, which was slinged and ready to be dismantled and checked for worn bearings and parts. (Pic 06) Piet Steenkamp did the removal.

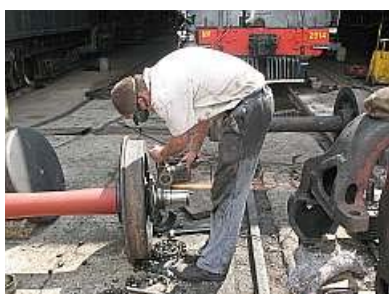
P07 A goggle eyed alien, who bares more than a passing resemblance to Shaun Ackerman, tackles the splitting of hardened steel bearing races with an angle grinder.

Bissel work today was the stripping of both the donor axle and the ordinal removed axle. The donor axle had both the axle boxes removed last week so the bearings were exposed. These had been cleaned last week with a spray gun loaded with oil and then lightly greased with soft white grease. But upon cleaning and further investigation, the bearing rollers were found to be pitted. Drat! So it was off with the races. It was quite a challenge as the parts were hardened all the way through, not just case hardened as in some varieties of rolling stock bearings. Shaun cut grooves in the bearing races (Pic P08) and then used a club hammer and chisel to split the parts. (Pic P09) His angle grinder disk was much diminished in size by the end of the day, and several trips had to be made to the bench grinders to re-sharpen the chisel! (Pic P10)

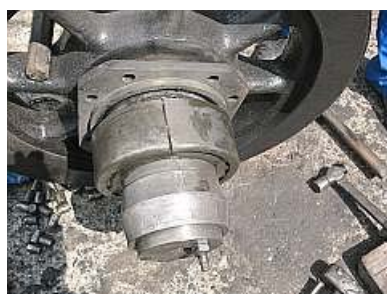
P08 An inboard outer bearing race that has been grooved just prior to some delicate hammer and chisel work to split it.

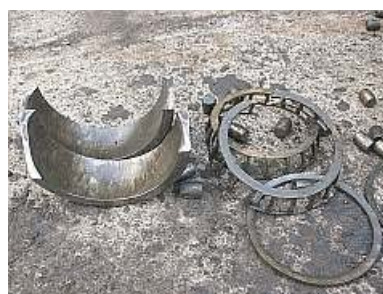
P09 Rest in pieces. A scatter of dead bearing parts. a split race, two bearing cages, a spacer ring and a generous sprinkling of bearing rollers.

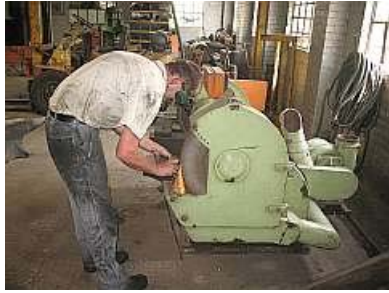
P10 One of many trips to the grinder to put a new cutting edge on the chisel used to split those very hard bearing races.

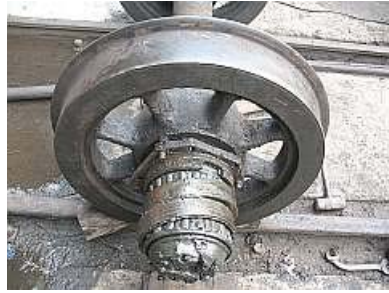
P11 An axle box surprise. An older self adjusting bearing is revealed as Kerry and Jaun removed the axle box on the original axle.

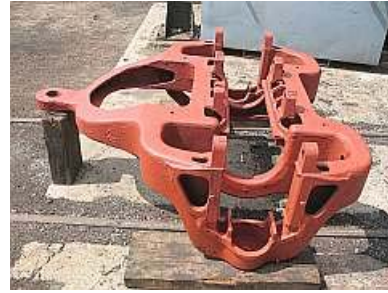
P12 The stripped and primed donor Bissel's frame waits patiently while it's components are stripped and overhauled.

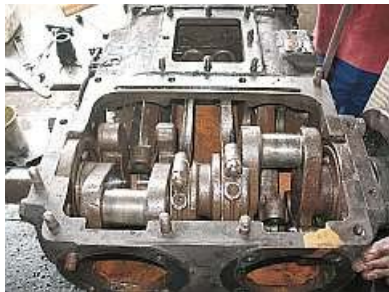
S01 The Stoker Motor Crankcase being stripped. It's a two cylinder engine. The two con rods remaining in the center are for the valve gear eccentrics. You can just see the big end of the left hand rod lying prior to removal.

The dismantling went without problems. Michael had to file down a rounded and bent big end cap nut. You can see a brazed scar in the crankcase in Pic S01 something nasty obviously happened in the past. And the person who repaired the crankcase must have re-used the nut. Michael got that filed-head nut off but then ended up with the unenviable task of getting all the metal filings out of the oily surfaces.

Piet 'Buffels' Steenkamp removed the Garratt's Stoker Motor during the week and had it set up for dismantling by Saturday morning. Michael Thiel, as an ex Spoornet fitter, was ideally suited to the job and started stripping the crankcase and its components. With the exception of the valve gear eccentrics and rods, the crankcase strongly resembles that of a mutant, low speed 2 cylinder petrol engine.

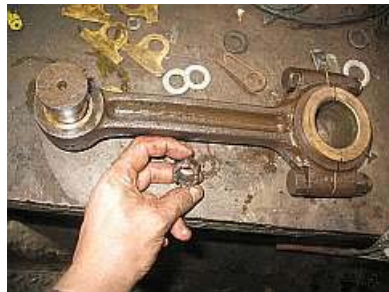
S02 Stoker Connecting rod being dismantled on the work bench. Here a badly worn big end cap nut is being examined. Those brass shims at the top left fit between the big end cap and the connecting rod.

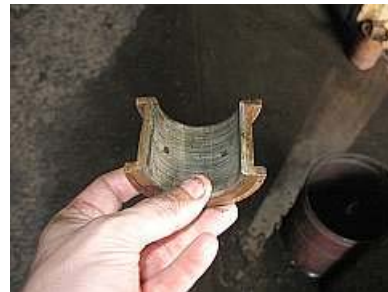
S03 A worn and scored Big End Bearing.

The big end bearings were found to be scored although the lubrication passages were reasonably clean. The crankshaft journals were found to be spalled as well. The gudgeon pins are loose and the crankshaft bearings (rollers) were found to be worn.

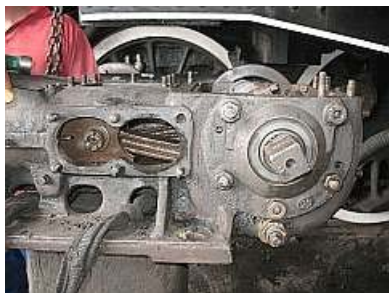
S04 Side view of the Stoker prior to crankshaft removal. Behind the inspection cover, you can see the LHS valve eccentric rod and the valve spindle's cross head.

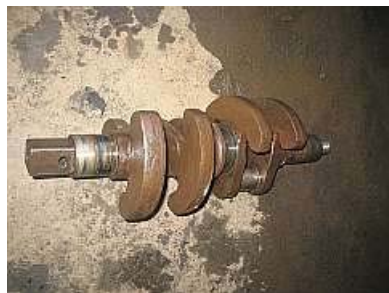
S05 The two-throw Journal Crankshaft with one of the valve eccentrics visible. Notice that the cranks are 90 degrees apart to avoid the situation of having both pistons at dead center and thus a motor that won't start. (A steam locomotive's crank pins are set up the same way.)

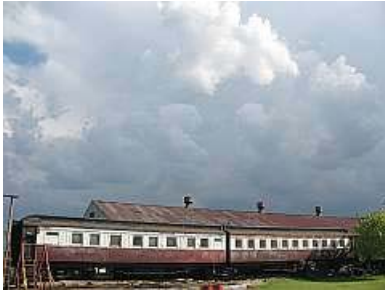
H01 Some good motivation for some roof sealing work, a thunderstorm builds up steam on a Sunday Afternoon. The LHS coach is the open-space coach while the RHS coach still has its original sleeper compartments.

So it was decided to finally make a start on cleaning up those coaches and getting them ready for interior work. The clean up operation was conducted last week. One half of the articulated coach set still has its sleeper compartments while the leading half has been gutted, although partition slots, roof trusses, and a basin still remain. (Pic H03) This week's work involved the repair and sealing of the leaking roof. (I didn't get photos of this work) The next step is to get a bitumen layer on the roof. All this work should help prevent further degradation of the coach interiors by water ingress.

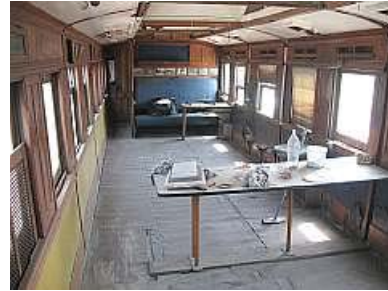
H03 Gutted coach interior after some cleaning. This used to be a sleeper coach. That blue seat at the end is one of the bunks against an intact compartment wall.

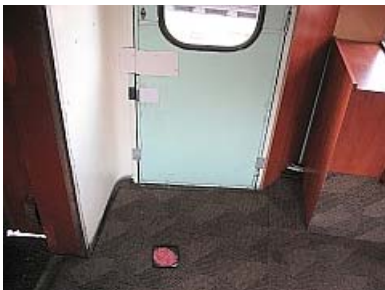
C01 - Completed sealed coach door with plating over the lock and latch cavities. You can see the grey coloured bolt plates a few inches above the floor. Now it just needs painting. Notice the rat treat in the vestibule.

Fred Sewell disappeared as he usually does and would have been found, if anyone cared to look for him, working on his own amongst the coaches. He actually prefers working this way and is often to be found wearing an i-Pod headset and totally tuned out. Fred continued his Bar Car Door upgrade project. All the four replacement doors are now mounted and screwed permanently closed. Their lock cavities have been covered and bozo-proof No-Entry and No Exit signs have been stuck up in the windows. (Pic C01) One of the doors needs to have a damaged interior panel replaced and they all need painting to match the interior colour scheme. But the sealed doors all function as they should do. (That is, by not functioning, if you know what I mean.)

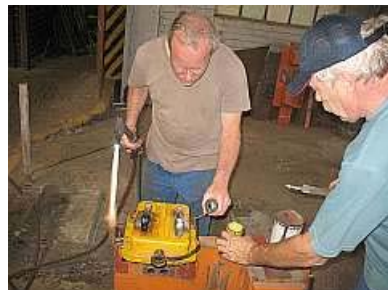
C02 - The generator radiator expansion tank receives some soldering on the flank panels. The tank is poorly designed as the flank panels flex when the water-cooled system is pressurized, contributing to metal fatigue and eventual leaks.

The Power Car's Generator also received some work. The expansion tank was removed and some weak points were soldered up. For a machine that has a long duty cycle, without the frequent expansion and contraction that the equivalent water cooled system of a car engine undergoes, it is surprisingly susceptible to expansion cracks and metal fatigue issues. And because the generator runs unattended, water loss is generally not noted in time. Furthermore, we no longer trust the automatic shutoffs.

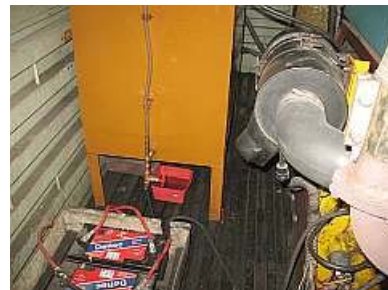
C03 - Relocated Generator Diesel Tank fuel intake. You can see the raised intake just above the lowest of the shut off valves. That red container under the tank marks where the original tap point was.

The generator failed twice on our recent trip to the [Potchefstroom Aardklop culture festival](#). Both times was due to the fruit milkshake effect. That is, when one has slurped through to the bottom of the glass, a piece of fruit jams in the straw. In this case, the fruit is the crud and sludge resident in the bottom of the diesel fuel tank and the straw is the diesel supply line. It's probably the little dinosaur bones still to be found that that primordial ooze. The fuel intake was from the bottom of the tank hence the frequent blocking of filters, as well as the primary fuel line and its taps with dirt. The fuel intake has been relocated to the side of the tank, allowing a few inches at the bottom of the tank to act as a sludge reservoir. (Pic C03) Let's hope we can keep the coach lights running more consistently!

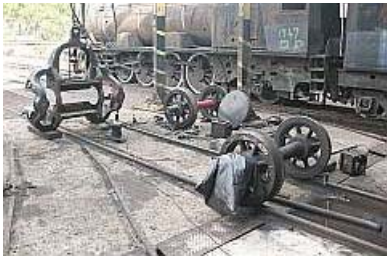
M01 A general view of the Bissel and Axle Servicing area at the East End of our workshop shed. That 12R loco in the background is No.1947 Fosie and is one of the locomotives for which we seek sponsorship to restore via Steam in Action.

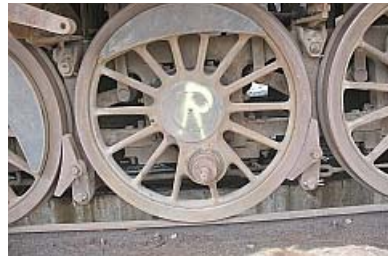
M02 The dreaded capital 'S' spells an engine's end as condemned for Scrapping. Here is an 'R' for 'Retain' or 'Reserve' on the wheels of a Class 15F loco otherwise marked up for cutting.

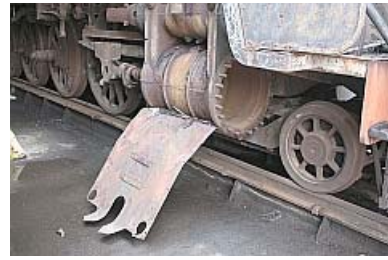
M03 A Class 15F Locomotive in the dead-line shows a clean set of cylinder castings behind a sprung and fallen cylinder cover plate. The total lack of the usually messy looking insulative lagging shows the complexity of the cylinder and valve chamber castings works of art.

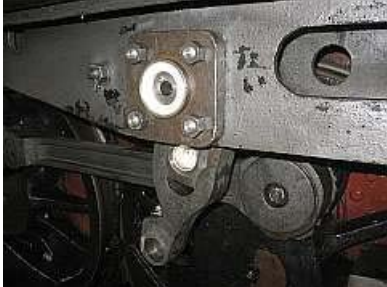
M04 Class 12AR No.1535 Susan now sports expansion links and die blocks with eerie looking shining white custom-made Vesconite bearings.

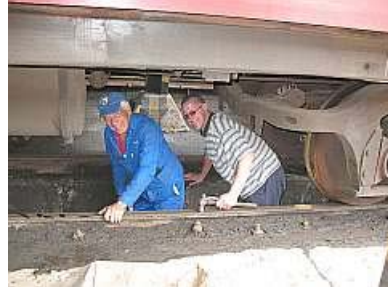
M05 Cliffie (Left) took a brand new Reefsteamer (Greg) around on his first day, and introduced him to the delights of coach brake and running gear inspection.

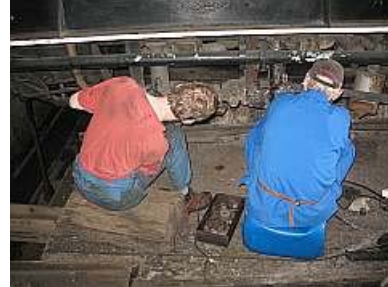
M06 Kenny and Tony look sweet as they sit side-by-side, each with a power drill and a wire brush, and tackling the cleaning of the brass and copper components.

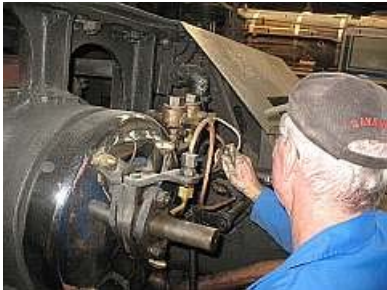
M07 Tony King gets to grip with the myriad pipes and fittings of the Garrett's pressurized lubrication system. He's remarkably patient with Brasso and a rag.

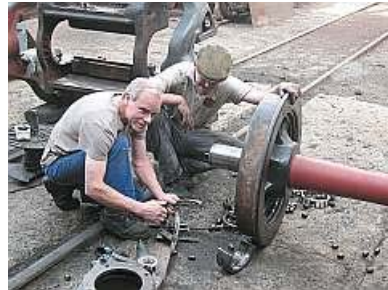
M08 Andrew King (front) got a bit teed off towards the end of the day. It was one of those days where he is constantly getting interrupted and asked for advice and he got none of his own work done. Here, he feels better getting a puller ready to pull a bearing back plate off an axle.
