## Introduction :

In amongst our slow, but steadily more visible and consistent program of Depot Improvements and Upgrades, the long under-utilized Reefsteamers Water Tank was given a good service and has been put back into operation. Along with a growing list of improvements such as stores, lighting, new window glass, paint work and many more, we now have a properly functional water tower! It actually was more or less operational, but was leaking badly from the swiveling delivery pipe and the valves. Thus, we left the tank standing high, dry and empty. As our Depot is supplied with potable water from the council mains, the financial waste of constantly running water 24/7 can be substantial. But there are two more subtle problems. One is the continued degrading of the tank's exterior metal work through constantly being wet with waste water. The other, more serious problem, would be the formation of pockets and "blow holes" in the soft soil around the foundations, from the constant dripping from a high level. It would take a lot of dripping to weaken the adjacent track, (but it is possible) but the damp mud and the pot holes would be trip hazards for train crews and shunting staff.

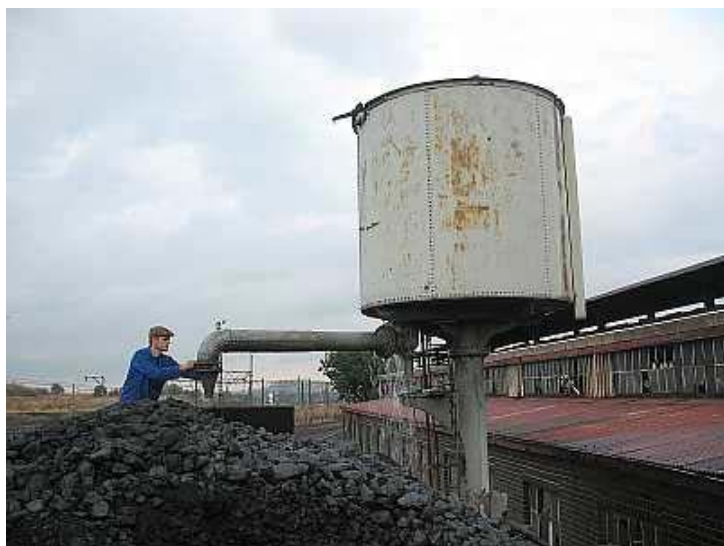
FP01 - Ironically, this photo was taken just over a year previously on this day, on the same locomotive (25NC) with Patrick Ackerman wrestling with the original hinged pipe. (6 Oct. 2007) You can clearly see the original swinging pipe arrangement and the bad water leakage from around the elbow. What you don't see is the leaking from the delivery valve as well.

- 5). The tank's concrete footing was painted in clearly visible white.
- 6). The leaking swiveling elbow was removed and the delivery pipe was mounted directly onto the tank drum. It now stands permanently fixed extended over the center-line of the track.

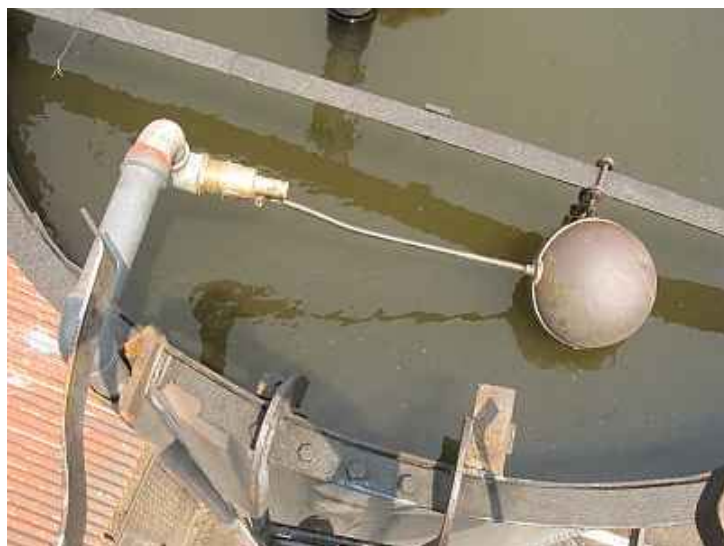
FP02 - Just like an over grown toilet cistern, the water tower uses a spherical float and a valve. The valve is brand new and you can see that the water pipes have been sealed from when they were taken off to remove the original. This water level was too high, especially with an undamped float and an open discharge, the rippling water causing the level to be higher than it should be in service. The arm was adjusted again before filling up the 25NC tender.

- 3). The water valve's float arm was adjusted (twice) to set the optimum water level under the built in overflow.
- 4). The exterior surfaces were de-scaled. The bare metal areas were undercoated and then the entire tank and its support column were painted in Battleship Grey enamel)

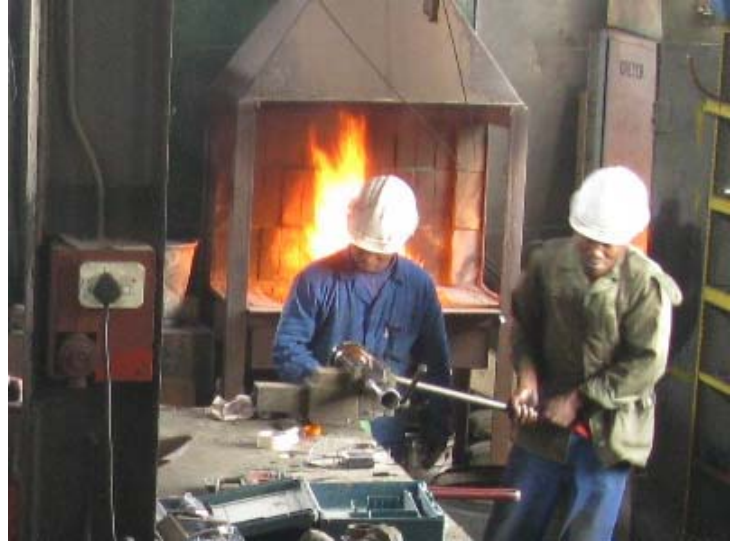
FP04 - This was primarily an Edward and Sakkie project. Here they are manually cutting the threads for the extra water line to be routed from the tower as a high pressure high volume feed for boiler washouts. The operating forge in the background, was being used to straighten and anneal the bent injector piping on the Class 25NC. (LG)

- 9). An extra pipe line has been run from the tank to the Top Shed for high pressure, high volume water feed for boiler washouts, boiler filling for hydraulic testing, etc.  
(Our water mains pressure is quite variable and often inadequate for high pressure jobs.)

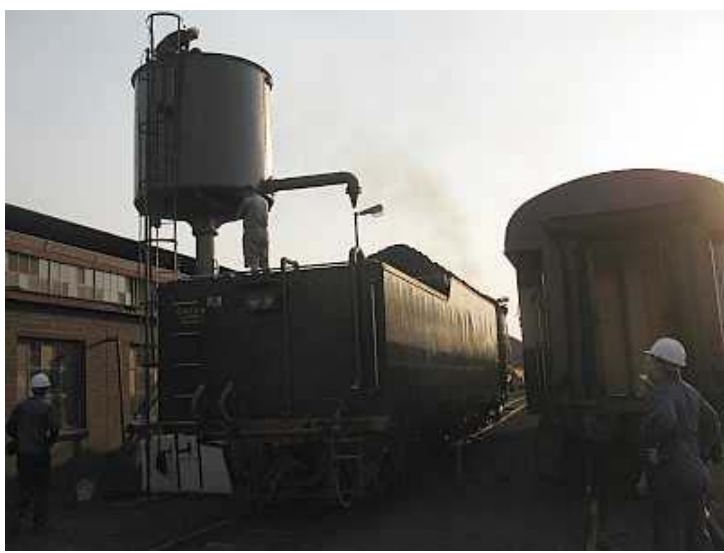
FP07 - The first attempt at using the water tower is interrupted when the tank's water supply is switched off and the ball cock is removed to bend the float arm downwards. Consuming 18 000 to 33 000 liters of water at a go in a tender or a water tank car is costly enough without water running to waste all day. The water level was slightly too high and the tank was set to overflowing when the float started bouncing.

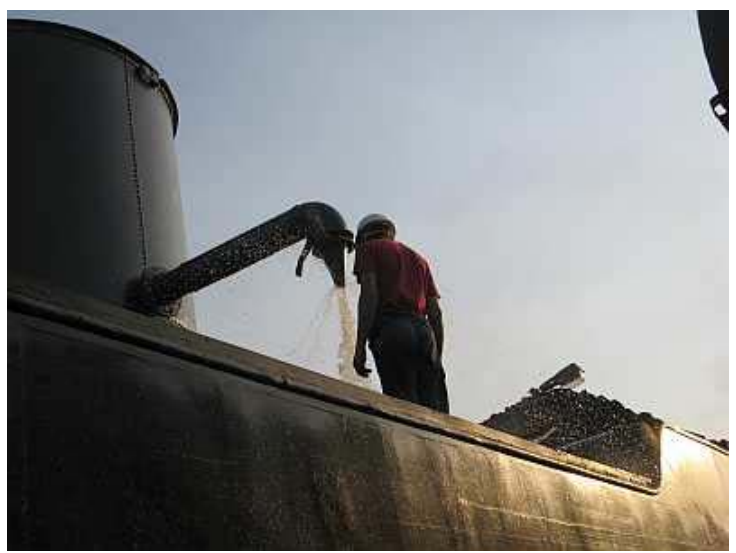
FP08 - Some of the Reefsteamers have commented on why I always bring a somewhat bulky sports bag in on my Depot Saturdays. It's because I always bring in an extra set of dry clothes and shoes, several sets of socks and some spare underwear for surprise soaking situations just like this.

A stoically standing Andrew King receives a H2O marinade as the choked water stream squirts sideways and he ponders the solution. As you can see, the valve lever is only halfway along its quadrant. (LG)

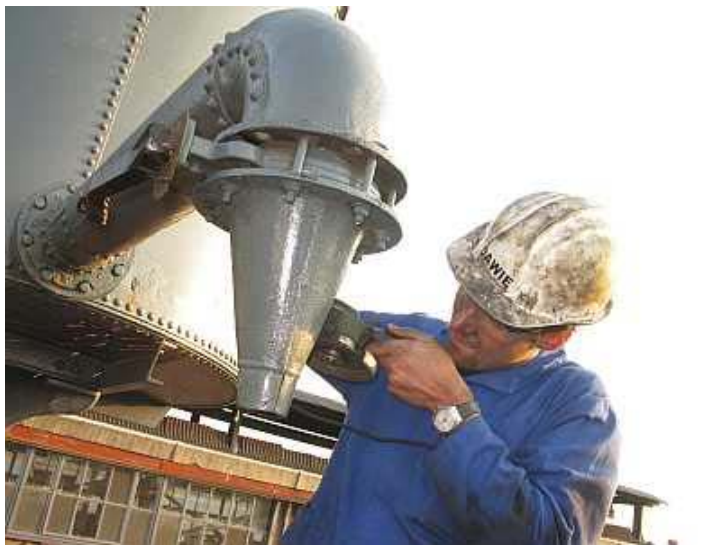
FP09 - Dr. Dawie performs the water tower's circumcision with much tongue-out concentration as he wields the delicately abrasive surgical instrument.

Getting electrical power out to the tender deck was a challenge as all the Top Shed's windows are welded shut. We ended up using yard power after resetting a breaker. I was the cable strain relief while Andrew King held the electrical plug and coupling away from the very low draining and flooded tender deck. Honestly, hadn't the old railway engineers ever heard of decent sized drain holes? (LG)

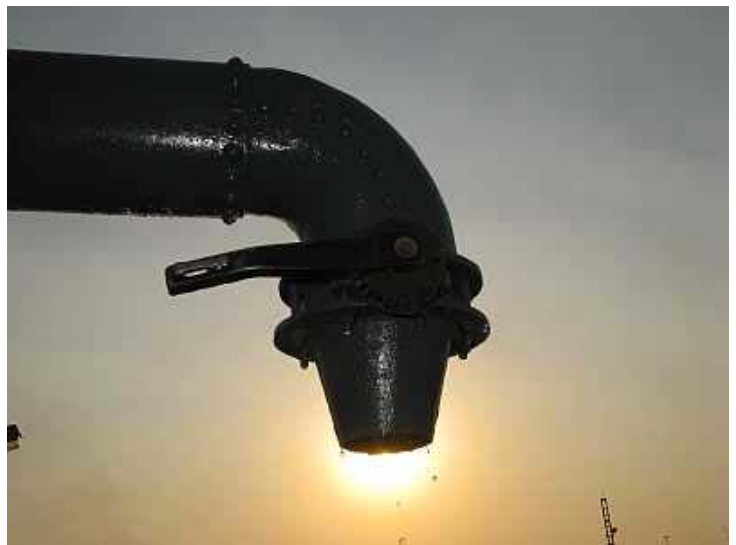
FP10 - Feel the pain! The truncated pipe came out fairly neatly and there is still enough of the cone left for us to put a drop bag on in the future. Excepting the plinthed A-Class, all of our tenders have centralized water hatches, so it isn't really necessary.

The newly serviced delivery valve seals great - there were only four water drops visible in the original photo. Notice the valve quadrant with the sector of notches to latch the handle in the desired position. (LG)

- 7). The 6 inch delivery valve was serviced.
- 8). A delivery "sock" is to be made up as the tank never had one.  
The tank has a 6 inch delivery outlet which is lead into a cone.

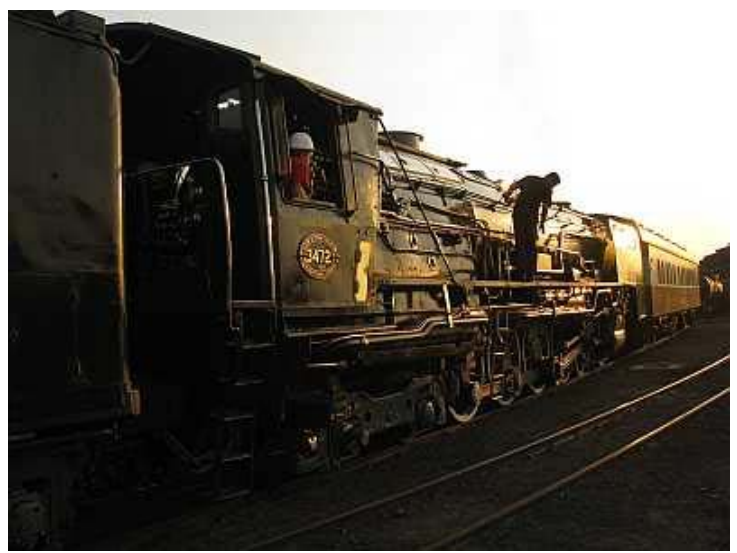
FP12 - Having just coupled to the coach, the Class 25NC No.3472 "Elize"; pauses with her rods down while the fireman checks the blowing gland on the rear of the power-reverser's actuator cylinder.

The newly rebuilt, re-bushed and line-bored Reverser's D-valve chamber, though, is a steam tight as you could wish for - courtesy of James Thomson and Patrick Ackerman. (LG)

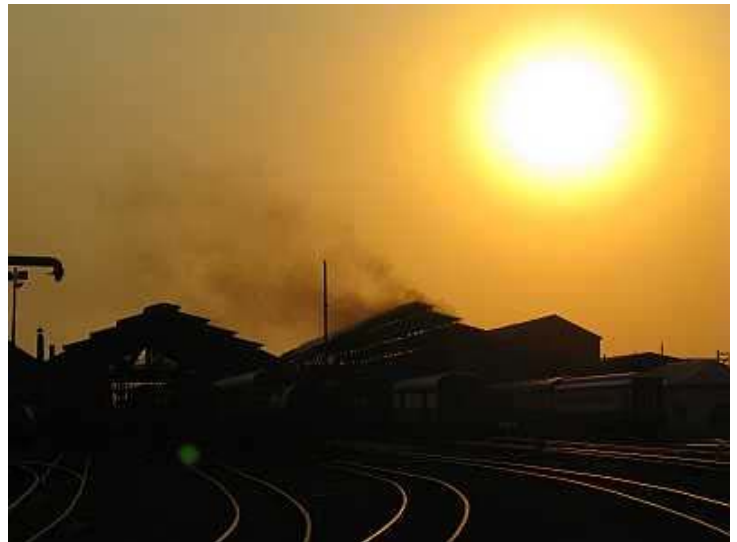
FP13 - The mighty locomotive hardly feels the weight of the single 40 ton coach as the shunt move pushes over the newly concrete sleepered track. The fireman is nervously running the injector for the first time of this shunt and after a blown gasket was replaced in the outer delivery pipe flange. He'd also fitted a proper square shank to the water valve and extended an old injector water valve handle and shaft to suit - so now the originally loose fitting valve truly does open and close fully through the 90 degree operating arc of the valve handle. (LG).

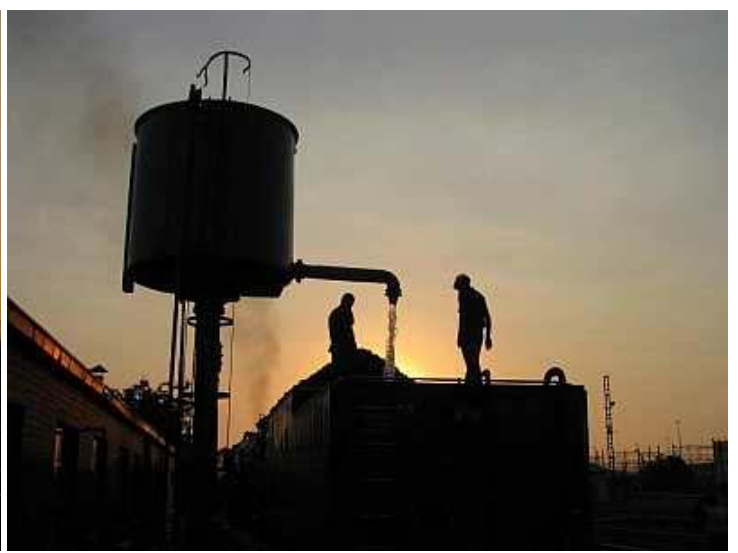
FP22 - The water stream is running great with the cut down nozzle and on a still day like this, it hardly needs a sock. But on windy days, the water stream is surprisingly easily deflected. Not much really needs to be said between Dawie (Left) and Shaun (Right) as they are mesmerized while watching the water tumbling in. (PA)
