Click on a day to read about its events.

[Wed, 9 April - Passengers at Boksburg East.](#)

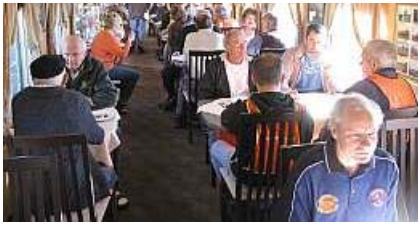
T04 ☞ The first breakfast on board the Free State Explorer Train. Oom Attie de Necker assembled each one of those chairs from kits and not one of them failed during this trip.

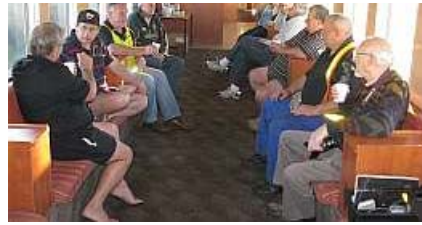
T05 ☞ The bar car with a mixture of Reefsteamers footplate crew, train staff and guests just naturally mixing it up. The common love of steam trains is a great social ice breaker.

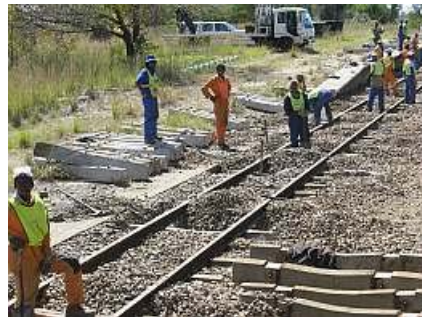
T08 ☞ Just a part of the very extensive road gang replacing damaged concrete sleepers with new ones.

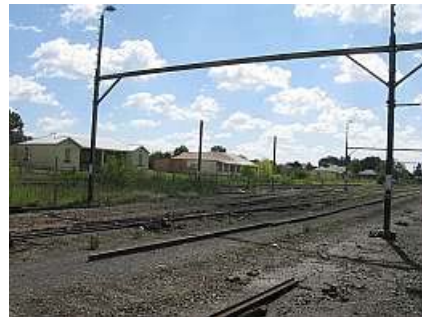
T09 ☞ The sad sight of continued rail system contraction as symbolized by the newly stripped goods yard alongside the Bethlehem Station.

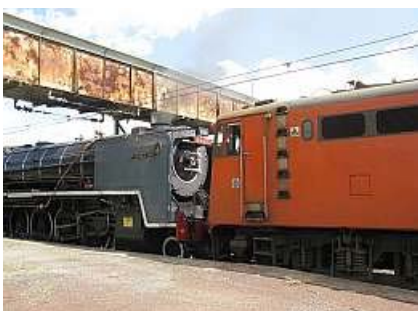
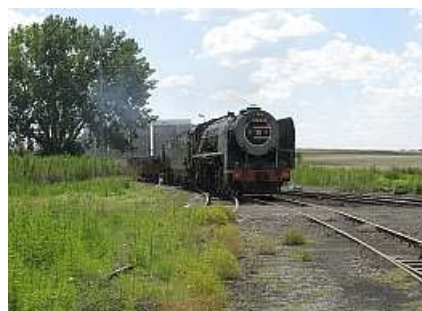
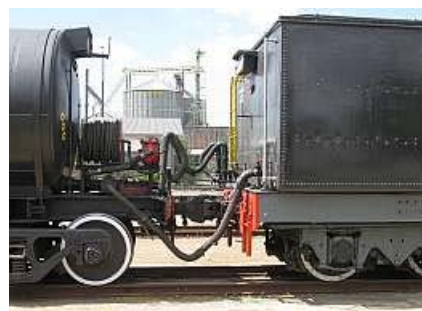
T10 ☞ Just before the handover from double-headed electric haulage to steam power. Notice that this orange can-o-sparks was a hybrid class 6E running on 6E bogies.

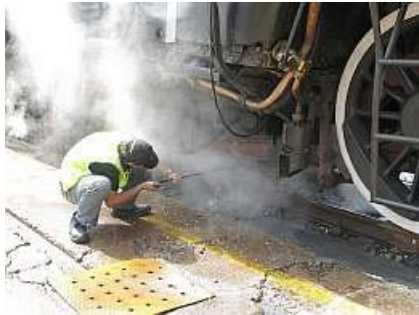
T13 ☞ Dawie Viljoen literally hunkers down to an uncomfortable job ☞ he's trying to clear the exit aperture of the ash chute and getting a healthy steam facial cleansing treatment in the bargain.

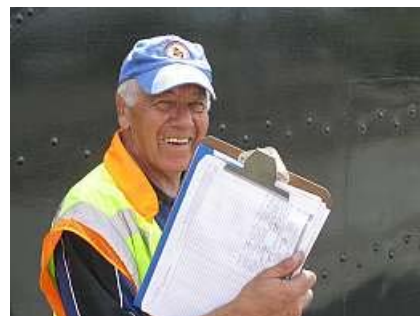
T18 ☞ A smiling Safety Officer is always good news on a long distance trip. Cliffie Mathee inspected the entire train before we took off.

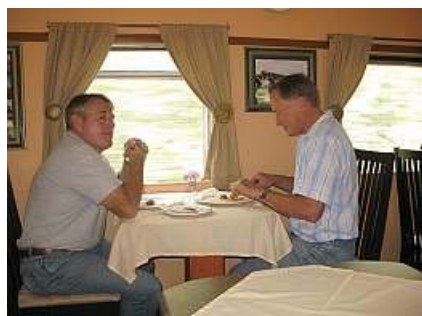
T19 Ackerman (R) and Armstrong (L) take a break from the mops n brooms and tuck into their pie and chips instead.

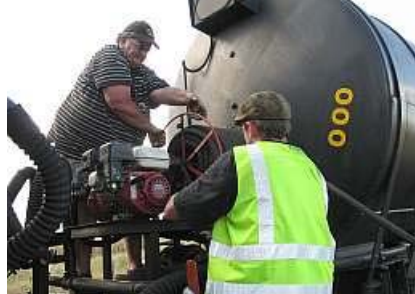
T24 The fire hose is carefully and neatly rolled back into its reel, right behind the purpose fitted fire pump.

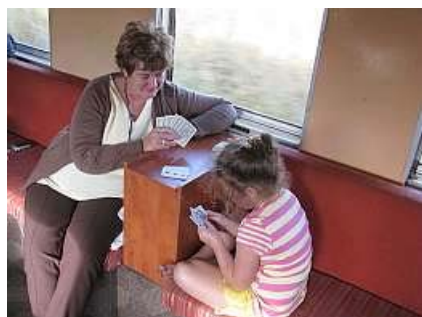
T25 Try doing this on a luxury road coach! This little girl had no female playmates on the train but seemed to thoroughly enjoy the adventure of the steam train ride.

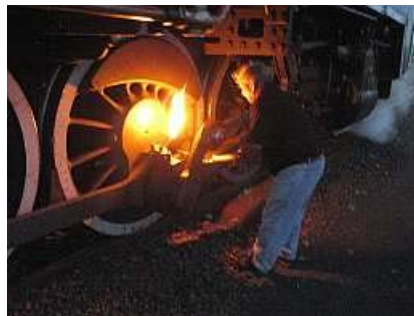
T30 📷 Coen Pretorius does the evening greasing by the traditional light of a driver's flare lamp. (Which is an oil can set up with a wick and burns like a roman oil lamp.)

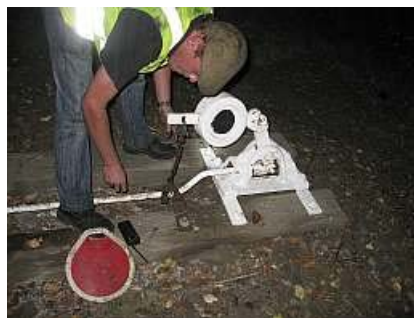
T33 📷 Shaun switches the points over and locks them to guard the occupied sidings. Note the train's tail marker which would be put up in passing as we walk back
