Introduction :

9th April Wed Last prep and short haul to Boksburg East Station :

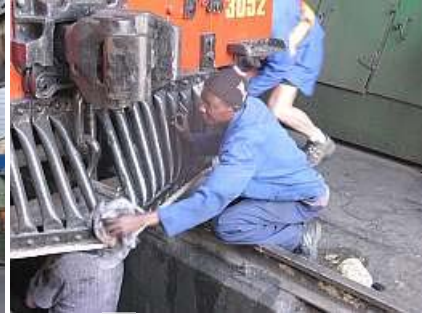
W02 Cleaning off the recently painted cow-puncher. It took a team of five people three weekends to get this locomotive looking clean and sharp.

The cleaning of a steam locomotive can be easily written off as a waste of time, because they get dirty again so quickly. This is especially true of the coupling rods, valve motion and wheels after one or two service stops with the inevitable grease and drips, and airbourne oil condensate from the cylinders. But it's a matter of pride for a depot to present a clean locomotive for her first foray out on the main irons. Shorty and Fielies were on the job of cleaning and painting the front end. (Pic W02 above) The wind deflector plates, front steps and the brake pipe stand were freshly repainted and the coupling rods and valve motion had been painstakingly polished with fine grit sandpaper.

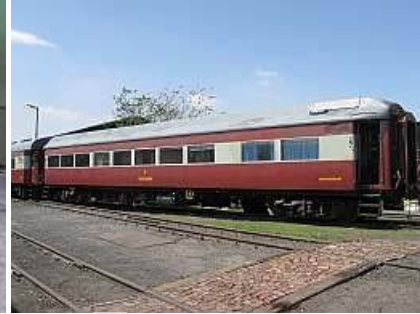
W03 The distinctive management coach (No.42) looks much more dignified after the delaminated paint job has been repaired.

The management coach, o/n No.42, occupied the crossover track, to be able to utilize ground power for the on-board electrical system especially for the refrigerators. (Pic W03 above) This coach was repainted back in 2006. However, the sub-zero (-6 deg Celsius) temperatures experienced during the 2007 Dave Rogers tour caused the sheet metal work to contract and the embrittled, thick coated paint cracked and lifted off in slabs. The exposed metal underneath then began to rust. This old coach was repainted last week, fixing damaged areas on both the Gulf Red and French Grey sides, as well as the application of polyurethane paint onto the roof. Because the existing paint from last year has just begun to fade, you can see the fresh patches but the coach looks a whole lot more presentable now.

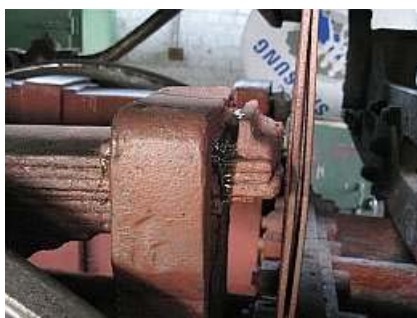
W04 A freshly oiled spring hanger bears testimony to the thoroughness of the roadworthy and preparatory lube work.

Shaun Smudge Ackerman got into his element, duck-walking amongst the cool greasy, gritty undersides of a locomotive. He was seemingly just pottering around with an oil can but was actually giving the engine a very thorough road worthy inspection and a simultaneous light-lube job of the undercarriage. (Pic W04 below) As we were only taking one loco with us, there would be no backup in case of a breakdown or simple lack of steam. No problems were found apart from some slightly loose bolts and a couple of split pins that needed replacement.

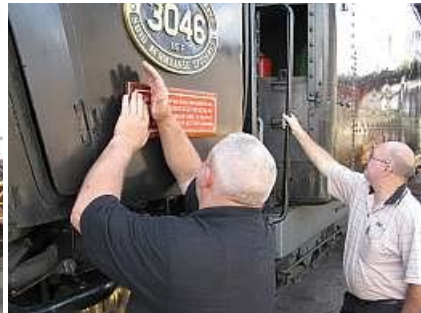
W08 Piet Cuffels Steenkamp holds the plaque straight as the mounting screws are blindly applied from the other side. Shaun was justifiably nervous of the delicate plaques falling and getting damaged.

Patrick Ackerman then disappeared again in a roiling cloud of dust and centripetic gravel, leaving the plaques to be mounted on the locomotive's cab sides. (Pic W08 below) The mounting holes had been carefully marked centrally and pre-drilled in the cab sides symmetrically under the oval name plates. But the catch came in that the pairs of pre-drilled mounting holes are actually drilled through UNDER the wooden floor board levels of the raised platforms upon which the fireman and driver's seats are fitted. Shaun Ackerman had the task of lifting those floorboards without damaging them undoing shallow screw heads with the slots long filled in with compressed ground coal. It's an awkward job with the seat still in place and it took over an hour and some gritted teeth just to get the plaques mounted.

The cab-side holes had been predrilled to dimensions separately given to the plaque maker but the two sets of dimensions matched up. The plaques mounted with a minimum of wriggling. The freshly mounted plates look great, although you can see the text just about fitted in the allocated space on the fourth line. (Pic W09 below.) They were made to fit within the width of the oval SAR number plate and it was a close fit. We were concerned about the effect of lineside thorn bushes on those plates as we often end our trips with long lines of scrapes and scratches on the coaches. But because the plaques are so difficult to remove and then remount, we decided to leave them on the cab sides, at least until they would be unveiled on Friday. As it turned out, they only got slightly scratched during the trip. We plan to remove them at leisure and remount them in a higher and more recessed, protected location.

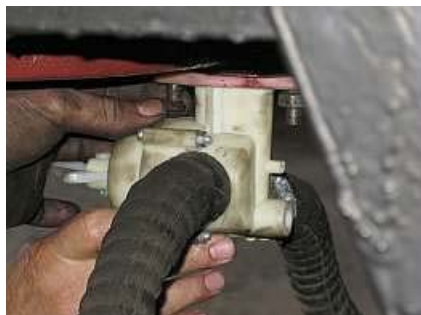
W13 The brake release valve being fitted. The cut down stud is the one to the left and you can just see the new washer being fed over the stud.

Yes, even we Reefsteamers don't always get it right. The team that replaced the tanker's vacuum cylinder the previous week has made some subtle mistakes in the assembly. The brake release valve attaches to its mounting pad with two vertical studs. One of the studs was so long as to foul with the cylindrical body of the valve when the nuts were screwed home. (Pic W13 above) And the protruding blank stud shank of the same stud prevented the nuts from going all the way home. So the flanges wouldn't seal. And there were no washers fitted as the original valve hadn't any washers. Visually, it looked okay but the true test was when vacuum was applied. The problem was solved with a hacksaw to cut the offending stud down. A nut was run up and then the stud was cut off shorter and the nut re-cut and straightened its own threads upon removal. Washers were found from the power van to allow the nut to tighten up on threads. It was a dicey job, working at full arm's length over an inspection pit, which would make retrieval of any dropped fasteners and hardware a yogic proposition. The power van was at the other end of the train so several of us got some exercise fetching tools and looking for parts. The train passed the first brake test after this minor repair with ease! (Especially with the in-house Reefsteamers overhauled brake ejector.)

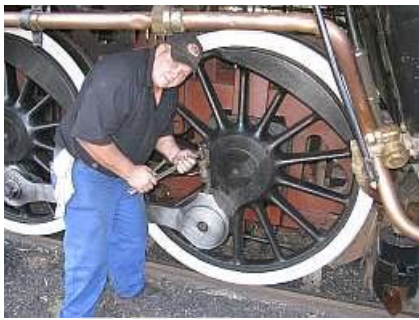
W16 📷 Piet 📷Euffels 📷 Steenkamp greases the left rear driver wheel while the bearings are still warm even after a short run. Note the beautifully shiny coupling rods.

We arrived in Boksburg East at about 5pm, rolling in much to the fascination of the afternoon commuters. (Pic W15 above) They got an eyeful of some steam action as the tender first engine was run around the train and placed at the head end and facing the right way for the outbound trip on the morrow. Unfortunately, photographic opportunities were seriously spoilt by a rail maintenance train parked between our siding and the commuter passenger platforms. Piet Steenkamp took the opportunity to get some more hard grease into the coupling rod bearings while they were still warm, even though we'd only done a short run. (Pic W16 below) The engine would have a long way to go the next day and one can never have too much grease in those vulnerable points. (Except maybe the sealed return crank bearing but you get my drift.) Andrew King, as Chief Engineer, has been hammering the drivers on regular lubrication and this practice was followed throughout the entire tour.
