PROJECT : Perimeter fencing project – new gates :

F01 – A bundle of scrap tubes being cut at one go – Miles Burton enjoys his first Reefsteamers project.

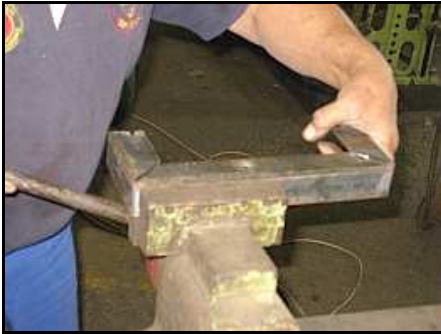
F07 – Using a vice as a bending brake, Frans has just finished this latch frame and is making fine adjustments.

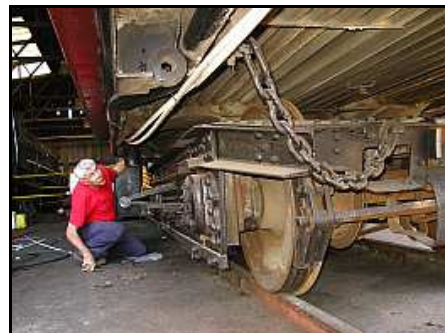
CW03 – Modern conduit for an old coach – the two PVC conduit pipes are still hanging loosely as Fred works his way up to tighten up the hangars and pull the cables through to the final positions.

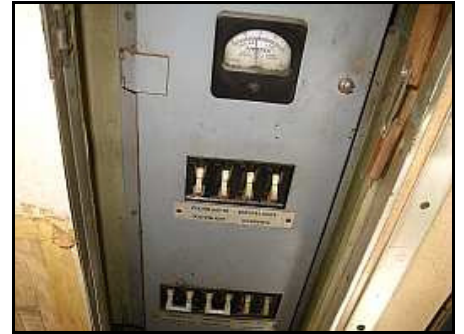
CW06 – A vintage DB complete with coach-dynamo monitoring ammeter.

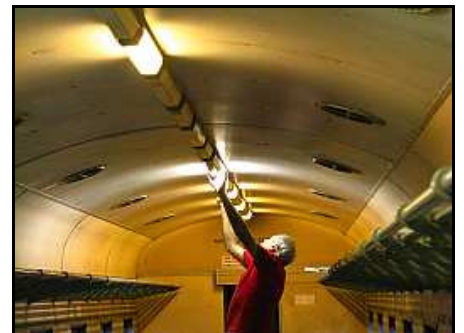
CW09 – Activating the coach aisle lamps for the first time on 220V. Fred is actually standing on the three seater benches in this picture.

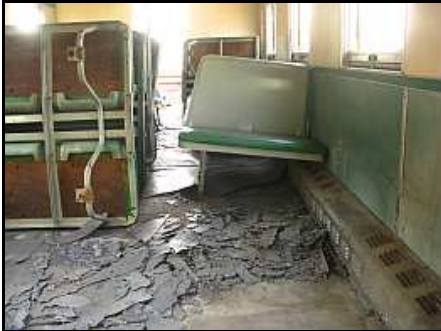
CW10 – Yes ... it's a mess. The hardened vinyl sheet has been labourously chipped off from the sub-floor of Sandstone Coach No.25206.

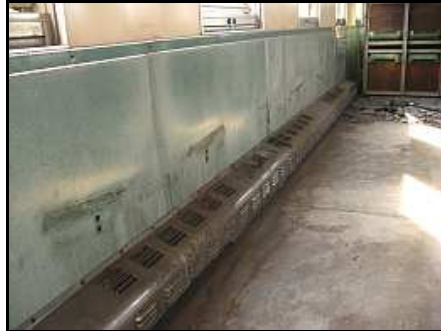
CW11 – Here's an original SAR spec coach heating system. These covers enclose a series of straight steam-filled heating pipes, with circular radiating fins. Heating steam used to come from the loco boiler and is the source of the photogenic steam leaks you see rising between coaches in movies. (Hogwarts Express, Polar Express, etc.) None of the steam heating systems are in current use.

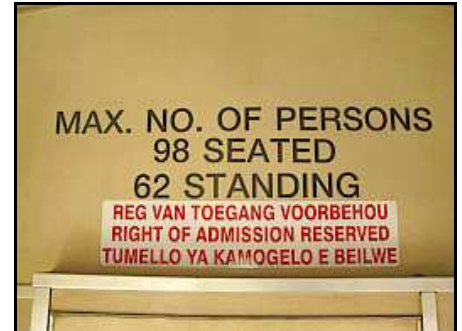
CW12 – Traditional coach capacity decals. I counted the seats and the capacity truly is 98 sitting hip-to-hip. (3rd class coach) For insurance and capacity purposes, Reefsteamers allow for 75 passengers seated and none standing on our day trips and tours. These old coaches don't have strap hangars – standing passengers must brace themselves against seat backs or by holding onto the parcel shelves.

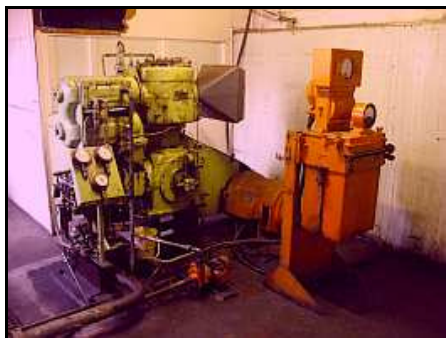
D01 – The old compressor plant. Behind the plant is the office in the corner which has been cleaned and is being converted into a chemicals store.

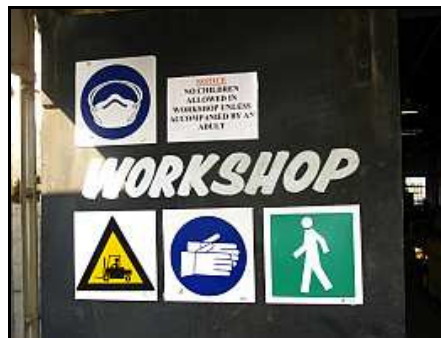
D03 – 4 of the 9 new safety signs attached to the workshop's main doors to comply with contemporary safety regulations.

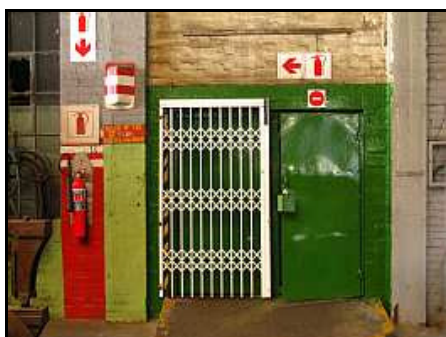
D04 – Refurbished tool store doors. Notice the new fire extinguisher and full set of contemporary and SAR era wide-view-angle fire services signs. This is the number 1 road end of the workshop

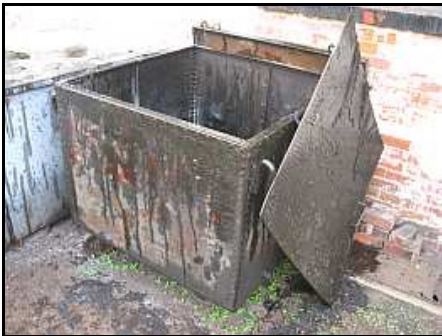
D07 – An elderly oil bin waits for refurbishment. The square plate to the right is actually the drip-grid.

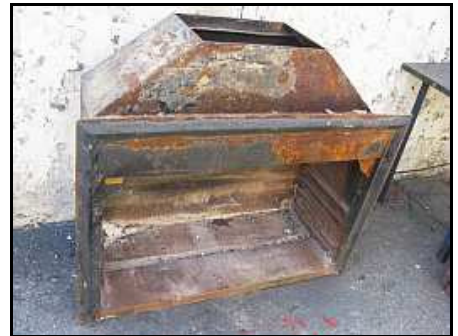
D09 – A donated used built-in braai (Thanks Andre!) which we'll be installing at the new clubhouse.

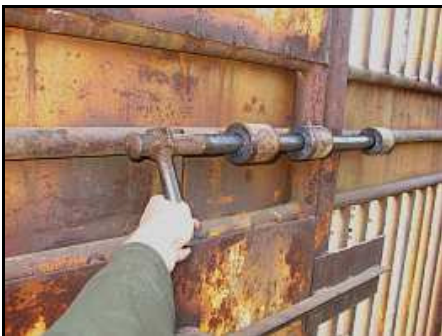
D10 – Greased steam-locomotive sized gate latches. What a pleasure not to have to hammer away at rusty steel bar to let a locomotive in or out the workshop.

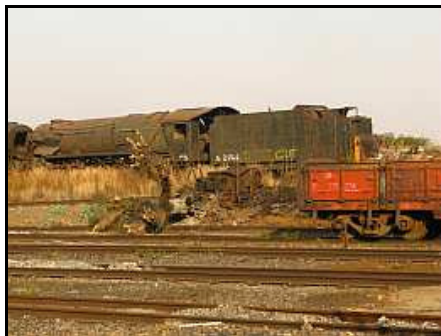
D12 – The week-day work crew, with Shaun Ackerman and a 15CA Steam locomotive, pulled out this tree.

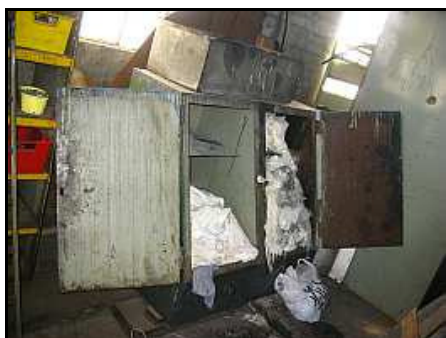
M01 – Here's the waste cupboard. We're topped up on waste but not much in the way of rags. The plastic bag in the foreground is full of fresh old clothing for rags use.

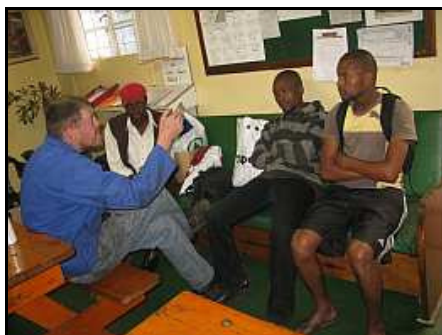
M05 – Shaun Ackerman is busy paying off casual workers and inviting them to try out for the massive depot-wide window replacement project. Reefsteamers is starting to benefit the local disadvantaged communities by providing opportunities for paying work.

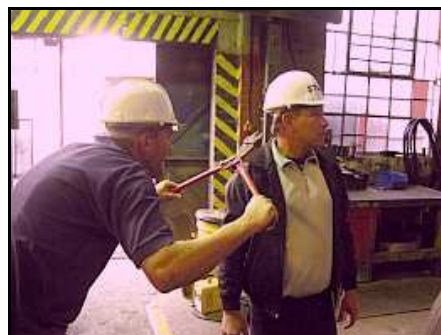
M06 – An unsuspecting Paul Hloben is about to get his right ear lobe snipped. Actually, the scissor-man is just posing but the author-man was blissfully unaware as he was studying the open smokebox of the Class 12AR.
