PROJECT – Class 12AR No.1535 ‘Susan’ – Preliminary Hydraulic Boiler Test :

PROJECT : Class 12AR No.1535 'Susan' – Piston Removal :

REEFSTEAMERS DEPOT NEWS REPORT - 17 AUGUST 2008-

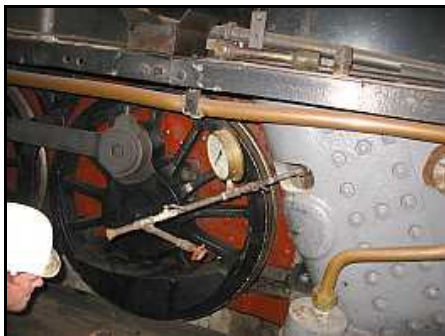
T01 – The vulnerable protruding test coupling screwed into the left wrapper plate’s wash out plug. The downwards pointing pipe is a bleed pipe to provide intake pressure control during the high-pressure low-flow part of the filling process. (As well as being a drain.)

The boiler was buttoned up by about 4pm. Shaun ‘Smudge’ Ackerman had been working on installing the hydraulic test coupling and connecting it up to the newly overhauled KEW steam lance. It’s a handy machine as, with the diesel burning heater left unlit, it acts as a high pressure pump and can be used to ‘pump up’ a boiler. Shaun’s patience was tried by incompatibilities and damaged threads in the pipe couplings although, for a change, the test coupling itself was undamaged. Because it sticks out from the side of an engine (Pic T01 below), it is prone to being walked into and the stress can spring joints and fracture valves. It’s also tempting to use the bleeder line as a handle to screw it in.

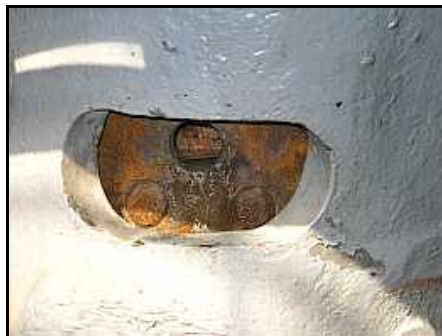
T02 – Oops. This washout plug on the right, opposite, corner of the wrapper plate had been left out. The draining water has slowed down to trickle. After leaking hoses and missing plugs, maybe we’d get it right on the third time.

Another issue turned up as the boiler team had forgotten to insert the washout plug on the right wrapper plate. (Pic T02 above) The water was coming out almost as fast as it was going in – although a little scale knocked loose with all the boiler tube work had come out with the water. So the fellows let the boiler drain down completely before finding the missing plug on the walk ways and buttoning up the wrapper plate.

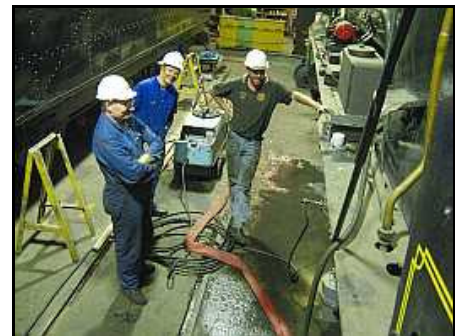
T03 – An important part of boiler hydraulic testing ... the sociable waiting for the boiler to fill up. Left to right – Aiden, Coenie and Shaun, with Patrick and Dawie out of frame, sitting cheerfully on top of the boiler. The pump has just been started in this picture

On the third attempt, the water was staying out within the boiler shell and not splashing out on concrete anywhere! But it still took quite a while to fill through an open washout plug at the top of the boiler. The gearbox work had finished, as well as the diesel axle dropping project – so this became a sociable and very important part of a boiler testing procedure ... waiting for the boiler to fill! (Pic T03 above.)

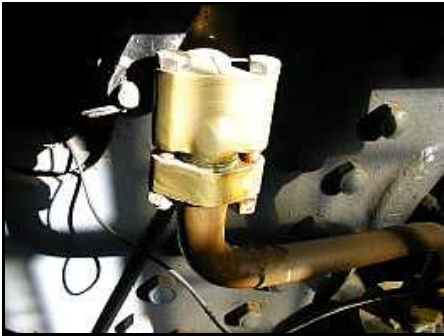
T04 – The right hand blow down is leaking a bit past the black rubber disk that was inserted to blank off the valve. The two through bolts were nipped up a bit and the leak promptly stopped.

The test went okay for a preliminary test. Problems were found but none that are major so far. During the fire hose filling of the boiler, the right hand blow down valve was found to be weeping under the natural weight pressure of the water. (Pic T04 below) It just needed to be tightened up to clamp up the rubber blanking disk inserted for hydraulic testing. Fortunately the leak stopped – otherwise we would have wasted much water draining from the boiler while having to split the valve and replace the blanking disk and backing plate.

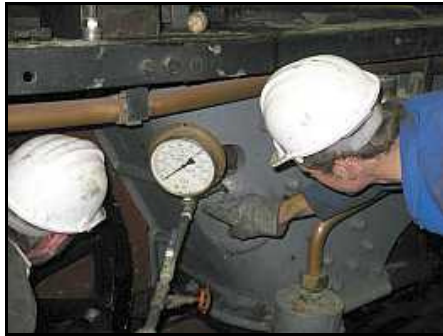
T05 – Patrick and Shaun discuss the regulation of the test pressure. Patrick has just, inevitably, succumbed to the temptation to tap the test pressure gauge.

No boiler hydraulic test is complete without the obligatory hopeful tapping of the pressure gauge to see if the needle will lift off the zero stop. (Pic T05 above) We had six grown men all focused on a little needle and practically all of them tapped the gauge. The backhead pressure gauge within the cab was still functioning and almost at the end of the pumping, it was showing 1460kPA. (Pic T06 above) The red line maximum safe operating pressure is marked at 1300kPA. (In operation under steam, the safety valves would have already lifted by this point.) The standard procedure for a boiler hydraulic test is to fill the boiler to 125% of the rated operating pressure. The cold pressurized boiler was silent with no popping or creaking.

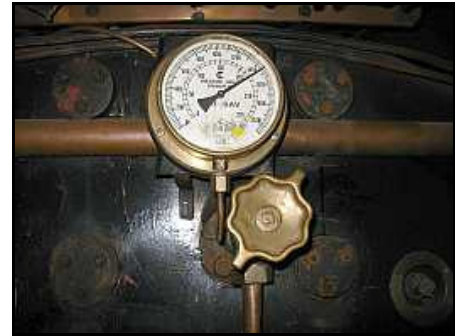
T06 – A strange sight. The back head pressure gauge is mounting up even though the water glasses have been removed and blanked off.

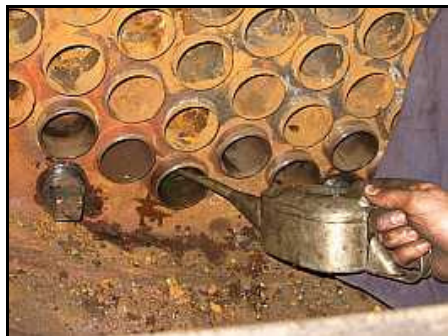
T07 – One of the first batch of seven tubes is weeping at the front tube plate next to the driver's side washout plug. Fresh MH Oil is being applied to the inner surfaces to lubricate the expander's rollers.

The single weeping tube at the front end was lubed up. (Pic T07 below) As these are 'merely' expanded into place, the expander cut be re-inserted and the tube expanded even tighter. The firebox end was worse off with a slight water weep at either end of the second row. Just one or two teeny little droplets on each side – but that's enough to require attention. Dawie marked them off with oversized white chalk crosses. A more serious problem was a cracked bead on an existing tube – which was more than just a weep! (Pic T09 below) It may have just failed under the increased pressure, but more likely had been nipped by the pneumatic riveting gun. It could probably be sealed with more expansion of the tube into its old ferrule – but that's only half a job. The bead has to be thoroughly cleaned before assessment of feasibility of re-expansion and/or re-welding, or whether it is to be scrapped and the tube withdrawn. It's an inconvenience – but you don't mess around with a pressurized steam boiler!

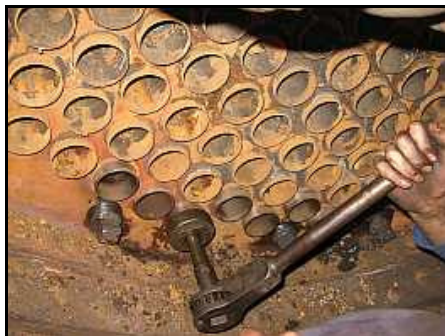
T08 – Putting the squeeze on the errant H₂O, Dawie ratchets it up a few more turns. The dark coloured mess in the crevices is actually oil left over from when the washout plugs threads were re-tapped.

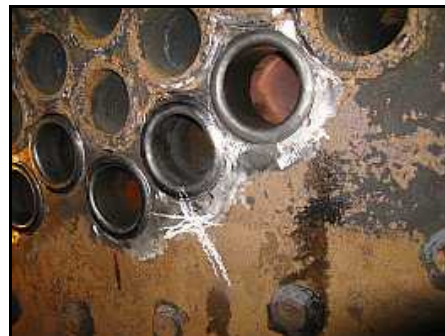
T09 – Two of three leaks at the firebox end. The cross marks the slightly weeping bead. That water is running from the tube at top right – a cracked existing bead.

The youngsters were preparing to start setting up the expanders – but the Chief Engineer forbade it. It's dangerous to use an expander on a pressurized boiler. (So nothing was said about the already expanded tube at the front end.) As per our usual practice, the boiler filling vent was opened to discharge the entrapped, pressurized water very slowly through a long, thin rubber hose routed alongside the boiler and footplate, and discharging the water into the inspection trench. Thus we slowly release the stress over a period of about 15 minutes.

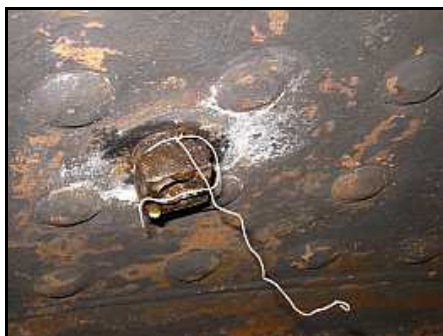
T10 – Putting the drip on things, the right front fusible plug is weeping through the threads. That tied on wire was for the inspection lamp.

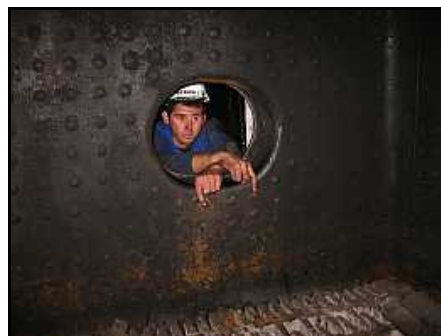
T11 - A sad and tired looking Patrick leans in through the firing hole to hear the news. Actually, we didn't do too badly but that cracked bead throws the score a bit.

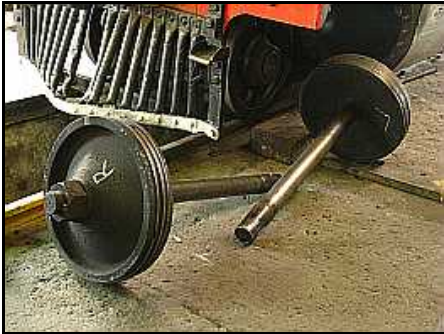
P01 – A pair of withdrawn pistons wait for stripping, cleaning and groove machining. They are attached to the crosshead by wedges passed through slots, hence the lack of readily visible fastener hardware at the end of the piston rods in this photo.

The pistons on the Class 12AR were uncoupled from the crossheads and withdrawn on Saturday 9th August. (Pic P01 below) I wasn't at the depot in that day so you don't get a running commentary – although Patrick Ackerman would be quite happy to supply the details!

The crosshead wedges were knocked out with a pneumatic hammer after quite a struggle to tap them out by hand. They weren't that tight – but the poor clearance under this compact, small wheeled locomotive, prevented a full arc of mallet swing. With a bit of air assistance, the tight wedges literally just popped out as the tension relaxed. A Class 23 extractor was used to push the rods out from the cross heads – apparently far easier than the use of a Class 19D extractor used when the Class 15CA No.2056 'Dorothy' was rebuilt.

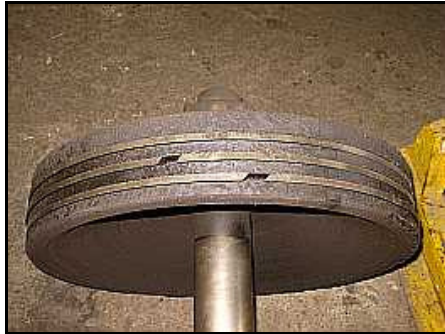
P02 – A close up of the three piston rings as removed. The rings are a little slack but not in too bad a condition. But they are going to be replaced anyway.

The piston rings are to be removed (Pic P02 above) and then the grooves are to be cleaned up and machined square and true, and also with identical dimensions. So the original grooves need to be measured and the largest required dimension after cutting will be the new standard size for the other five grooves. This isn't as arbitrary as it sounds, as when steam locomotive pistons are originally cast, they were usually cast with blank working surfaces and the grooved are subsequently cut by the fitters erecting the locomotives. In fact, we have some rusty, but never used new piston 'blanks' in our stock of Millsite spares. Thus, the piston rings are to be custom machined to fit the pistons. The new dimensions will go into the locomotive's records for future reference. The wedge will be replaced and the glands for the rear cylinder head will be serviced. (Pic P03 above) The piston valves are to have new rings fitted in a similar fashion.

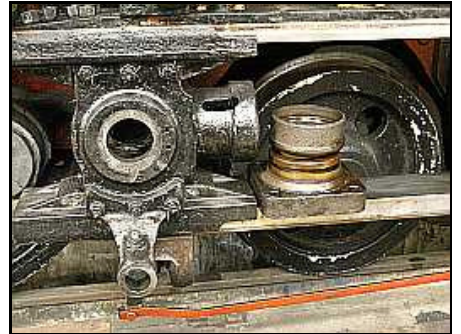
P03 – The dismantled crosshead and piston gland assembly – front of locomotive is to the right. The crosshead wedge slot is clearly visible. Notice that the piston glands are heavily spring loaded. The red lever at the bottom is the pull rod for the cylinder cocks.

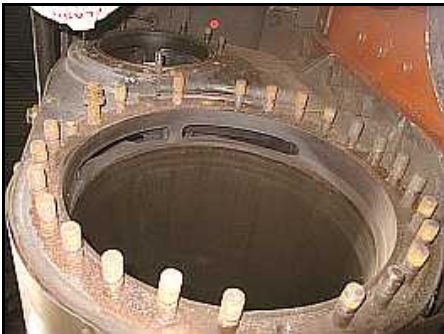
P04 – A worm's eye view of the front steam ports at the front of the double acting steam cylinders of this 12AR locomotive. There is an identical set at the rear. These act as both intake and exhaust ports, the function being switched by the piston valves.

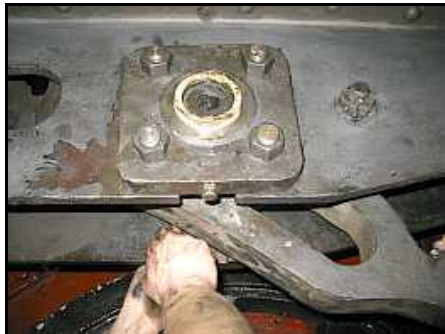
P05 – James Thomson and Juan 'Nippies' Buys installed the expansion links three weeks ago, with new white vesconite bearings in the trunnion bearings.

The newly installed expansion links had to be removed. The brand new vesconite bearings fitted well. A little too well. For safe operation in the dirty, rough world of a working steam locomotive, they need to have 1mm clearance between the trunnion bearing and the pivots on either side. Vesconite is tolerant of dirt, water contamination and lack of lubrication. It is, however, not tolerant of hot operation caused by tight clearances. The expansion link trunnions need a bit of free sideways play to allow the locomotive drive and valve motion to move laterally should components wear or the locomotive run on consistent tight curvatures.

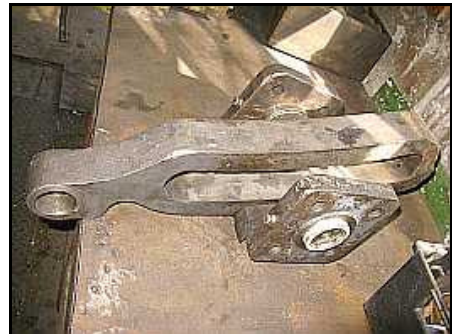
P06 – A removed expansion link waits to have the bearings modified. The valve gear of this locomotive is to be completely refitted with Vesconite, just like our successful Vesconite conversion of the Class 15F No.3016 'Gerda'

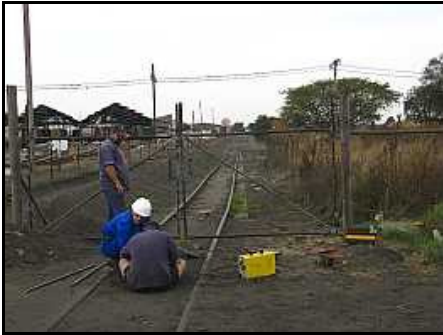
F01 – The gate gang working on the first set of gates to be installed today. This is the back entrance track alongside the western shunting yard. The vehicle road, also gated today, runs parallel to the right.

They mounted all five new gates today. The area shown in Pic F01 below is in line with the existing gates across the western yard approach tracks. The two new gate sets span the back approach track and the road vehicle approach road. Eventually, the guard house next to the existing road vehicle gate (No 6) will be moved out here so the guards can check the rails as well as the road.

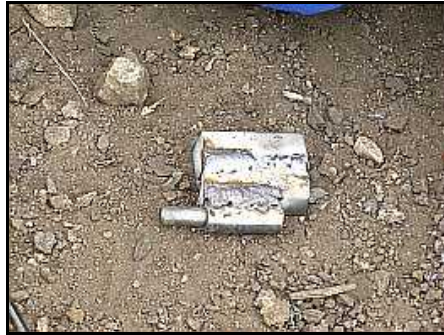
F02 – A fabricated half-hinge has been welded to a spacer block.

The job was complicated by the fact that the prefabricated hinges had to be welded to spacers (Pic F02 above) before welding up everything to the posts. Power to the welding machine was supplied by pick-up bound generator as there is no electrical power at this end of our compound. 8 hinges had to be welded up with half directly to the gate frames and half to spacers. The hinges were mounted in opposite directions to prevent the gates from being lifted vertically off the hinge pins. This team mounted 2 sets of two gates and a single 5th gate in one day. Coenie was sent out to call them in for lunch ... so their existence out side the workshop wasn't totally forgotten.

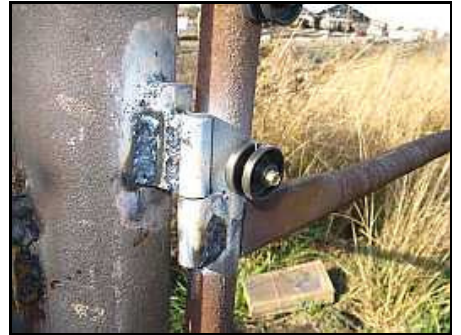
F03 – An assembled upper hinge correctly right at the upper cross rail. The split hinges were mounted in opposite directions so the gate cannot just be lifted off it's hinges

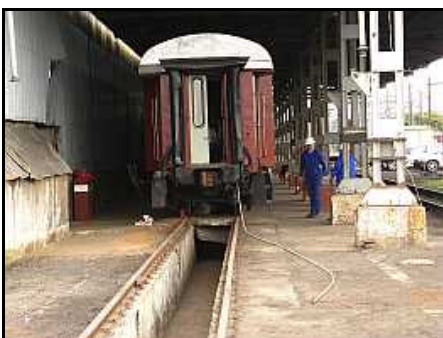
C01 – The first of the two full length white PVC conduits has been 'stuffed' with a pair of wires and the process of threading it under the coach has begun.

The two young men started with the cutting of the individual phase and neutral cables and routing them through conduit loosely laid on the ground. (Pic C01 above)

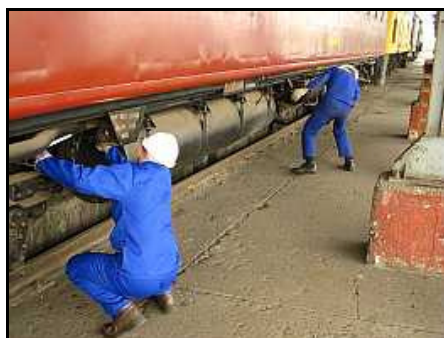
C02 – Miles (Left) feeds the new PVC conduit through the hangers for the coach's water tank as Coenie (Right) looks for the end.

Because this Bar Coach hasn't had the redundant undercarriage equipment removed yet, Coenie and Miles were faced with a real obstacle course through which to pass their conduit. (Pic C02 and C03)

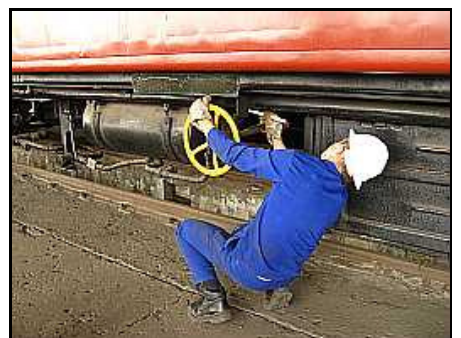
C03 – Coenie catches the end past the vacuum tank and threads it over the handbrake wheel shaft.

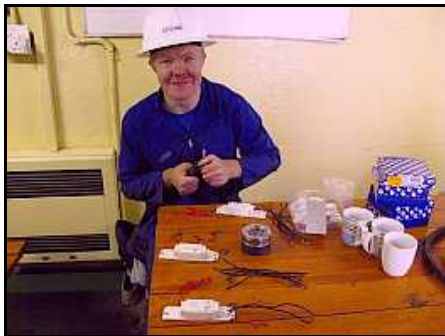
C04 – A cheerful Coenie Gildenhuys busy at the 220V ballast pre-wiring station, very conveniently in the workshop clubhouse itself.

When the conduit was threaded and after a morning tea break, Miles got peeled off to go and assist Andre van Dyk at the new gates. It didn't affect Coenie much as his work from then on was single main work anyway. He got into Fred's stores and got the new 220V series ballasts out and started cutting and fitting 'pig tail' wires for quick installation. (Pic C04 below) The table was cluttered with 11:15am tea break cups and new spares for the Hunslet Taylor shunter, but Coenie found a comfy spot and in an ideal location for the first response for lunch! Coenie also pre wired the starters for the hot-cathode tubes. He had a set of 10 to do for each component t. (Pic C05 below.)

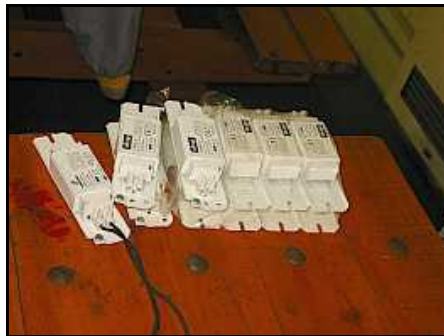
C05 – One down and ten left to go. The wired ballast is a sample, and ten had to be done for the center lighting strip in the coach cabin.

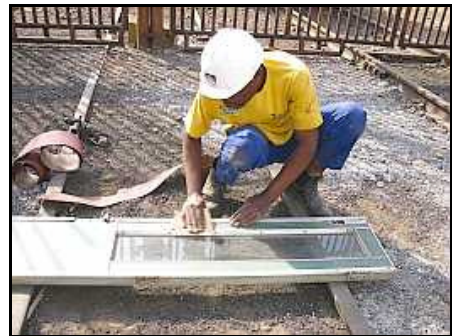
C06 – Spare gangway doors being cleaned for installation – here the oxidised and paint spattered aluminium window trim is being polished.

The already Fred-phase wired Day-Sitter Coach No.25163 is to be treated to a set of cleaned and rebuilt interior doors. This coach originally had the gangway blocked off with a plywood panel. These gangway doors have come out of our stores and are being cleaned and prepared for installation. (Pic C06 above) We could get away without installing these doors as this coach will not run at the end of a train – but it is more original to be able to close off a gangway. And it helps when a coach is reserved by a group on a run.

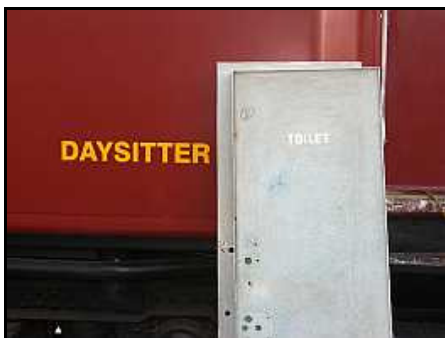
C07 – Removed and stripped toilet doors waiting for new white paint. All the hardware has been serviced and cleaned. These long-disused doors need to be rubbed down for spray painting but they are out of the way of the plumbing work.

All of the original toilet doors have been removed for cleaning and retrimming, and all the hinges and latches are to be replaced. New adhesive signs are to be mounted as well. (Pic C07 above) Granted, this could have been done with the doors left hanging in their frames. But the spring-loaded doors would get in the way of the toilet compartment refitting project. These 3rd class coach toilets are cramped places in which to work! But the clincher for door removal is the fact that entire coach is to be spray painted on the interior surfaces, including the roof panels.

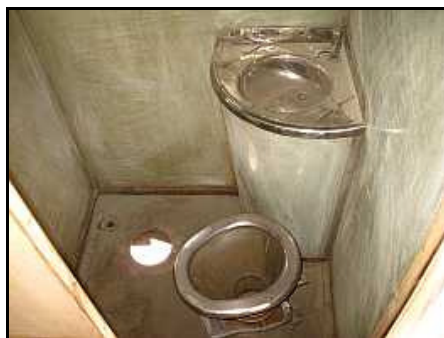
C08 – A recovered corner sink and stand from the Sitemela sleeper coach conversion project, have found a new home in one of the four Sandstone ex-Stilfontien Mine coaches. (The toilet bowl is original)

The toilet refitting project is underway. Both rather dusty toilet compartments, disused for many years with the doors blocked off with steel sheeting, have been cleaned out. The only hardware remaining were the toilet bowls themselves, and even these were loosely mounted on the floor, and the compartments open to the exterior through the empty pipe holes. A pair of functioning flap-type SAR toilets has been selected from our spares, and 'new' sinks have been fitted. (Pic C08 above) These parts are from our sleeper coaches that were converted by Sitemela – of which the original bathroom compartments were converted into on-suite bathrooms and all the fittings replaced with domestic type bathroom fittings.

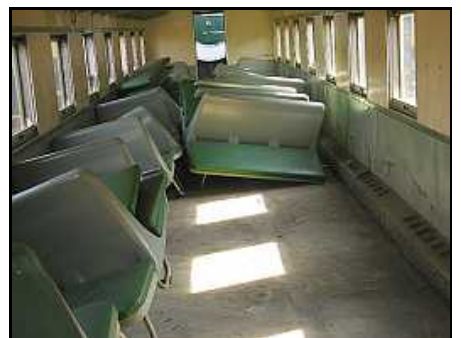
C09 – This typical 19mm marine ply coach floor has been stripped and cleaned. It needs to be power sanded before the new vinyl sheeting is laid. It is to be laid with Marley Tile Sheeting.

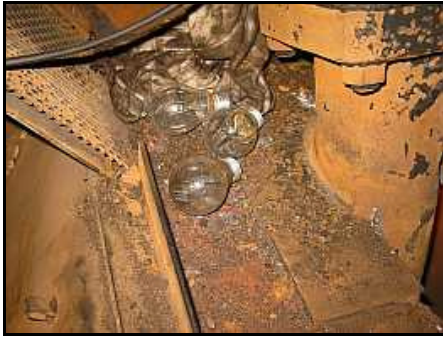
M07 – Patrick Ackerman's dead light bulb collection. These are 32V locomotive-standard globes and are the casualties of two Saturday's worth of smokebox work in the isolated-secondary 32V inspection lamp.
