SIA PROJECT : A 125 ton Beauty Salon session:

SIA TASK : Class 15F No.3052 ☞Avril☞ Fire Lighting and Preparation :

SIA REPAIR : Class 15F No.3052 n Avril n Vacuum Brake Line :

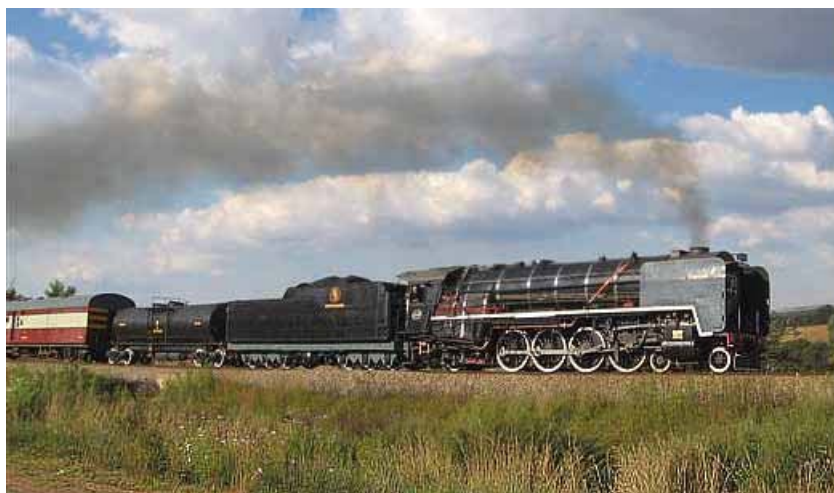
FP01 Struttin her newly painted (and repaired) stuff, 15F No.3052 Avril is now running in the livery that she originally wore when she was retired and first passed into the private ownership of Dave Shepherd. (Which was in 1991) (Pic by Shaun Ackerman)

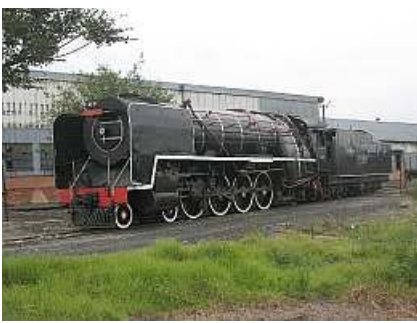
L01 ☞ Avril in her as-delivered paint scheme. Note the plain black un-badged SAR style smoke deflectors and the custom bulls-eye driver wheels. Also notice the lack of a cab number plate and wing heralds.

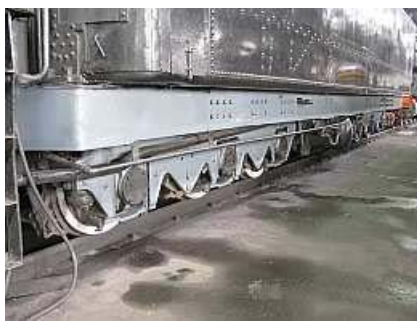
L02 ☞ Gloss-grey painted tender frames and bogies just as delivered, Mr. Shepherd.

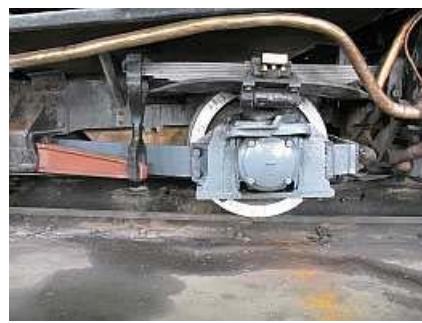
L03 ☞ Grey painted Bissel truck. Notice that this engine uses roller bearings on the trailing axle. The red painted beam to the left is the compensating beam.

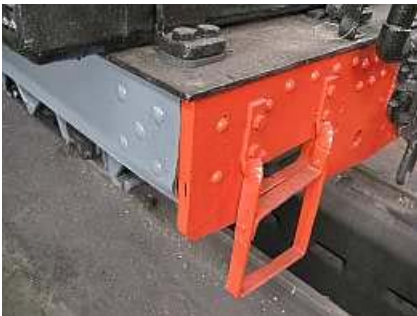
L04 ☞ The grey, black and the red all meet in fine style on the rear corners of the tender.

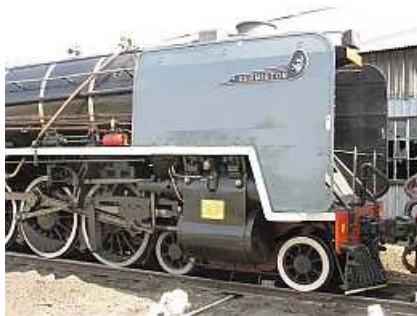
L05 ☞ Reminding one of the old Easter tradition of wearing a new Easter hat or a bonnet, Avril sports shiny grey smoke deflectors as she is shunted into the reception track for fire lighting on Good Friday.

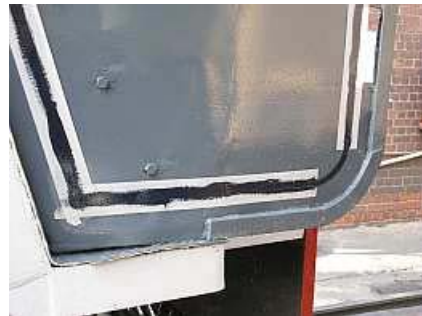
L06 ☞ Locomotive pin striping. Notice that the curved corners are being hand painted.

Lee Gates was put to the job of painting the embossed brass SAR oval cab plates, and some of that blue was borrowed to line out the plain grey smoke deflectors. The original proposal was to use automotive type pin-striping for a quick solution. But would that stand up to the rigors of use on a locomotive? It took three fellows to lay out the masking tape for the pin striping and they did a remarkable job of keeping everything lined up and parallel to the edges, while standing in their awkward positions. The corners were painted freehand though. (Pic L06 below) The grey background paint had been applied generously and with no runs ☞ so it served to smooth out the rough surfaces. Thus, it was easy to prevent the dark blue paint sneaking under the tape ☞ and resulted in a sharp striping job.

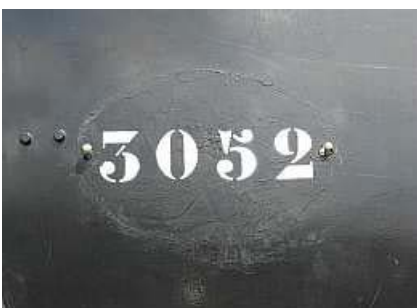
L07 ☞ Plain-Jane stencilled cab numbering. It doesn't look too bad, but reminds us steamers of the scrawled white graffiti numbers roughly sprayed onto the cab sides of to-be-scrapped locomotives.

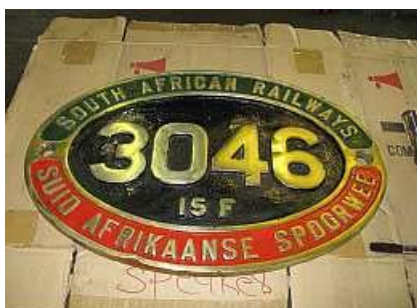
L08 ☞ An unusual multi-coloured locomotive badge in red, green and black. Remember that this is a borrowed cab number plate while new plates for No.3052 are being made.

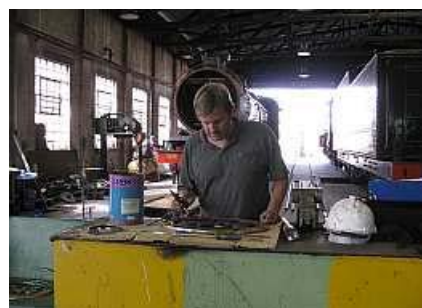
L09 ☞ An artistic genius at work, guiding that sticky, stiff paint brush through the brass relief obstacle course. What a job!

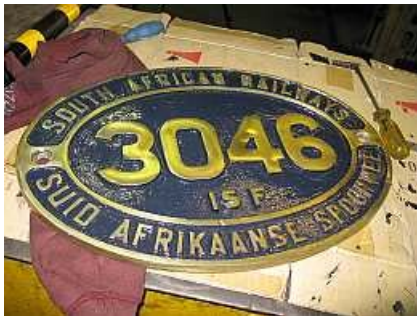
L10 ☞ The ☞Tricky Blue☞ is revealed nicely in this angled camera flash.

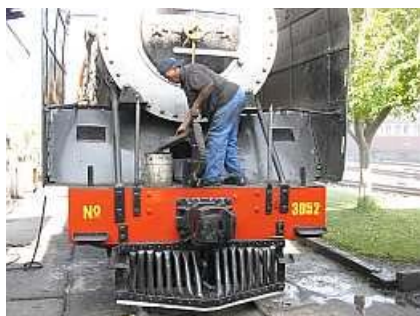
F01 [Sakkie](#) wields the short-shovel to clean up the leftover smokebox char from the front deck. This turned out to be well timed as this was the area upon where the brake vacuum pipes would be removed later on that day.

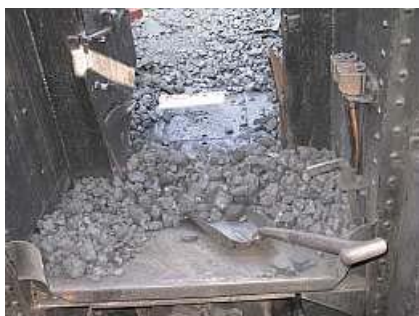
F02 [The shovel plate](#) after the first helping of coal. Looking through the coal doors behind the front heap, you can see that the stoker slides are all closed. The [gobble-hole](#) is buried two slides in the heap at the rear.

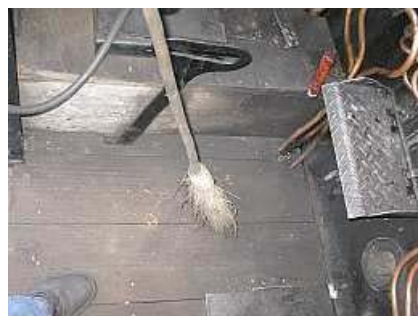
F03 [Exciting job](#) sweeping out the cab. But it made the day's work more pleasant. We didn't want to just later on blow out the splinters into the grass with the spray pipe, because of the 24 doggie paws in the vicinity.

Lee also took some time to sweep out the cab (Pic F03 above), which was pretty dirty from the recent gauge relocation and piping work, as well as the ejector overhaul and installation project. [Avril's](#) cab floor is rotten and there were many splinters remaining from a recent patch that was done, as well as two more planks that were breaking up at the driver's steps. Sakkie then joined in, and they cleaned up the upper surfaces of the draft gear ledge between the tender and the engine, which collects much coal and dust over time.

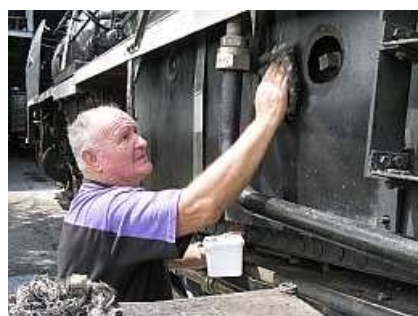
F06 [\(Prev week\)](#) Oom Attie cleans the left side of the fire box with his secret blend of oils, wax and paraffin. This is a tricky area to clean on a live locomotive because of the heat, and that very hot injector steam line.

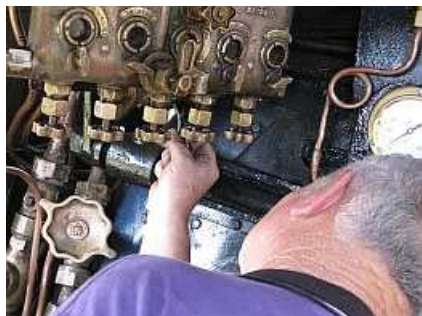
F07 "Picasso de Necker" paints behind the lubricator. Notice the five sight glasses a characteristic of a mechanically stoked locomotive oil being fed to the two valve chests, the two cylinders and the stoker steam intake. (A hand bomber's lubricator only has four sight glasses.)

Some painting was required too, around the newly cut down gauge plate and also some of the mounting hardware behind the lubricator. (Pic F07 below.) Meanwhile, a pair of wide floor boards came up on the driver's step-side, leaving a broken off chunk under the step header rail and some remains of cross braces. Lee started the job by cleaning the area down to the pitted metal work. (Pic F09 below) Andre van Dyk, who had arrived to prepare the locomotive for his fireman's run on the morrow, ended up as the carpenter.

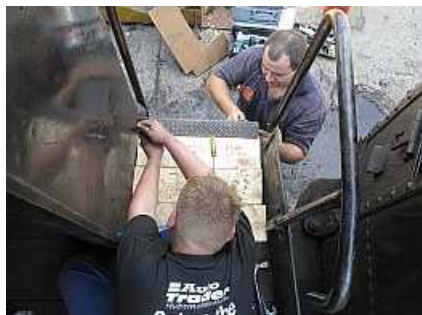
F10 Victor (Bottom) and Andre lay fresh planks on the Driver's entrance side.

Andre simply broke up some old wooden pallets and cut them down, being careful to get all the original nails out. It sounds like a simple job but the plank ends were not to be cut evenly as there's a slight taper at the cab's toe board. They weren't able to use a power saw either. (No electricity.)

The new narrow planks were screwed into place not just wedged. (Pic F10 below) This is untreated pine and won't last very long (but good enough for a few trips). We'll eventually re-lay the floor with longer lasting hardwood and take the effort to match the edges to the taper as well. The new floor stayed clean for about, oh, like 5 minutes. (Pic F11 below) Oh well, it will soon blend in with the existing weathered and coal-tinted wood. Actually, we aren't usually so dirty, but there was a lot of wet coal dust and chunks in the vicinity of the loco steps.

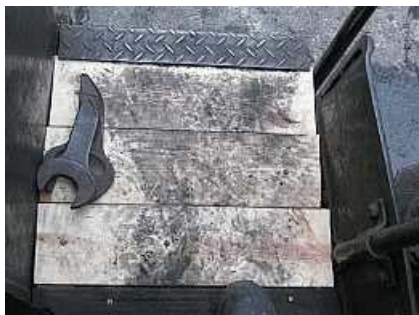
F11 Wouldn't our shiny floor obsessed mothers be pleased to see this!

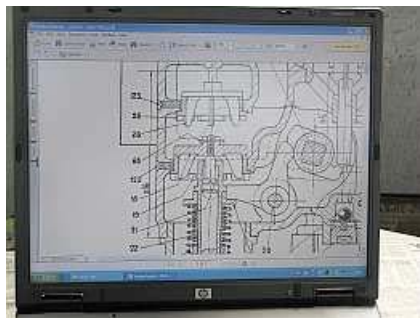
A problem discovered with the original set up was that the main air clack valve wasn't operating properly. It was found to be a combination of an incorrect limit pin and a very worn can follower. The new valve limit pin was measured up and turned down in the lathe from a 15mm stainless steel rod. (Pic E02 below) The barrel is in two diameters. This was done using the tailstock of the lathe, and a thread die-nut held in the chuck. (Pic E03 below) The lathe wasn't powered to cut the thread but being turned over by hand, the chuck providing a bit of leverage.

E01 A blend of modern technology and vintage machinery. Here's a CAD drawing on an ejector vacuum valve. The L-shaped object in the center is the valve lifter and the cam is clearly visible middle-right.

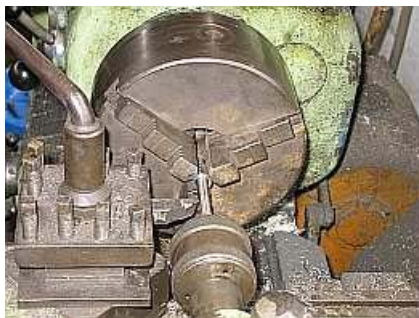
E02 The new lifting pin is being turned down from 15mm stainless steel stock on the lathe. That small hex-head took some centering before the bolt would spin straight in the lathe's chuck.

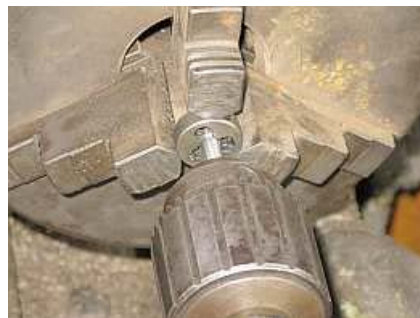
E03 Cutting the threads by hand, using the lathe chuck as a hand-powered die-nut spinner.

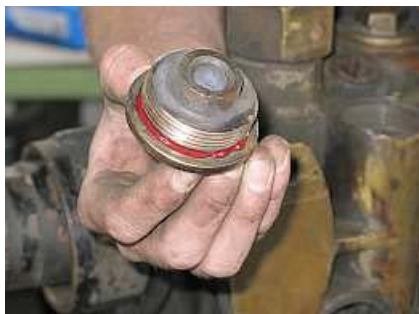
The cone covers and access covers were replaced, each one being carefully sealed and locked with a generous application of LockTite thread treatment. (Pic E05 below) The Stag sealer so frequently used by Reefsteamers for piping and flange work isn't really suitable for high temperature threaded applications as it remains soft. The LockTite is more for sealing rather than preventing the threads working loose. Loose covers not only hinder the efficiency of the ejector, but loose covers with steam behind them are both annoying and dangerous to the driver as the ejector sits right in front of his face. Worn and leaking rear facing cone covers are a particular annoyance.

E05 Installing a valve cover. Notice the fresh red bead of LockTite thread locker fluid being used as a high temperature cap sealer.

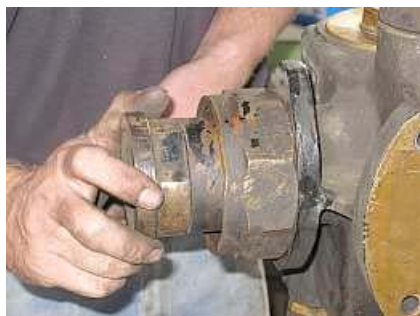
The vacuum pipe union went on by hand with little trouble with cleaned, reconditioned threads. (Pic E07 below) Shaun forgot the union nut that had to go behind the sealing face, but luckily remembered before the pipe union went fully home and squashed the sealing bead. (Pic E07 below) It looks a treat with the surfaces cleaned on the lathe, but more importantly, the spanner flats will ease removal for future work. While other work was progressing on the ejector, Andrew King got going with the ball peen hammer and tapped out a brand new gasket. (Pic E08 below) No way were we going to try and re-use the flattened original.

E07 The new vacuum union is being screwed in by hand - testimony to the cleaned reconditioned threads. Note the retracted union nut which is

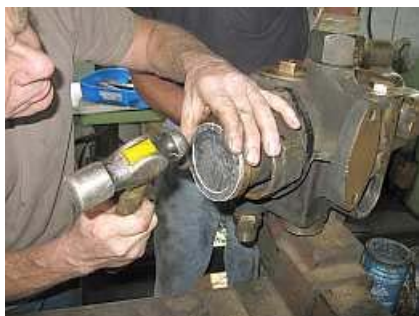
E08 In one of the many positional adjustments of the ejector in the vice, Andrew finds a convenient angle to opportunistically tap out a new gasket

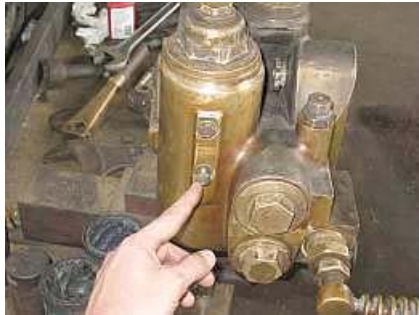
The next job was to make a new bolt to serve the function of a valve seat retainer. (Pic E10 below) These two bolts don't physically engage with the seats, but rather their outer ends press into the sides of the threaded seats and functions to stop them from turning. This makes the length of the bolts critical. Too long and the valve seats will be distorted as the bolts are screwed in all the way home. Too short, and only the threads between the valve seats' outer circumference and the brass casing would keep them in place. This means the bolts have to be individually cut and fitted, and possibly shimmed with precision washers. An otherwise competent fitter who's unaware of this issue may damage the valve seats, or leave them without safety locking, just by mixing existing bolts up.

E10 One of two valve seats retainer bolts that have to be carefully cut and machined to fit against each valve seat exactly. (The ejector is upside down in this picture.)

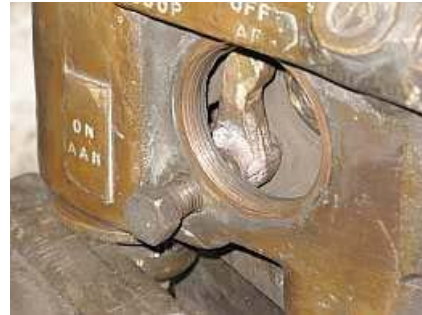
So the built-up valve lifter was fitted, through a remarkably small hole which caused some cussing! Hardly room for the knuckles much less the hand. The valve assembly is spring loaded and there was some difficulty in engaging the two stirrup-like claws. And then the center hole on the lifter had to be lined up for the insertion of the spindle. (Pic E12 below) No, not an easy job at all. One would need the hand of a gynecologist or an obstetrician to do this job with a small profile and strong fingers.

E12 The valve lifter after being wrangled home and the pivot pin has been half installed. The valve is heavily spring loaded, which added to the fun.

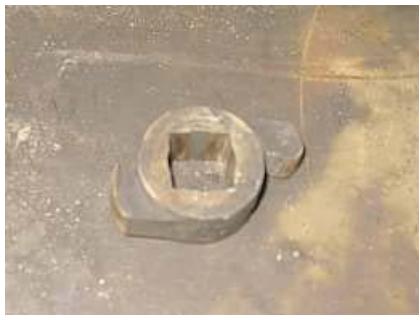
The removable cam (Pic E13 below) was then fitted to the camshaft and the camshaft was re-installed. This is tricky as it passes through two glands in the housing (One visible in Pic E10 above) and has another cam on the leading end. The slot-machine-like brake lever was put loosely back onto its square shank and the turning action checked. The initial action was reasonably smooth but the follower profile was too high. The cam and the valve lifter baulked. The driver would have felt that the lever doesn't want to go all the way horizontal when applying his brakes.

E13 The removable cam. You can just see one of the re-dressed cam profiles at the lower left.

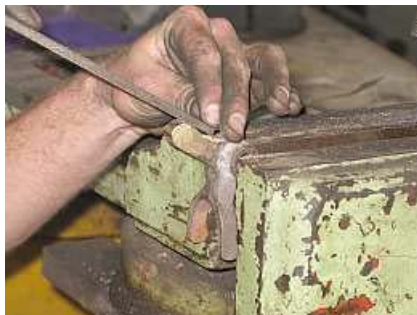
The valve lifter was removed with the same irritating caesarian puzzle. It was then clamped in the drill press vice and carefully filed down, with special effort taken to keep the profile round. (Otherwise it would put a false notch into the movement of the brake lever.) This removal and re-fitting process was done three times before the valve action's tactile feedback was deemed satisfactory. (Pic E14 below) That's why they call the job 'fitting'. And it was done with the knowledge that the valve action and/or tactile response would probably be different when the ejector is hooked up and functioning under steam.

E14 The cam follower is being carefully re-profiled to bring the valve lift back into spec.

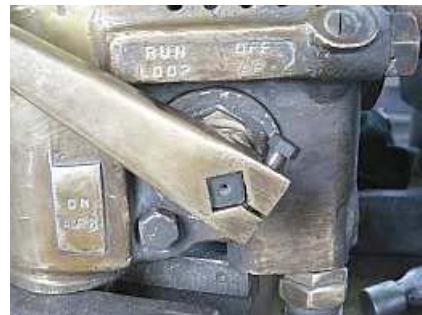
E15 Detail of the end of the brake lever. Notice the annotated three positions of the lever. (Off \ Aff) (Run \ Loop) (On \ Aan)

After this persistent fitting and removal, and the cam follower profile deemed acceptable, it was time to button up the bearing nut and the gland nut of the ejector. (Pic E15 above) This was done with ease but that protruding hex nut for the valve lifter pivot (bottom left) really messes up the access to the two nuts. (Pic E16 below) Naturally, the sealing faces were all LockTite sealed. The assembled brake valve lever feels much firmer with a tighter valve train and a tighter set of sealing glands a fact that the drivers will have to get used to.

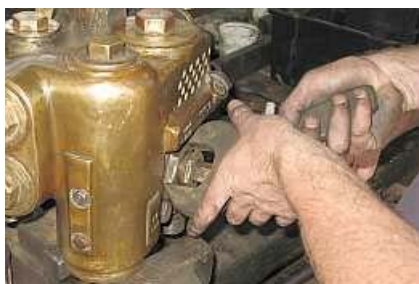
E16 Spinning in the nuts with a loose spanner, before laying it flat for the final tightening. The hex head for the pivot, visible just below the spanner, blocked access. The grid above the spanner is the air intake.

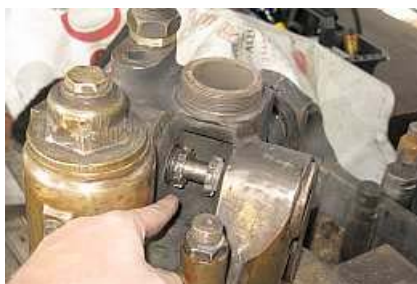
E17 A pair of castellated gland nuts halfway along the cast-iron shaft, which is visible spanning the two. These should be tightened by means of a c-spanner, not by a hammer and punch as we've so often seen evidence of being done.

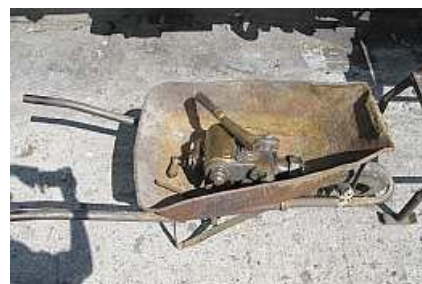
E18 The finished ejector is waiting in the wheel barrow, which also helps to give a sense of scale to this large, beautifully convoluted brass casting.

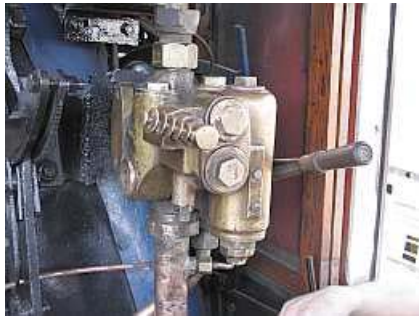
The ejector was refitted to Class 15F No.3052 Avril late on Good Friday. (Pic E19 below) The locomotive was not in steam at the time so a live test could not be done. But the advantage would be that the pipe work would be cool to the touch, especially if some last minute pipe fitting would be required. Ejector fitting is a two man job but there isn't enough room for two people to get into the driver's corner of the footplate. So one of the team usually has to work from the outside and leaning in through the window. (Pic E20 below) The cab number plate polisher was happy to give up the steps for a good cause.

E19 Newly installed brake ejector. The top pipe is the steam inlet and the bottom pipe is the vacuum line for the train's brakes. You can see the T-junction tap off for the duplex brake vacuum gauge. The small pipe at the lower back leads to the locomotive's vacuum cylinder. Not visible, coming in horizontally through the back, is the steam, entrained air and vacuum discharge lines which blows to waste inside the smokebox.

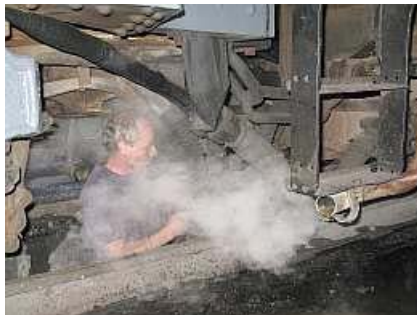
The fellows first checked the brake lines n Andrew literally stepping down between the locomotive and tender to split and isolate the brake pipe by inserting a brake line dummy. (Pic E22 below) The vacuum picks-up the dummy and pulls it against the sealing rings, blanking off the brake lines. They've been suspicious of the tender brake cylinders for a while. The test was inconclusive and the fault remained.

E22 Tight quarters. Andrew is just inserting the blanking disk into the locomotive side of the tender brake line. You can just see the disconnected tender brake line angling down in front of his forehead. The pipe in the foreground is the water feed for the RHS boiler injector.

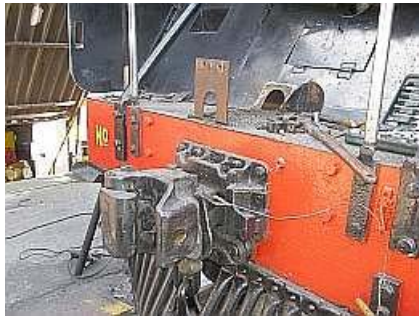
This narrow triangular cavity contains one oil pot, the ledge under the smoke box and the two valve covers. And today, it contained some members of the steam team. Pic 01 (Below) shows the front deck and the brake stand bracket after the pipe had been removed, with the angled wind deflector plate clearly shown.

B01 A view of the stripped down brake pipe stand. That mouse-hole leading out to the front deck plate is the pipe aperture.

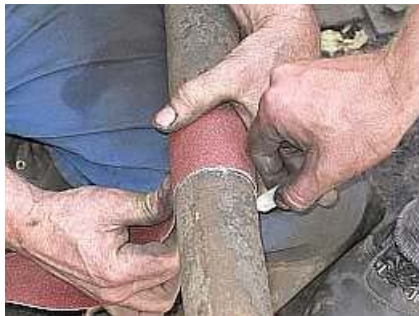
B04 Using a strip of sandpaper as a ruler, the edge of the pipe is marked off square around the entire circumference..

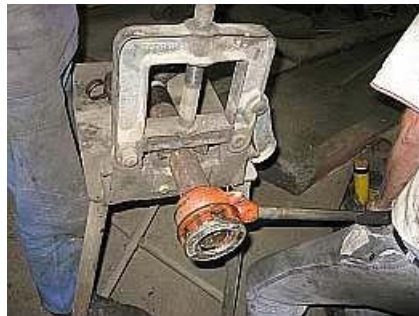
Once the pipe was cut, the ends had to be dressed and then clamped in a pipe press for the threads to be clamped. (Pic B05 below) The leverage was a bit high for the stand and we had Andrew acting as a highly skilled counterweight to stop the rather tall pipe stand from tipping over. (Pic B06 below)

B05 A bit of grunt work cutting threads on a 2 inch pipe.

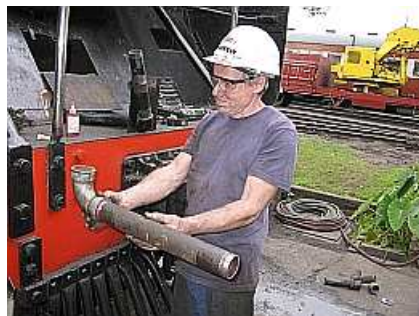
B08 The troublesome buggler and I don't mean the Chief Engineer. Andrew King sarcastically holds out the newly cut and threaded dropper pipe.

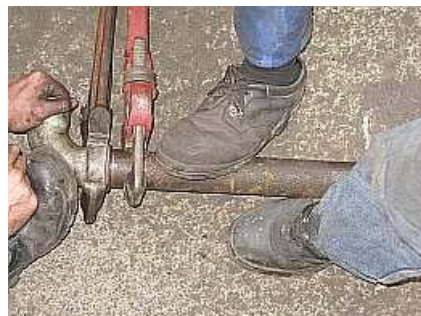
Putting the pipes back together was tricky in the confined space behind that wind deflector plate. The job was made even more interesting by the fact that this engine was in steam, and those cylinder heads and valve covers were getting hot. (Pic B07 below) It was a bit of a monkey puzzle to get all those pipes together again with little space to swing a stilson wrench. The dropper pipe had to be test fitted and then removed once more to cut the other end, with care to allow for the hidden depth of the threads once all the elbows are screwed back on. Eventually the dropper had both elbows inserted after some testing and three-way clamping with safety shows and a pair of bobbejaan (Stilson) wrenches. (Pic B09 below.)

B09 Three men and a baby, or a pipe, in this case. There are two Stilson wrenches in use here so we needed a combination downwards force and sideways restraint.

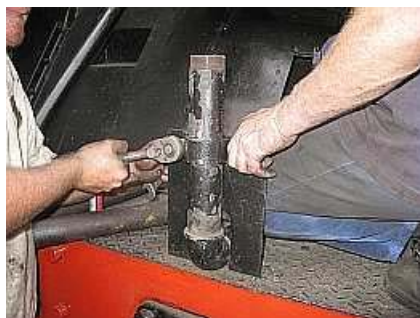
This mess of piping is actually only attached to the engine at the brake stand, so the exposed front pipes had to be put back in first and the saddle tightened up. (Pic B10 below) Otherwise there would be nothing to turn against when using the wrenches. It still took 2 sets of hands to get those pipes in, without jamming or cross threading. Shaun worked from the side, just in front of the cylinders, using his long arms to advantage while more compactly built Andrew worked through the access hatch looking like he was being eaten. (Pic B11 below)

B10 The brake stand section of the pipe is clamped to the stand to provide something to work against. The dummy pipe has yet to be installed.

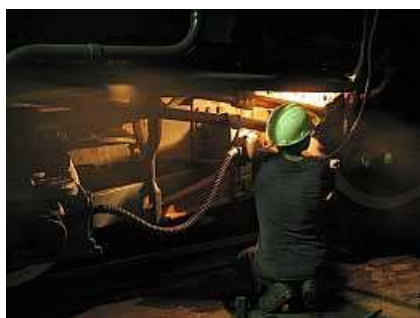
The engine was backed in and Andrew and Shaun got going with what looked like a very late evening of locomotive work. Attie de Necker did a bunk seeing he would have to report for duty at 4am. The brake testing took on a surreal air with the dangling work lamps back-lighting the drifting steam. (Pic B13 below) The brake pipes and cylinders were carefully checked for any missed leaks, and the overhauled ejector was partially dismantled to check it once more. (Pic B14 below.)

B13 Night shift work on the brakes. Andrew is checking the train-brake vacuum line for leak in the area where it rises from alongside the firebox and runs under the walkway. The flexible pipe in front is the speedometer's signal cable.

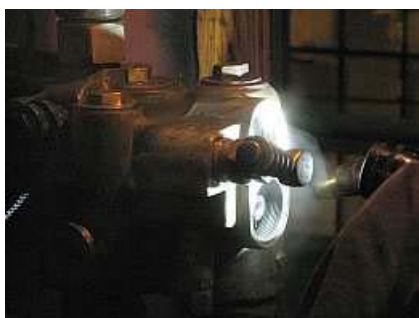
The known-functional brake ejector from Class 15F No.3016 "Gerda" was temporarily installed, to eliminate whether the rebuilt ejector was at fault and it did. The response was pretty much the same so the problem wasn't the rebuilt Ficksburg era brake ejector.

B14 yet another ejector check, checking the injector cones by torch light.

The problem was resolved when an ex-railways member of Reefsteamers (Johann "Stitch" Versteeg) pitched up and looked over the issue. The problem turned out to be a simple one the ejector's steam feed from the turret valve wasn't open all the way. The valves in the turret manifolds, which supplies steam to all the auxiliaries, are operated by what we call "Spindles." Each spindle has a single universal joint. (Pic B15 above) Sometimes, the joints get cocked and jam and then the shafts lock up, usually on the closing cycle. The result is a valve handle that won't open again and the footplate crew has to manually operate the spindle shaft with a shifting spanner. Sometimes it happens when a valve is over-opened as well, and it needs a spanner to reclose it. But this one had unusually, repetitiously jammed suddenly and tightly halfway through its travel, misleading the operators to thinking that the valve was open against the back stop. Such is the benefit of experience. The rebuilt ejector has been refitted and Avril's brakes are now running a treat.

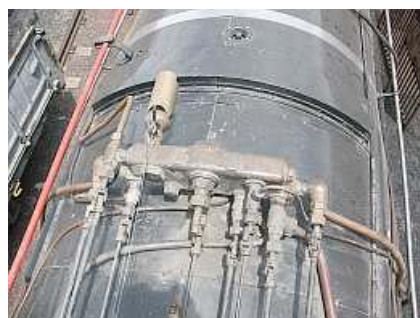
B15 The turret manifold, valve spindles and universal joints of the Class 12AR. The 15F's have a two piece manifold which is closer to the cab but the principle is exactly the same.

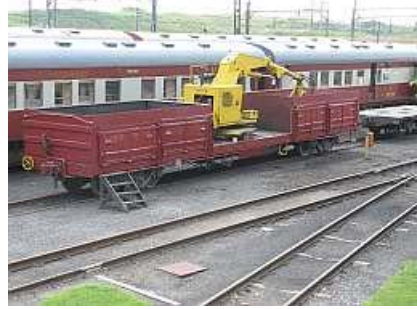
C04 📷 The roller finally comes out for the flat panels and the plate work. The size of the photos doesn't really show how smooth the paint job is.
