### **PROJECT - Hunslet Taylor Engine Reassembly :**

**PROJECTS : Sandstone Coach Fitting :**

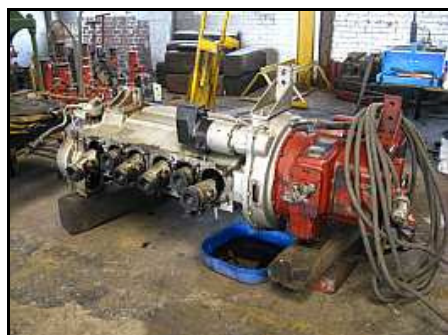
E01 – With the six pistons hanging limp, the engine lies submissively on its side, waiting for a sump scratch, just after the covering tarpaulins have been removed at the start of the Saturday Depot Day..

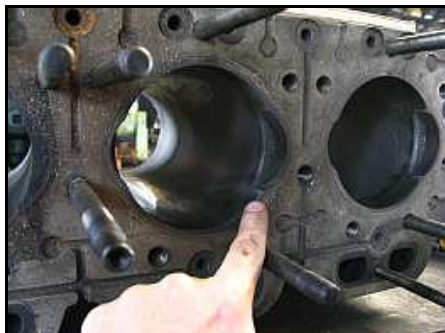
E05 – Here's a rather unusual valve pocket. You can see the carbon ring in the right most cylinder, which shows the position of the upper compression ring at Top Dead Center. The piston land actually 'covers' the valve pocket.

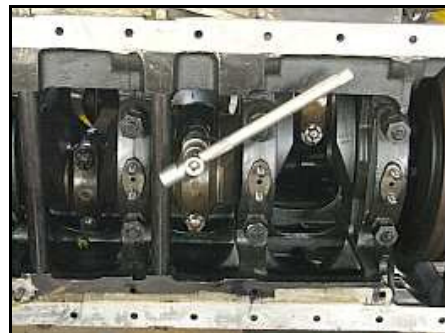
The big end bearing caps were taken off in turn and checked. They are plain steel-backed white-metal shell bearings as can be expected for an engine of this vintage. (Pic E06 below) There was no serious damage found – just wear and a few fine score marks. The pistons were removed with a few curse words as they had to be withdrawn past the naturally obstructive crankshaft journals. While the crankshaft was being rotated to suit, the other, loose, dangling pistons had to be held and guided through into the sleeve apertures as not to snag and crack their tilted skirts against the crankcase.

E06 – Having put the grunt on a bearing cap, the engine is about to be rotated and the crankshaft held locked for the next bolt.

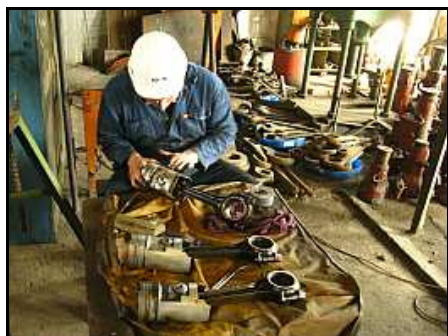
E07 – Aiden settles down scraping the carbon deposits off the pistons while avoiding longitudinal grooving and scratching of the alloy material.

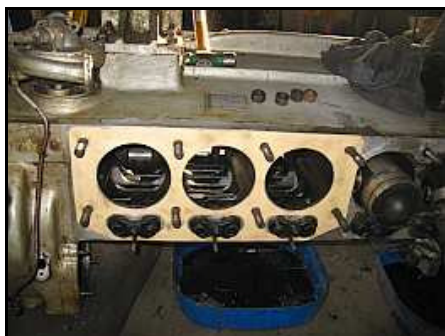
E08 – Freshly inserted crank case gasket. The pushrod guides have already been re-inserted. The object protruding into the left most cylinder is the exposed crank throw

The studs needed cleaning and their threads were lightly re-tapped. The gasket still had to be fed carefully over those long studs as not to snag and tear. Because it's a crank case gasket, it does not have the complication of sealing off the cooling water galleries. What was a remarkable luxury in this engine reassembly is that brand new sets of gaskets are still available for this engine that was built back in 1952, when the locomotive's bell was originally used to ward the dinosaurs off the track! This gasket was just withdrawn from a spare parts kit instead of being fabricated by hand ... which looked like cheating. Just way too easy...

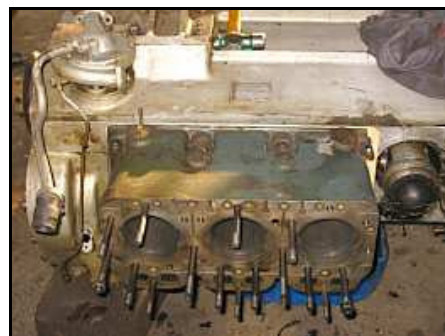
E09 – The block's revenge. Those deeply insert mounting bolts don't allow sockets – open ended spanners had to be used, 16<sup>th</sup> of a turn at a time. This is when I chose to 'disappear.'

The engine block had its revenge though. The center four studs are deeply inset in cast channels that block the use of sockets. (Pic E09 above) It was a time consuming project to gently screw down the block evenly. Luckily the protruding cylinder sleeves 'pegged' into the crank case and helped to take up the weight as the bolts were snugged up. By the time the rear block was buttoned down and a raw-fingered Aiden had managed to clean the pistons, the evening was approaching. So the day's engine work ended with comparing the bearings and fiddling with the piston rings.

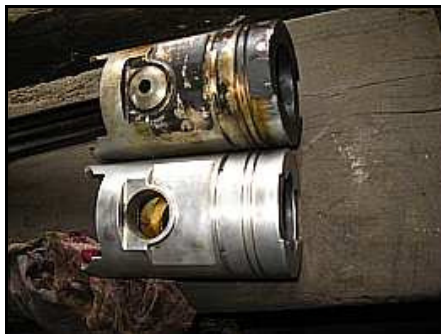
E11 – An almost completely cleaned piston contrasts with one in a just removed state. The surgically smooth finish should be worth a few extra Kilowatts at the flywheel I think.

Initially, the piston cleaning was a scrape and then a sanding job, with great care not to make linear scratches in the alloy. But when doing the inset skirt areas around the gudgeon pins with the powered wire wheel, I discovered that the piston material is hard enough to withstand a good stiff power brushing. If I had put some light radial scratches in the gudgeon pin areas it wouldn't have affected the piston at all – so it was a good 'sacrificial' test area. But the grained surface came up flawlessly, so I put these three 108mm diameter bad boys to the wire. (Pic E11 below)

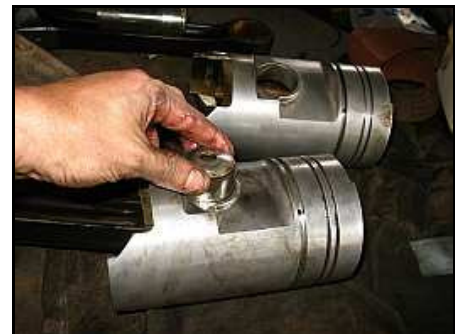
E12 – Installing the fully floating gudgeon pins.

I was glad that Aiden McCarthy wasn't around to witness the job as he probably would have felt a bit sick to watch me do the work in a fifth of the time he took to do the job by hand. But it IS rare to be able to wire brush an alloy piston. One disadvantage of the power wire brushing was that the gudgeon pins dropped out and I lost the relationship between two of the pistons and their con rods. Luckily, in the cleaning process, the original finely stamped 'forward' arrows became visible in the piston crowns and by examining the installed pistons, 'Forward' matched up to the odd number stamped side of the connecting rods. Because there's very little play in the gudgeon pin bearings, fitting the pistons back to the rods was an exercise in patient wriggling to get the chamfers to match before the pin would slide in. (Pic E12 below.)

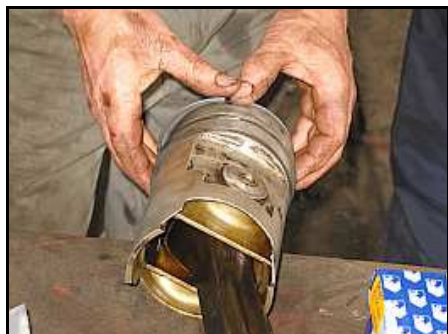
E13 – Inserting the new piston rings. The very wide top land meant extra care had to be taken in walking each ring down to their slot without snapping them. This is the top-most (easiest) compression ring going on. Note the massive fully braced construction of the piston skirt – typical of a diesel engine.

The piston ring grooves were cleaned with bits of broken ring. It's not always a successful method as it's hard to get the ring to break at an acute angle and one has to be careful not to gauge the groove. With the crusted carbon gone, the grooves were cleaned by threading rough manila parcel string through them and using it like dental floss. Meanwhile, Andrew was walking the new piston rings into place – which he achieved without breaking a single ring, (Pic E13 below)

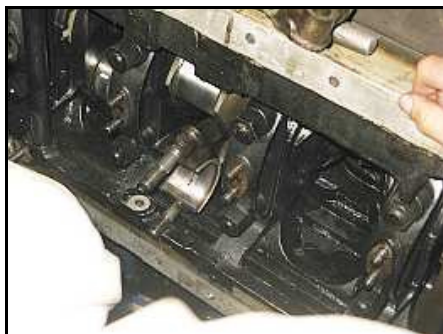
E14 – The old bearing shell is still in place as not to expose the new bearing shell and the connecting rod casting to knocks when getting the piston up past the crank.

With this parts matching drama going on at the bench, the bearing caps on the existing three installed pistons were re-installed. The pistons were reinstalled with the existing bearing caps in place, so if they took a knock during the awkward maneuvering, and during the chore of closing the piston rings to get them into the bores, it wouldn't be new parts getting damaged. (Pic E14 below) Because of the limited enclosed space, a piston ring compressor could not be used.

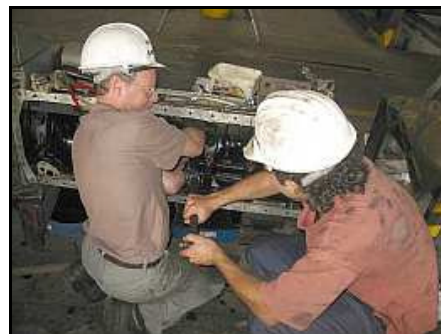
E15 – I'm not the piston pusher, I'm the piston pusher's son! But I'll muck in pushing pistons when there's pushing to be done!

Andreas applies traction while Andrew (Working by feel and pulling the funniest faces) manipulates the piston rings

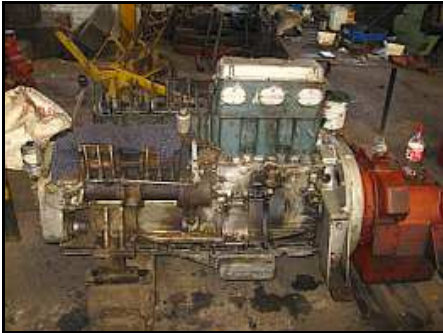
E16 – The engine is coming back together. One cylinder head has been installed with all valves, rockers and the decompression shaft. The sump has also been re-installed.

At the start of Saturday 6<sup>th</sup> September, the diesel engine had progressed with one half being loosely tiled with the as yet unbolted rocker cover and the other half being up to block height. (Pic E16 below) The sump pan was re-installed the previous Sunday. Mounting the rear cylinder head went with little problems but some parts had to be 'borrowed' from the front half of the engine to complete the assembly. One of the valve springs was found to be weak and was replaced, and two cylinder head studs were damaged. A pushrod was found to be damaged as well. So, disappointingly, the front cylinder head couldn't go back on until new studs can be made and a replacement valve spring obtained.

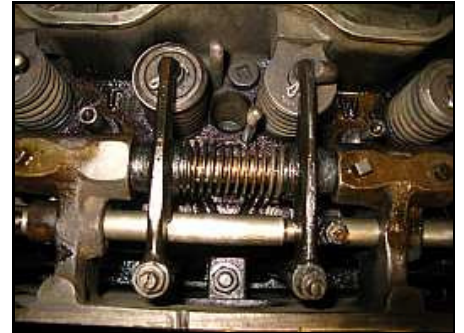
E18 – A rather complicated top end for a 1952 year engine. The light coloured shaft is the decompression shaft and carries three shallow cam-ground grooves actuating small adjustable bolts on each rocker – the extra bolt on the right rocker is clearly seen.

The rocker shaft is actually in three pieces – you can see the three square shanked locating bolts on the bearing pedestals. Injectors not installed yet.

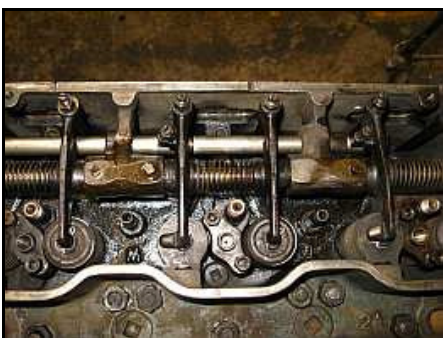
E19 – The diesel injectors have been installed and clamped down. The diesel fuel piping actually couples to the threaded clamp and not to the injector itself.

The recesses for the fuel injector bodies were cleaned quite carefully, being natural dirt traps. Then the injectors were installed and their saddles tightened down. You can clearly see the injector's pocket between the valve springs in Pic E18. (Above) Care was taken with this as to not cock or distort the injectors, and to not damage the fine threads for the piping.

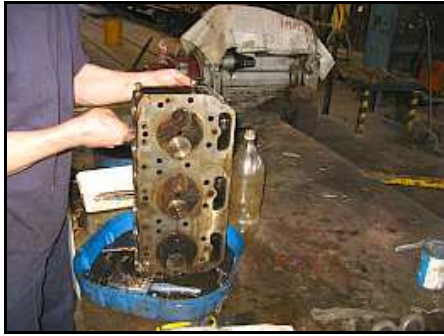
E21 – The cylinder head gets an afternoon bath. Notice how the larger inlet valves, naturally cooled by the induction mixture, came up shiny without brushing. You can see the fuel injector holes right between each set of valves.

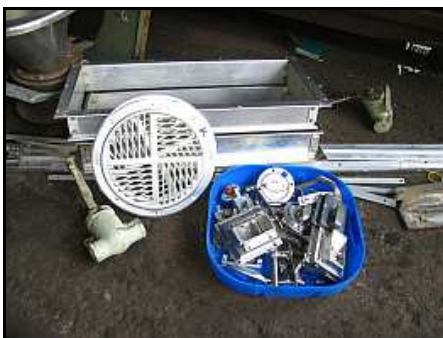
C01 – Doesn't look like much does it? But look carefully and you'll notice that all these coach parts are clean, straight and reusable.

The interior fittings, right down to the aluminium strip beading, the lighting channels, the door hardware and even the roof vents, had all been carefully removed. (Pic C01 below) The temptation is always there to just lever them away from their panels, especially with the SAR-speciality seized countersunk Phillips screws where you have to chisel years of embedded dirt out of the screw slots before one can even engage the screw driver. Shaun Ackerman did the strip down and on occasion he used a low-gear power drill to remove stubborn screws – and chewed up a few bits in the process. Only a few of the more stubborn full lengthed aluminium trims got bent – but they can be straightened again. (Care was taken not to twist or graunch them.) In any case, about 50m length of various sections of brand new anodized aluminium have been purchased at a cost of R1500 to replace damaged or missing sections. (Pic C02 below) These channels not only tidy up the gaps between the panels but also hold the panel edges to the coach's frame work.

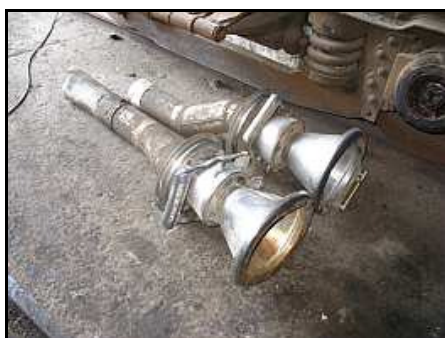
C04 – Two spare toilets with working flap valves and intact drop pipes wait for test installation to check the fit. Note the angled discharge pipes. The originals go into the spares stock.

Two intact toilets were recovered from the spares stock. (Pic C04 below) This coach needs to run soon and there's no time to mess around with dicky flap valves and wobbly linkages. These toilets are of the more modern, rounder type and can be used with a domestic toilet seat and lid set, which adds a little more homely touch. Although it was initially discussed to only install two toilets, all four toilet compartments are to be brought back into service. The toilets were installed temporarily to check the fit of the discharge pipes. Remember that the bogies of these coaches are of the older riveted fully elliptic spring bar frame type, as opposed to the coil spring equipped bogies of the more modern coaches. The pipes have to fit around the bogies and discharge to the outside. The pipes need to clear the bogie for rotation and care needs to be taken that the discharge doesn't get onto the bearing boxes and the bearing covers.

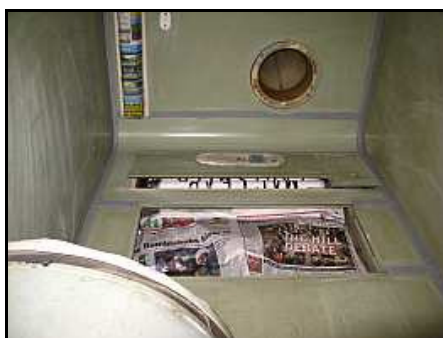
C05 – A toilet brush's eye-view of a masked toilet compartment. The still decent looking aluminium panel trimmings in the toilet compartments is to be painted over – which gives a cleaner look and eliminates unhygienic crevices in the walls.

The extra work of removing all the interior trim and fittings in the toilet compartments much reduced the masking required for spray painting of the undercoat. But there was still a surprising amount of masking to be done – much of it awkward with rounded, deeply inset edges. (Pic C05 below) The coach vestibules, gangways and toilets were spray painted in white primer before the rest of the coach, while the removed gangway and toilet compartment doors were spray painted outside. The vestibule doors, albeit stripped, were left on their hinges.

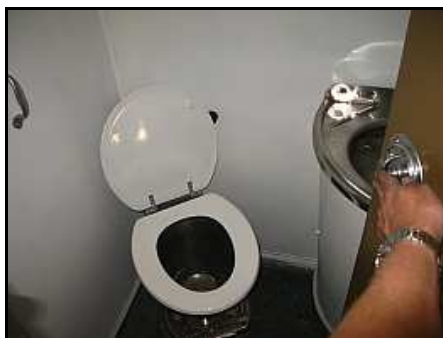
C08 – What a comparison! A gleaming white toilet compartment with a temporarily fitted and seated toilet. Luckily, the flooring in these compartments is still in good shape. (Because they were sealed up and out of use.)

The toilet compartments have been painted sheen white, as have all the ceiling linings. There will be no more dingy toilets on our trains, thank you very much. (Pic C08 below) The spray painting was done with a proper protective suit, goggles and a face mask throughout the entire coach (Pic C06 above) but especially in the confined spaces of the toilets and the vestibules. It's the only time you'll ever see a Reefsteamer wearing white!

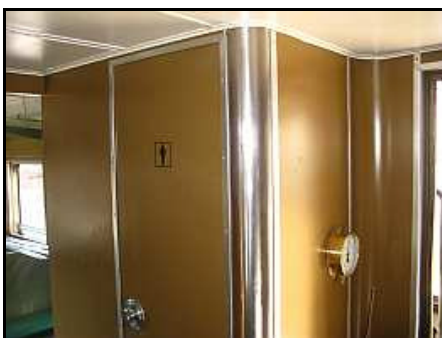
C10 – A freshly painted coach vestibule. Note a typical Dr. 'Smudge' Ackerman touch... the brass brake vacuum gauge had been polished before refitting. The 2-leaf gangway doors are still missing in this picture.

The coach received its top coat during the last week of August, after the under coat was allowed to have several days to dry and cure properly. The coach No.25206 was pretty bad in the vestibules (Pic C09 above) but the sister day-sitter No. 25163 was almost as dingy. The vestibules have been spray painted 'Zirconium' brown and have had their aluminium trims strips fitted. It looks much more attractive than it sounds ... check out the sharp looking results in Pics C10 and C11 below.

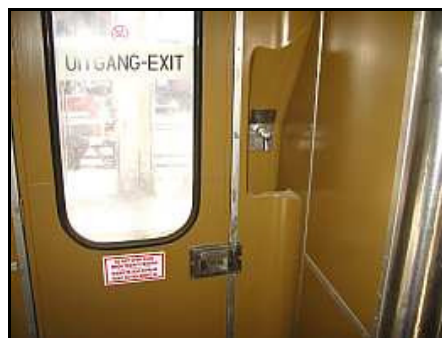
C11 – Details. The aluminium needs to be polished and the window needs a good clean. But notice that original style bilingual 'door leaning' decals have been re-applied, the latch is perfectly straight and all the aluminium is present.

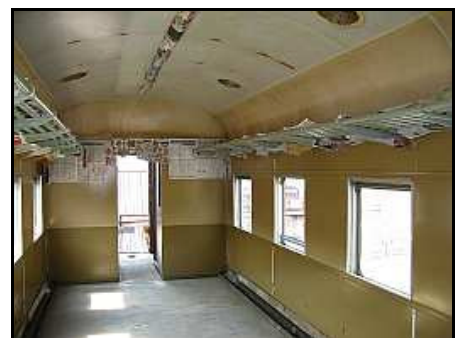
C12 – The two tone paint job for the walls. The entire ceiling is still to be painted white in this pic – but the curved quarter panels just above the luggage racks show just how dirty this coach's laminates actually were.

Pic C12 shows a shot of the painted coach interior masked off to do the ceiling lining and the quarter boards. A purist might complain that we are removing the original SAR finish and colours. And so we are and without apology. The Reefsteamers have tried both mechanical and chemical methods of cleaning the 20-30 year old laminated boards without ruining the finish and it has proven to be impossible.

So, it's been decided to smarten up our coaches with decent interior paint jobs. This way, it is also possible to fill in and patch up holes left behind when fittings have been removed or roughly modified – whereas it is quite hard to make an invisible patch in a laminated board. With spare paint, a hole can be plated or puttied in, sanded down and simply repainted. The 2 Sandstone Day-sitters are to be the test coaches for the new colour scheme. If the paint scheme is well liked, and proves to be practical in terms of cleaning and patching, all of our coaches are to gradually be cleaned and painted like these. The brown was selected as a neutral colour. The darker brown under the window sills will obviously not show dirt as much. (Pic C14 below)

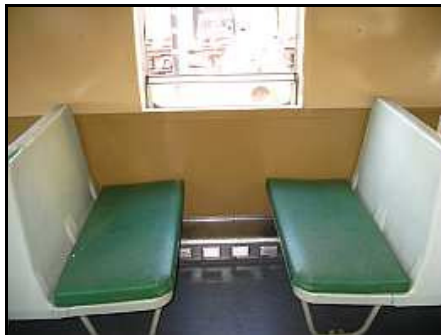
C14 – The new two tone paint scheme and the polished heater covers show to advantage here. The seats were fitted over the new flooring the previous day. Plans are underway to make Velcro-fastened slip-on padded covers for those hard-back seat shells.

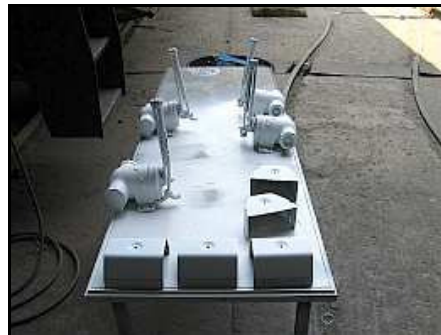
C15 – Painted coach parts after primer coat application. In the foreground are supports for the central lighting strips and the background are the four (non original) coach door closers.

The coach interior is almost finished with the various painted parts (Pic C15 above) being refitted. The central lighting strip has since been reinstalled and the lights reassembled. (Pic C16 below) Reefsteamers electrician Fred Sewell went once through the strip to restore the lights back to operation. The old tube connectors can be finicky when removed and reinserted at a slightly different alignment. The painted lighting strip looks sharp in Pic C16. (Below)

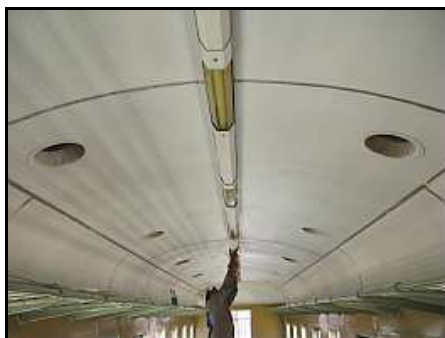
C16 – The painted ceiling having the converted 220V fluorescent lights re-fitted. Notice that the channels and support saddles for the lights and their lenses have been painted separately to match the ceiling.

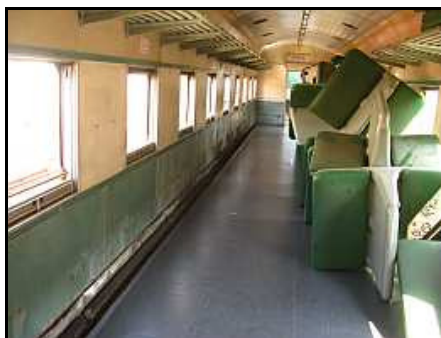
C17 – A newly laid vinyl floor in the currently unpainted coach No.25206. The seams are all heat closed and notice how the edges neatly wrap up into the open heater channels, The steam heating pipe is still in place in this photo

The flooring has since been completely re-laid in both coaches with Markey Supoerflex™ vinyl sheeting, with about 40 sq. meters used for each coach. The marine ply flooring itself was sanded down to provide a smooth surface for the adhesive. Fortunately, because of the drier weather conditions of the eastern Free State from whence we fetched the coaches, and the four 'Sandstone coaches' being properly stored under cover by the Sandstone Heritage Trust, the exposed flooring wasn't badly swelled or rotted by water ingress. So far, only sections of the vestibule floors of Coach 25163 had to be replaced. (Good on you, Wilfred Mole!)

This vinyl sheet material, called 'Marley 'Super-Flex'™ is applied with adhesive and the separate strips are fused together with heat. The seams remain visible as smoothly cambered indents but without open gaps and corners that can get picked and lift. (Pic C17 above) This material needs to be waxed every 6-12 months while the more conventional sheets need constant polishing. In the future, shallow scratches and lifted areas can be repaired by gentle application of heat. Strips of this material were heated and when softened, were formed around the short panels and awkward curved corners within the vestibules. (Pic C18 above) They now form easily repairable single piece waterproof mouldings which should extend the life of the flooring.

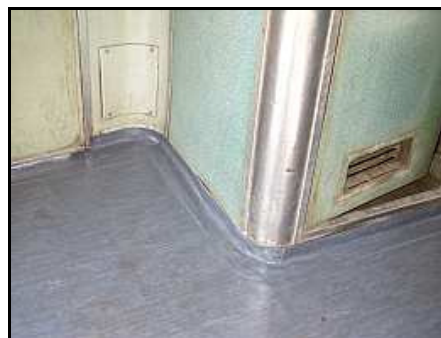
C18 – The free-form heat formed skirting wrapped around the circular section corners in the vestibule and forming a great water seal. The skirting on the green panel wasn't quite glued properly, but if Reefsteamers can fix locomotives, they can certainly glue a bit of vinyl flooring!

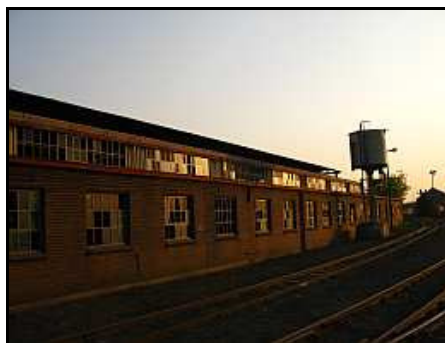
G02 – The Top Shed looks a bit gap toothed in the last light of the day – but look how shiny the new clean windows are in the clearstory rows.

The broken panes are being removed first and being replaced with fresh, clear new panes of glass. When this is done, the existing intact but very dirty window panes will be removed, cleaned and then re-installed with fresh putty. (Pic G01 below) So at the end of this project, every single window pane will have been serviced.

The project started in the yard facing wall of the Top Shed with all the broken glass taken out. The out facing clearstory has already been closed in and when the above pictures were taken, the entire outer wall was being started from the cloak \ washroom end first. On the 13 September, the cycle started with the larger window panes for the east facing wall of the workshop. It's going to be cramped work for the staff as these windows are shaded with long corrugated iron awnings at 45 degrees – awkward to get to the top panes.
